Hooks™

Capital Improvements Review

WHATABURGER

City Capex Summary

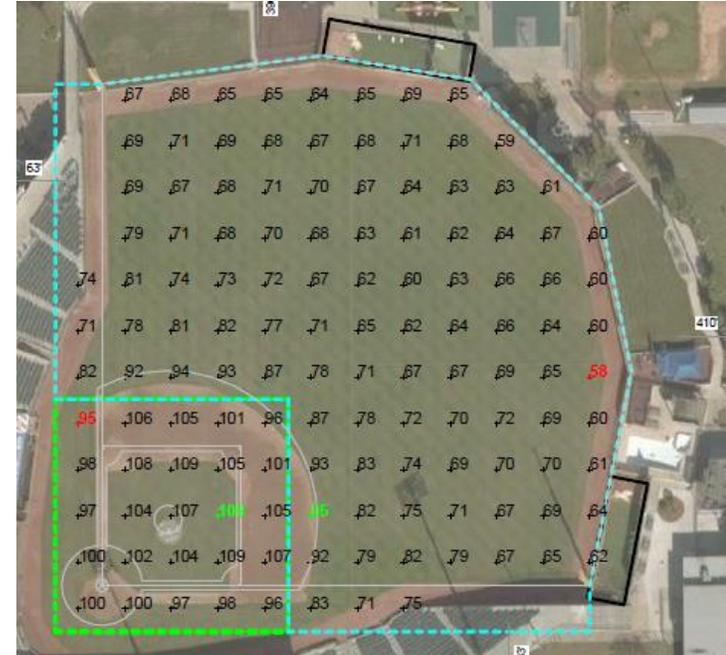
2016 Musco Illumination Summary

ILLUMINATION SUMMARY		
MAINTAINED HORIZONTAL FOOTCANDLES		
	Infield	Outfield
Guaranteed Average:	100	70
Scan Average:	102.41	70.68
Maximum:	109	95
Minimum:	95	58
Avg / Min:	1.07	1.21
Guaranteed Max / Min:	1.2	2
Max / Min:	1.14	1.63
UG (adjacent pts):	1.11	1.18
CU:	0.59	
No. of Points:	25	105

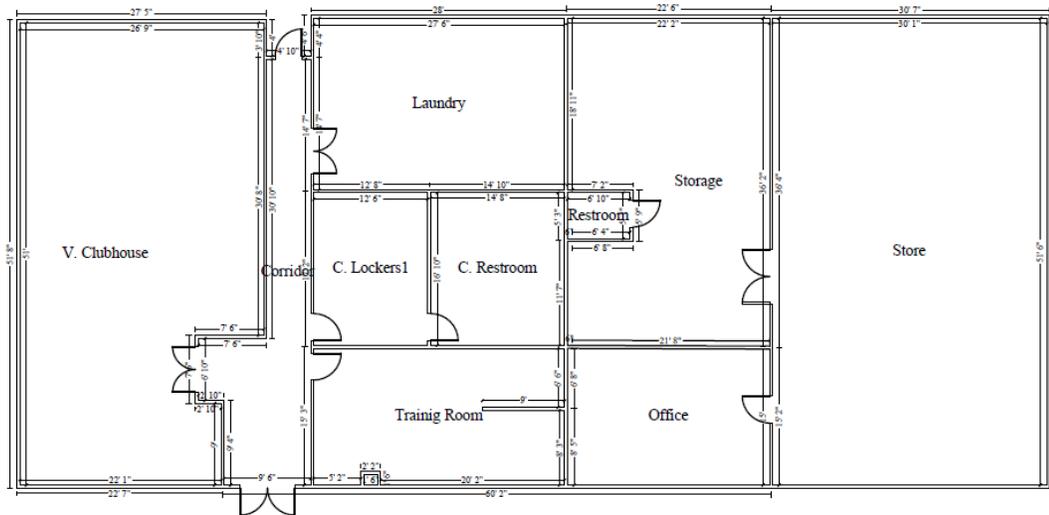
Current floorplan without dining area

- 4.2 Visiting Commissary and Dining Area - All facilities shall provide an area of not less than 300 sq. ft. dedicated to food preparation and consumption. If these two areas are separate (e.g., a seating area across the hall from the food preparation space), then the combined space must be a minimum of 300 sq. ft. The commissary shall include a refrigerator, a freezer, a sink, a dishwasher, a microwave, cabinets for storage, and a seating area that can accommodate at least 8 individuals at one time. All kitchen equipment shall comply with applicable local and state standards related to sanitation and cleanliness. In all circumstances, the commissary and dining area shall be separated from the player and staff dressing areas but should be immediately accessible by players and staff and located in, or in direct proximity to, the general visiting clubhouse area. For the avoidance of doubt, the commissary equipment above shall be dedicated for the sole use of the Major League Baseball Club and will required irrespective of the existence of a separate kitchen or restaurant area located away from the visiting clubhouse area (e.g., elsewhere in the facility).

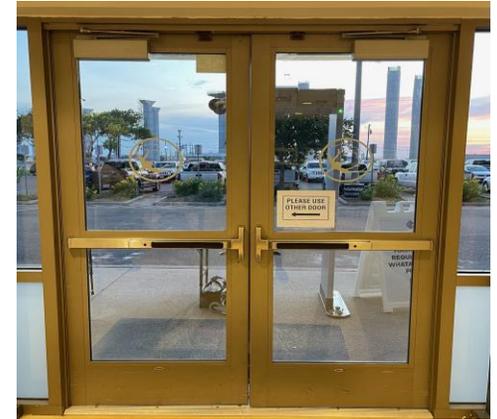
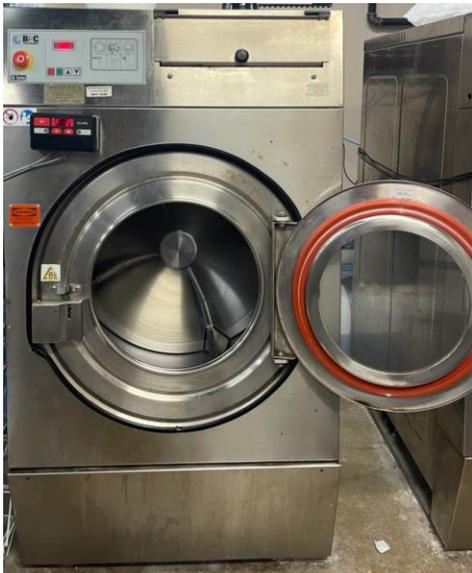
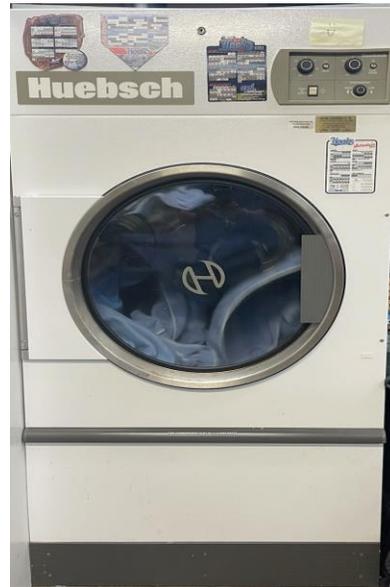
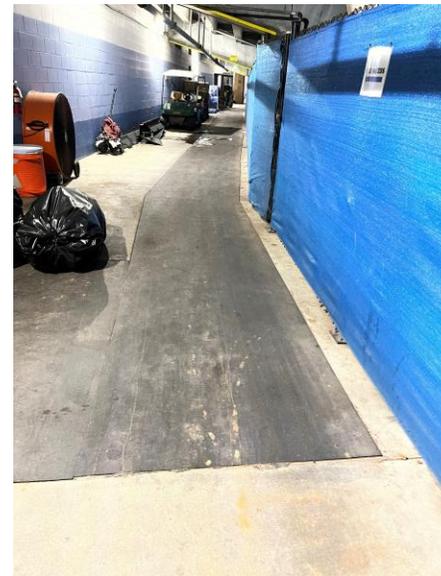
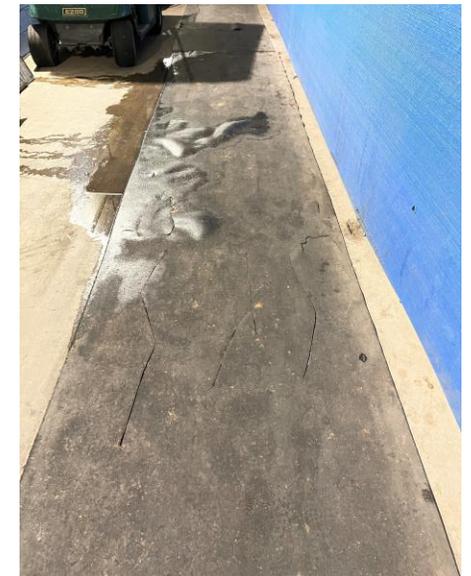
- Cotton Club entrance door replacement (\$16,000)
 - Cotton Club doors are original from 2005
 - Various internal parts have been replaced, but additional issues continue to occur (\$2,500 in repairs over 2019/2020)
 - Current state of doors are difficult to open and are a safety hazard for egress in the event of an emergency
- Home Clubhouse Washer/Dryer replacement (\$35,000)
 - Two washers in the Home Clubhouse are original from 2005 (life expectancy is 8 years)
 - Cost per washer is \$12,000
 - Two dryers in the Home Clubhouse are original from 2005 (life expectancy is 10-15 years)
 - Cost per dryer is \$5,500
 - Visiting Clubhouse washer failed in 2021 and was replaced
- Floor matting tunnel walkways (15,000)
 - Current walkways are bubbling and tearing

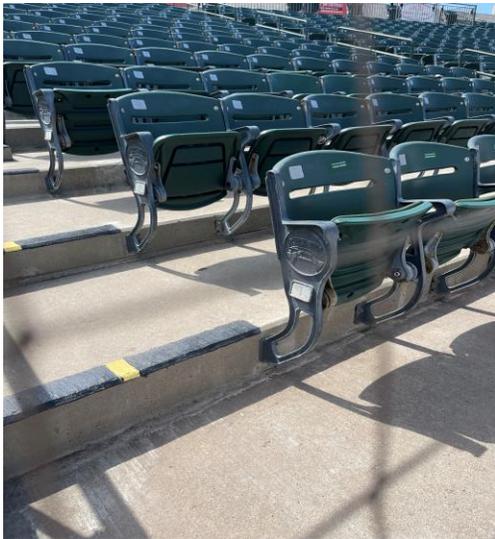
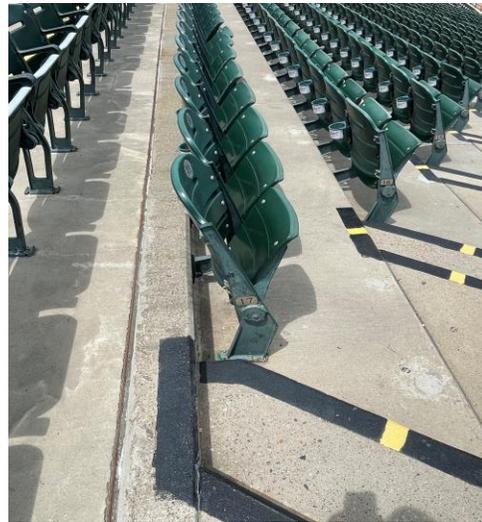
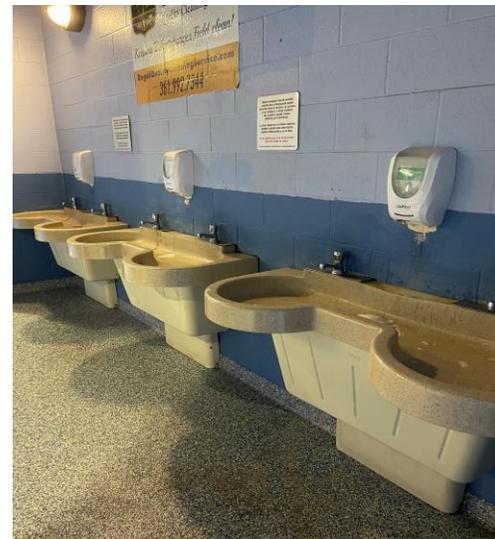
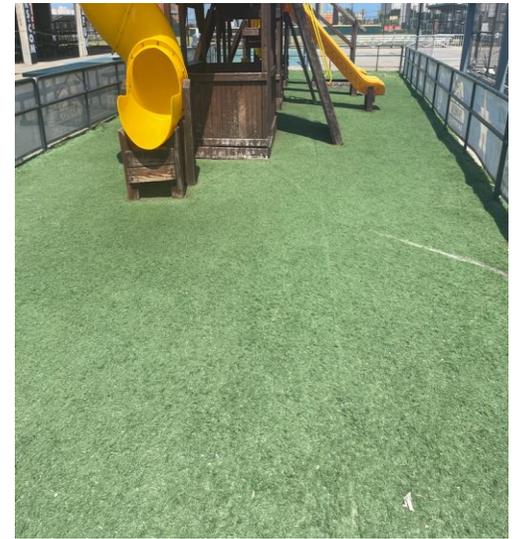
- 1,549 stadium seat replacement stanchions & seats (\$200,000)
 - Replaces short support bar seating that has major break issues
- Concourse light fixtures to LED (\$43,000 / \$175 per LED fixture)
 - 277 total light fixtures (Concourse, Suite Level, RF Tunnel)
 - On average, replacing 100 lights/ballasts per year
- Touchless faucets- fan facing (\$38,000 – 60 total faucets)
- Returf Kids Zone playground (\$10,000)
 - Ground needs to be releveled with dirt and laid over with new artificial turf
 - Current ground has become unlevel over the years and turf is showing signs of wear and tear

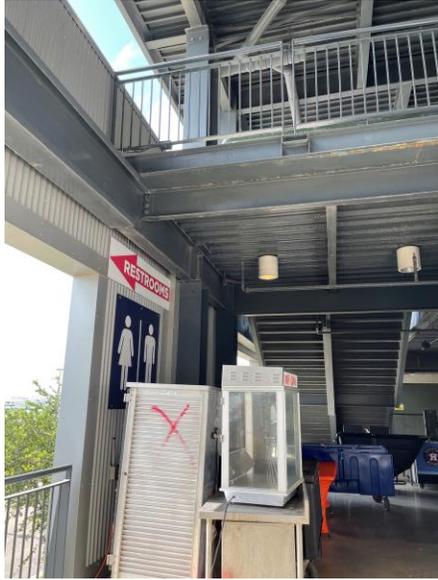
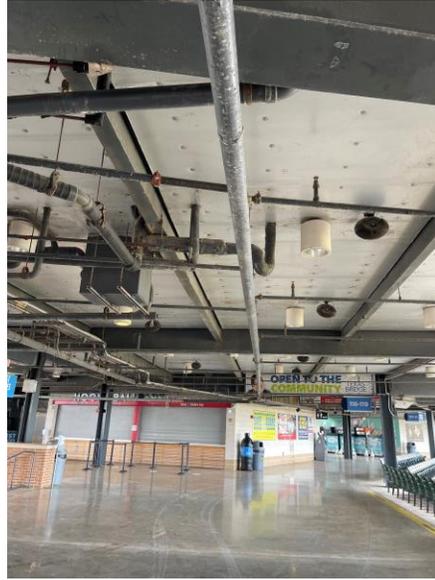
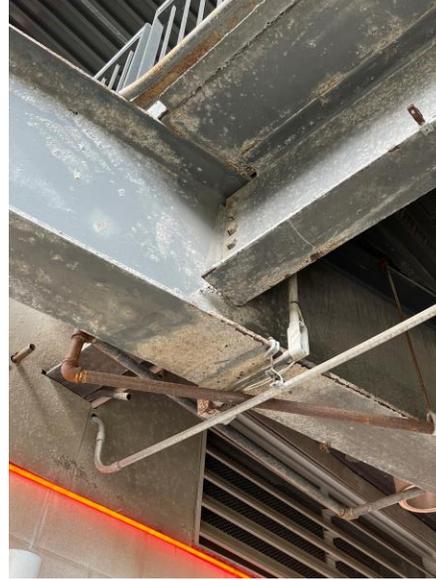
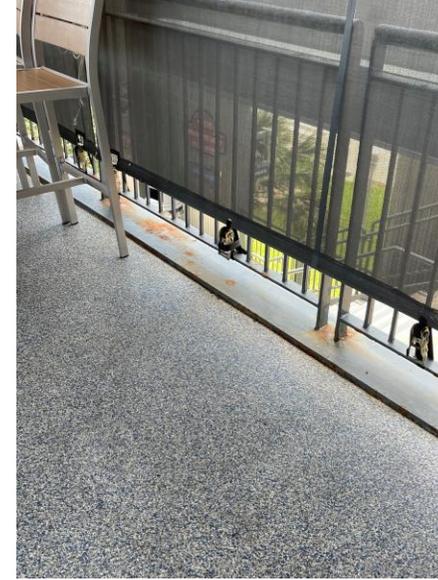
2023 – Steel & Structure Paint

- Entire ballpark needs painting of structural steel. Beams that were done in '18 are already showing rust. Recommend consolidating line items for I beams, handrails and foul poles and spread project over 3 years. Need to set a scope that includes proper finishes for all. Prefer marine grade or epoxy finishes. Cost of prepping and painting entire structure and handrails would be around 1.5 - 2 million dollars.

Steel & Structure Painting – \$2,000,000

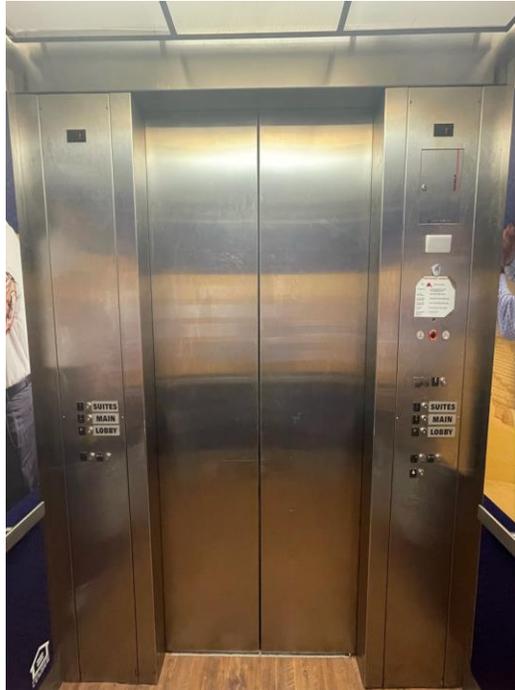
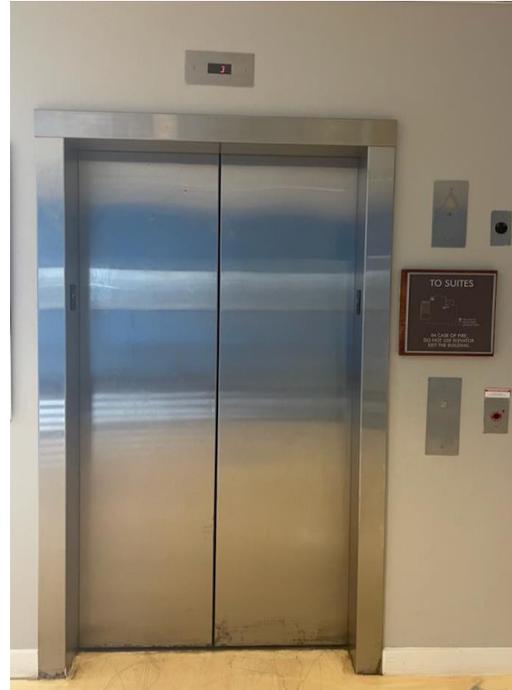
2023 - Elevator Refurbishment

- Elevator is original from 2005
- Internal parts need to be updated to become more modern – replacement parts are becoming harder to find
- Schindler recommends upgraded controller, power unit, door operator, COP, push buttons, and position indicators

Passenger Elevator refurbishment (\$110,000)

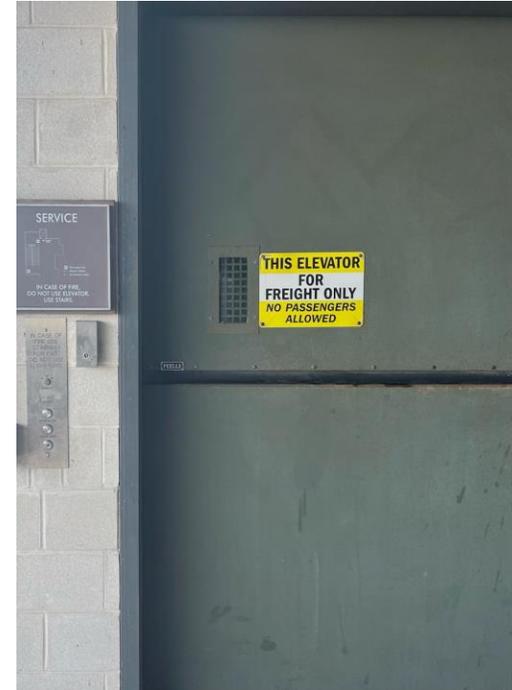
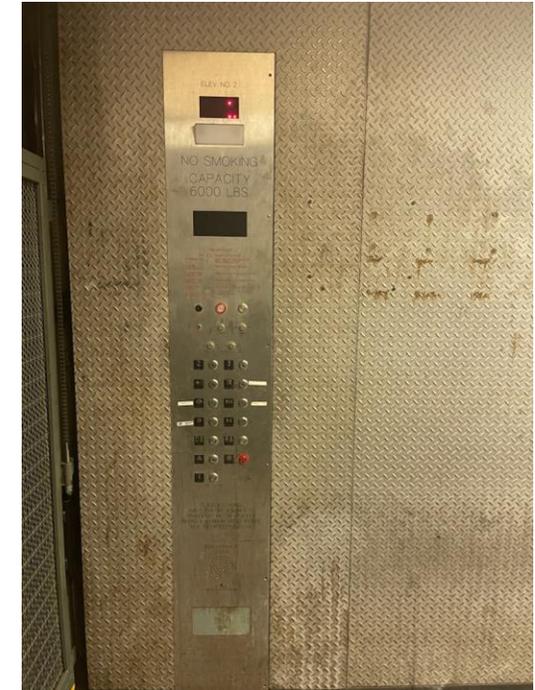
- Elevator is original from 2005
- Internal parts need to be updated to become more modern – replacement parts are becoming harder to find
- Schindler recommends upgraded controller, power unit, door operator, COP, push buttons, and position indicators

Freight Elevator refurbishment (\$140,000)

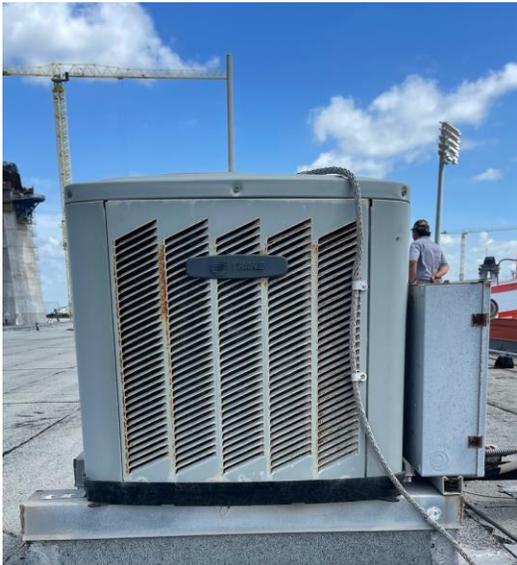
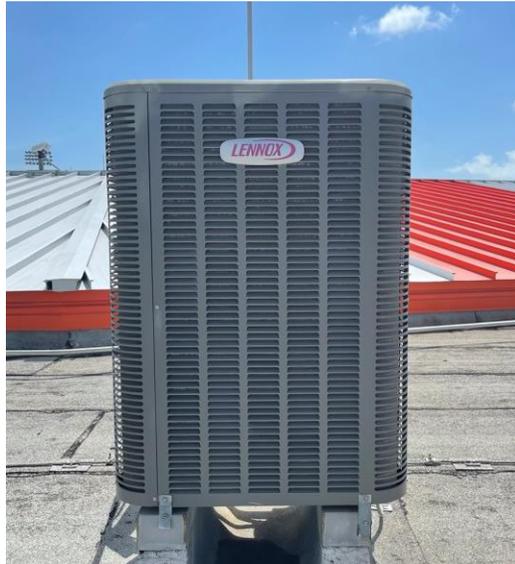
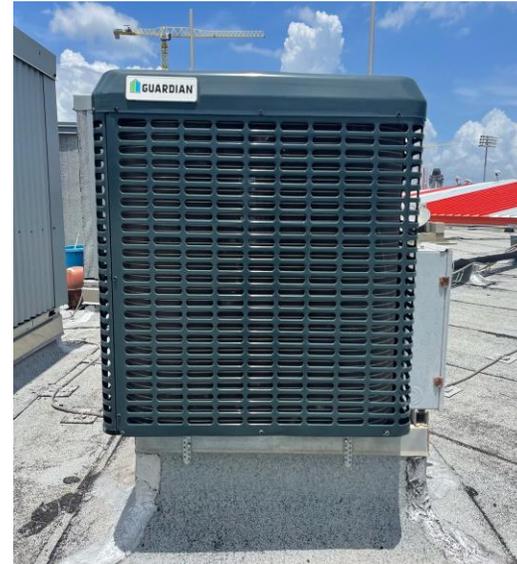
HVAC Replacement - \$250,000

- Facility currently has a total of forty-five (45) AC units
- Twenty-four (24) are original Trane units from 2005
- Life expectancy is 8-10 years (corrosion from salt air)
 - In-house electrician has expanded unit life span by replacing internal parts as they failed
 - Replacement parts for Trane units are becoming harder to find
- Due to original placement of units, portions of ceiling grids and fire lines will need to be removed and reinstalled during replacement process
- Aging Trane units have been replaced with a combination of Lennox and Guardian units
 - Organization recommends sticking with Lennox Units (life expectancy and durability)

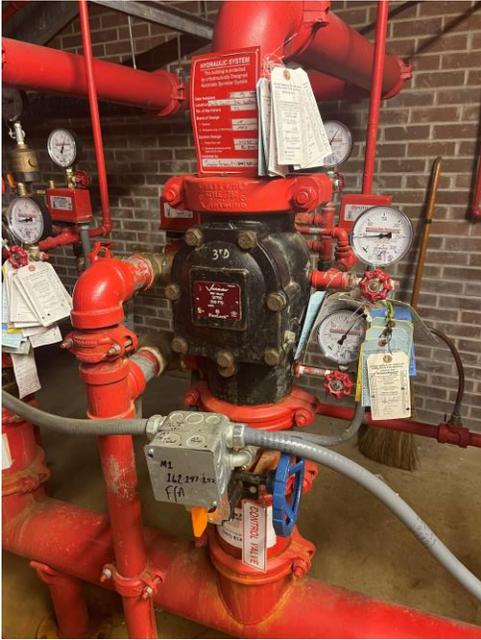
Fire Pump Valve Rebuild

- Rebuild of one Victaulic 756 dry valve
- Manufacturer recommends rebuild of valve every five years. Current valve is going on 10+ years.
- Cost - \$3,305

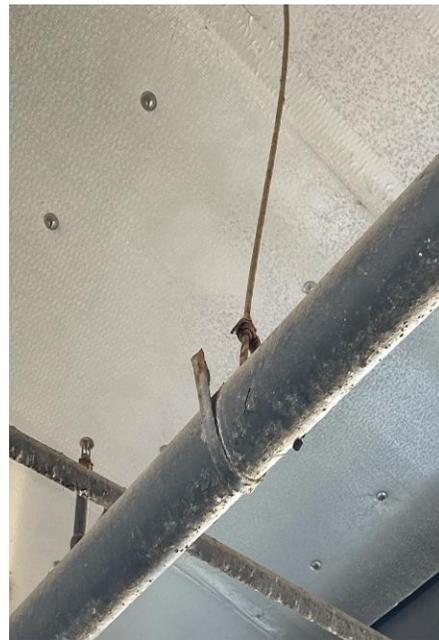
Clevis Hangers

- Majority of clevis hangers around facility are beginning to rust and multiple are beginning to break
- Clevis hangers support water/fire lines
- Cost per clevis hanger install - \$66
- Roughly 100-150 total hangers

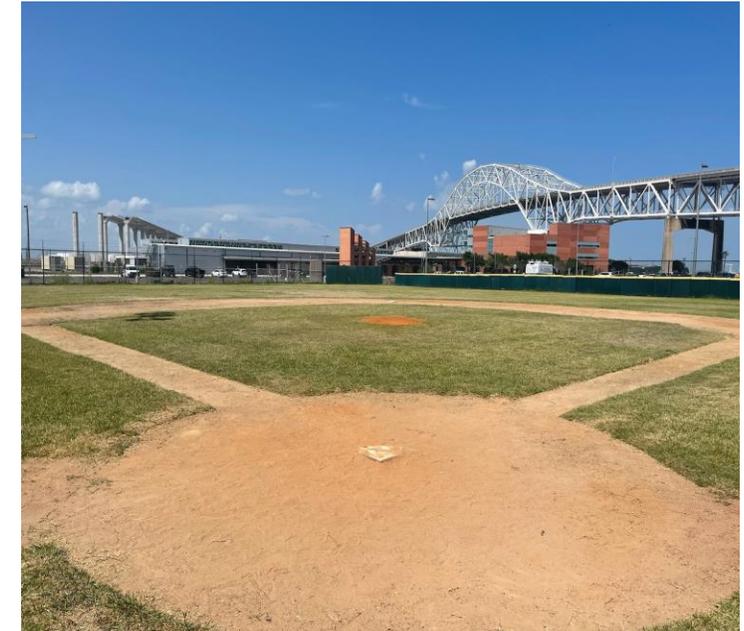
Turf Kids field

- Area sits on former parking lot sub-base and floods with even moderate rain levels
- When playable, sees heavy foot traffic from kids attending games
- Has the potential to serve as a Group Sales asset that could include a Little League game opportunity followed by Hooks game attendance

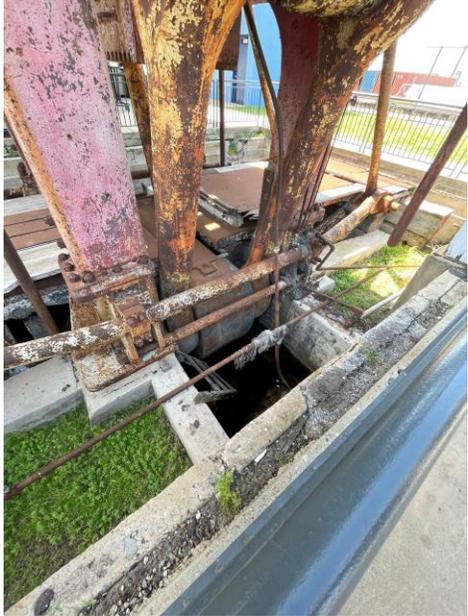
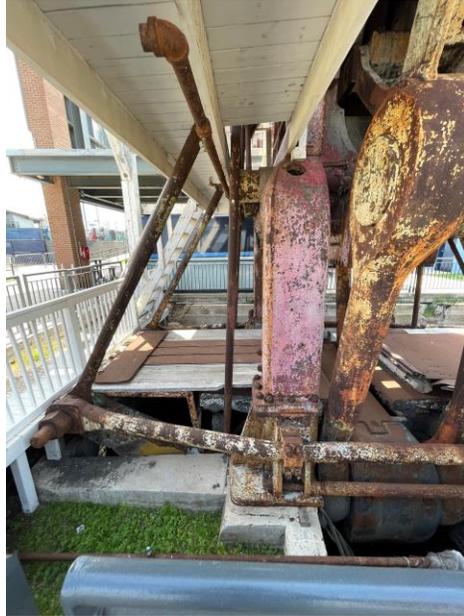
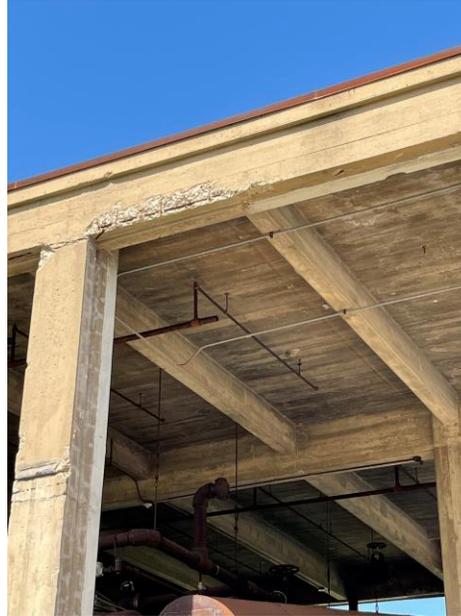
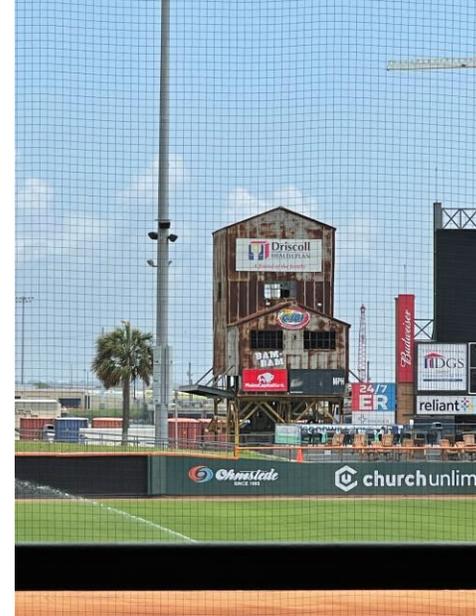
Hooks K Box – High Priority

- Stairwell and deck replacement. This is a very unsafe area of the ballpark and should get addressed immediately. Suggest using Trex Composite Decking to get best lifespan.

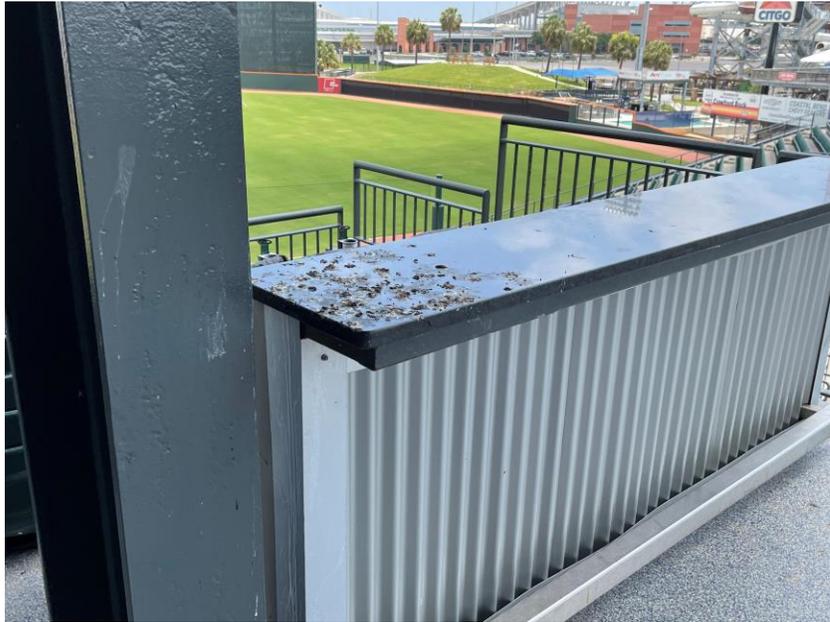
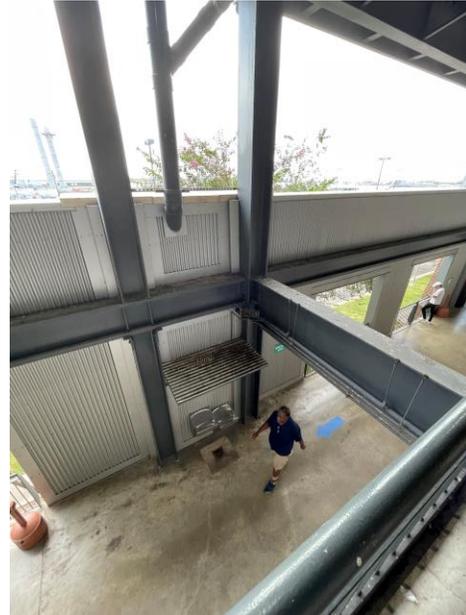
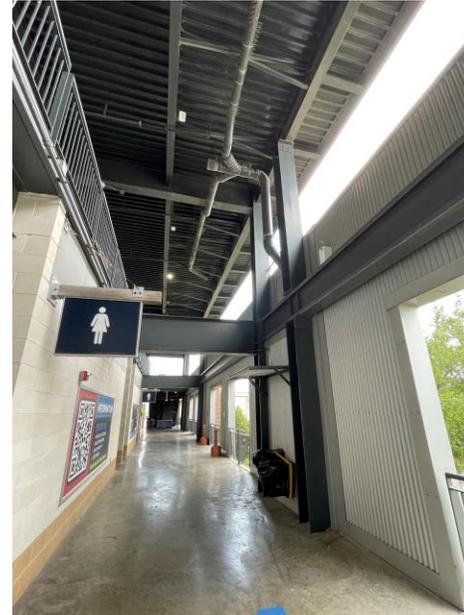
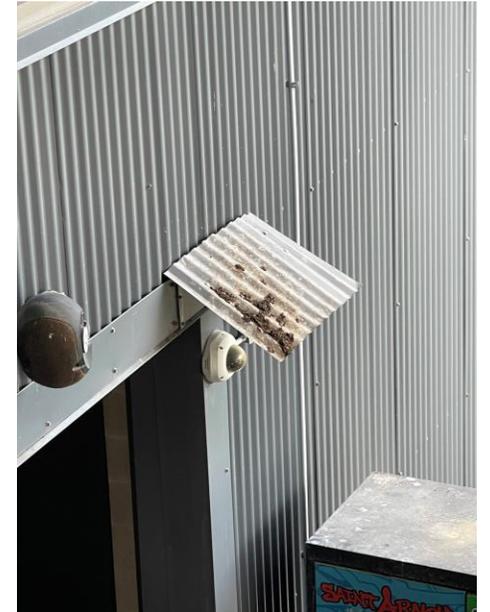
Bird Remediation

- Installed bird repellent misting system in 2020 – located down 1st/3rd base concourse beams
 - System did not remove birds, only pushed them down further along the concourse
- Net Installation – researching costs

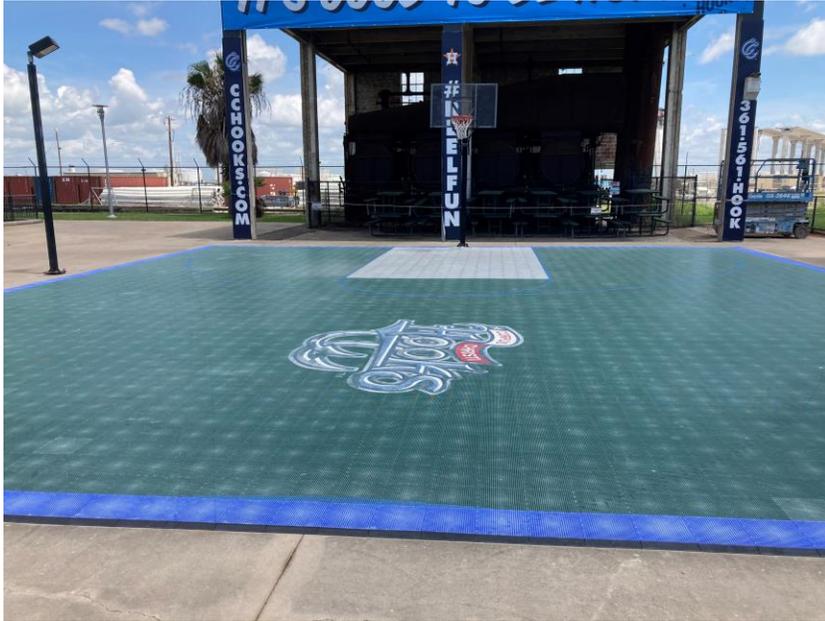
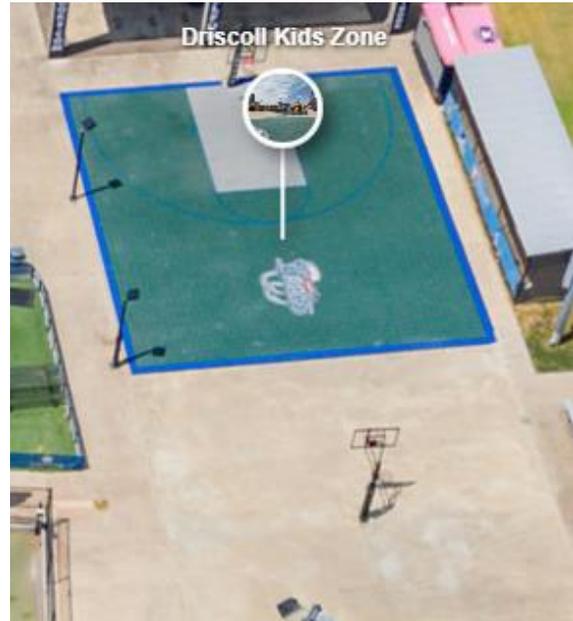
Sport Court replacement

- Cost - \$18,000 (Full court replacement) / \$9,000 (Half court replacement)
- Half of court was damaged in 2018. Damaged portion was removed and never replaced
- Currently only utilize half of basketball court for guests
