CORPUS CHRISTI

East General Aviation Hangars

Structural Condition Assessment

January 2011

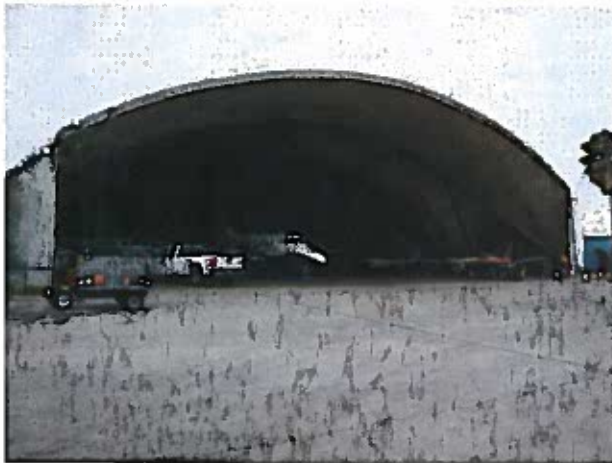
East GA Hangar 1 – Aircraft Bay

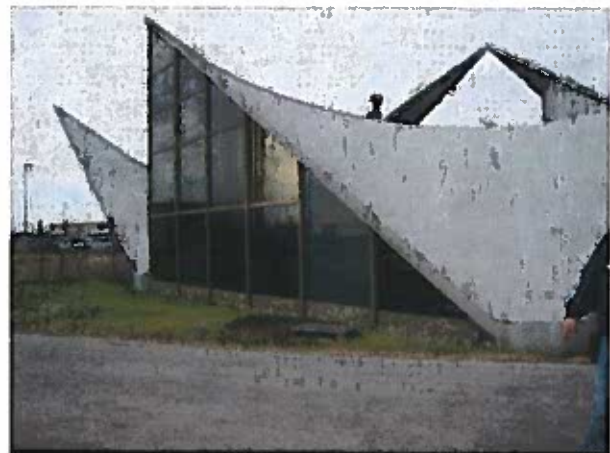
East GA Hangar 1 – SWA Office Area

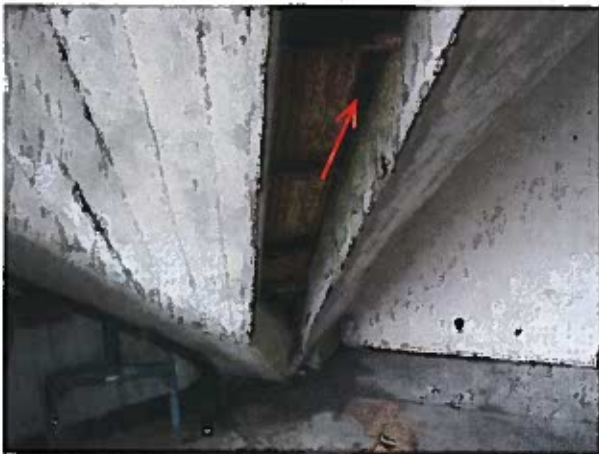
In general it was noted that concrete spalling has occurred in some of areas the structure and pop-outs are evident. Cracking has occurred in limited areas. All of the fiberglass infill panels and wood support framing are not weather tight and are in need of replacement. There is evidence of water infiltration through the concrete shell. The water infiltration has caused numerous areas to receive water damage to walls, ceilings and floor finishes. Secondary framing for metal wall panels is also corroded.

Fiberglass Infill w/ Rotted Framing

It is recommended that the roof of this building be treated by application of a white elastomeric coating system to prevent further water infiltration. Any required concrete repairs should be performed in conjunction with the roof repairs as well as replacement of the translucent infill panels and support framing. Concrete repairs should include chipping out deteriorated concrete and blast cleaning the substrate. The repair material should be a high strength mixture containing a corrosion inhibitor such as “SikaTop 123 Plus” or equivalent. Once the shell is weather tight, repairs to the interior can be undertaken. Interior repairs should include demolition and replacement of all water damaged framing and finished surfaces. The storefront at the Southwest Airlines Cargo office has broken glazing panels which need to be replaced. It should be noted that most of the observed damage is due to water infiltration and lack of continuous maintenance of the roof coating is the primary cause.

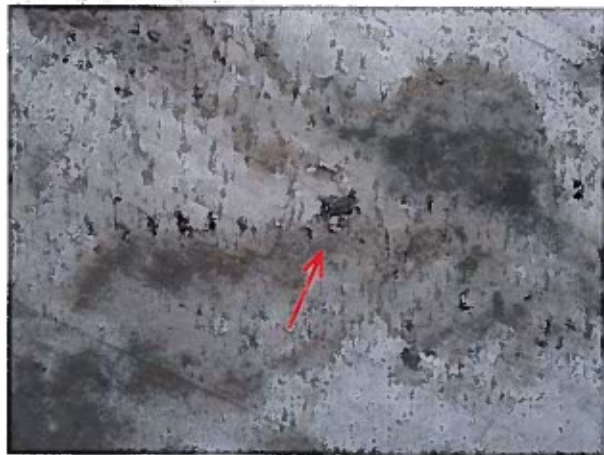
Water Infiltration w/ Spalling

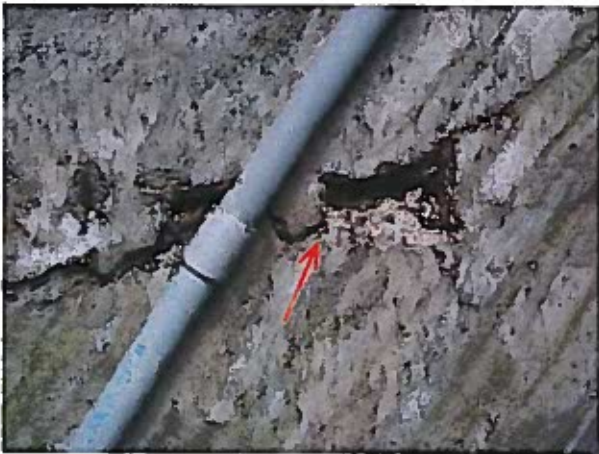
Cracking in Concrete Shell

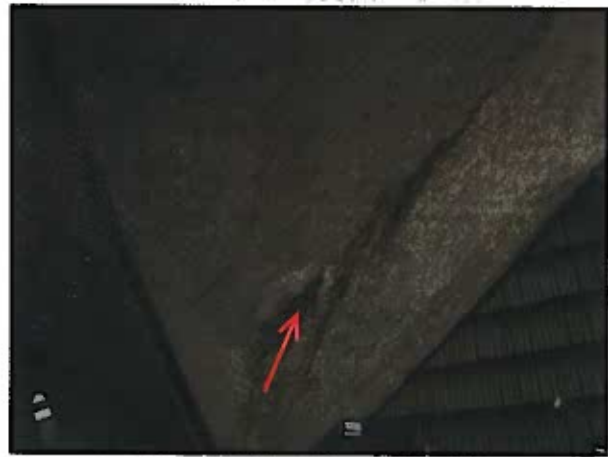
Water Infiltration w/ Spalling

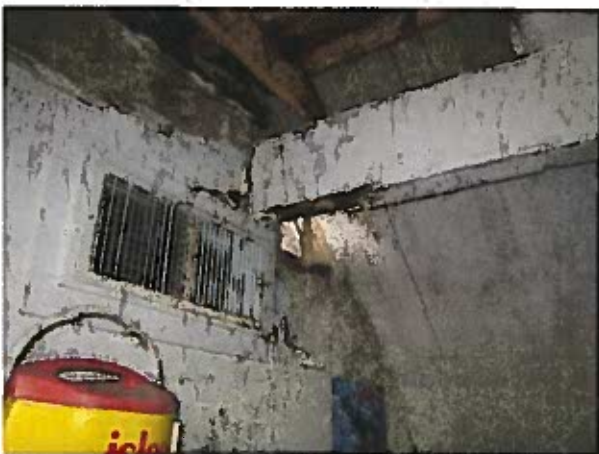
Water Damage to Walls and Wood Framing

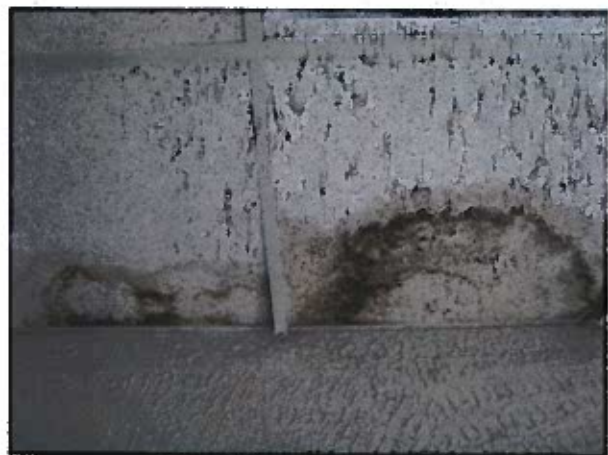
Water Damage to Ceilings

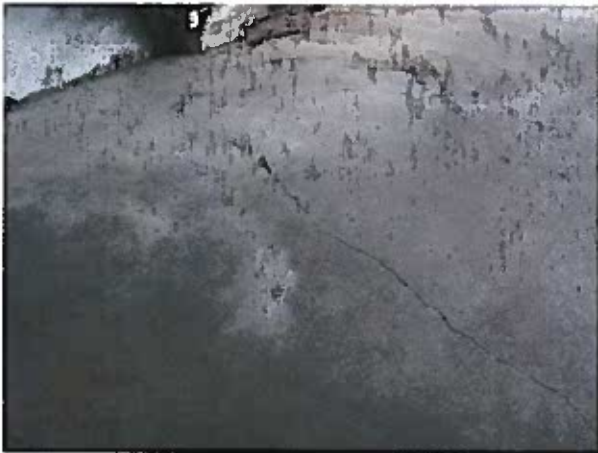
No signs of significant foundation movement or distress were noted for Hangar 1. However there has been movement of the floor slab causing water to run towards an office area. This situation can be addressed with the installation of in floor drains if conditions warrant. Several locations on the exterior of the shell have experienced corrosion of the reinforcing and are spalling. Water infiltration has also damaged electrical conduits. In general there is poor drainage between Hangar 1 and the adjacent Signature offices. This has allowed water to build up and damage a portion of the wall panels.

Floor Slab Cracking

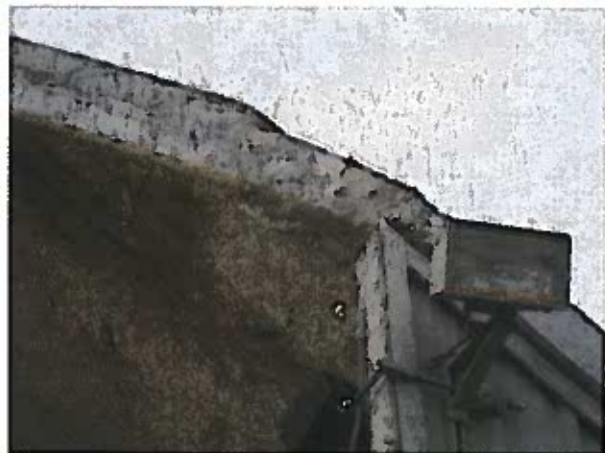
Exterior Spalls – Previously Patched

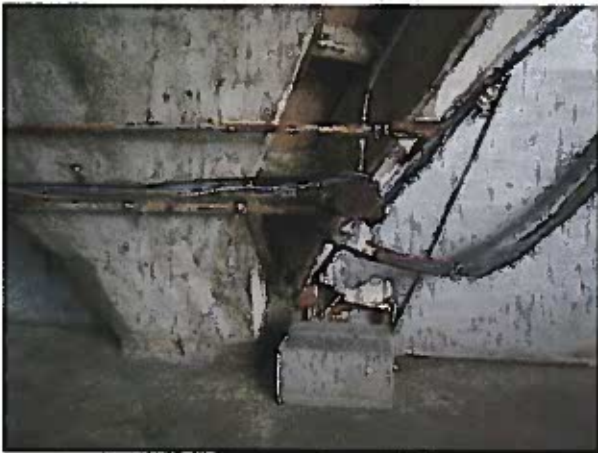
Water Damaged Electrical Conduit

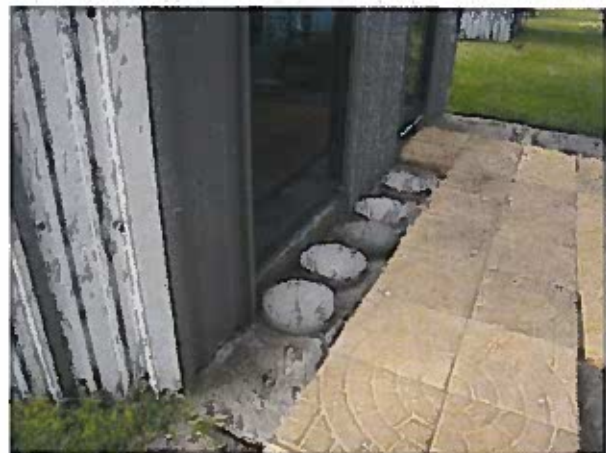
Steps added due to poor drainage

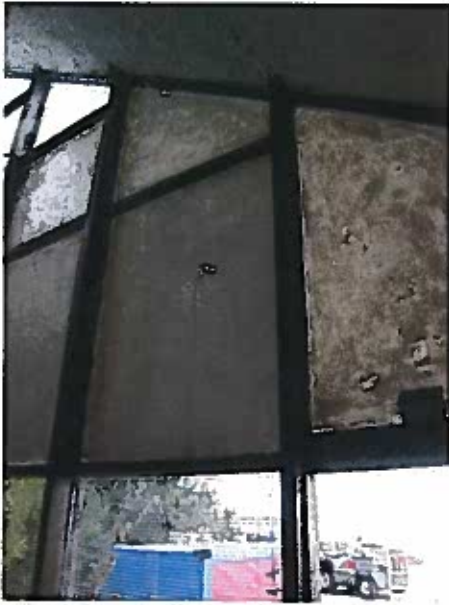
Damaged Glazing @ SWA Cargo

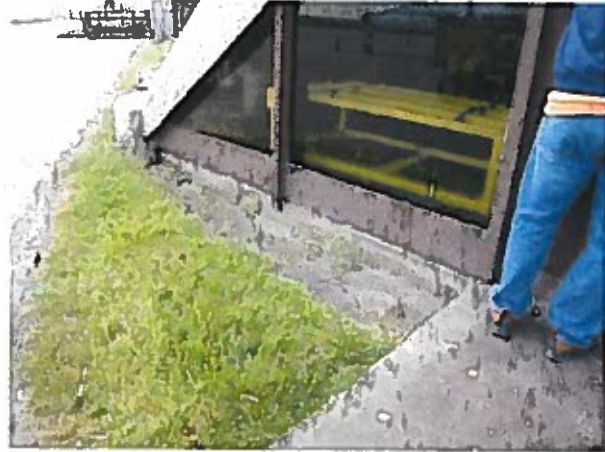
Poor Drainage @ SWA Storefront

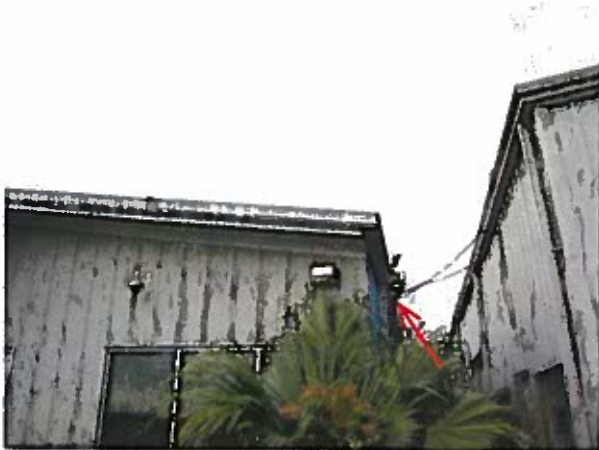
Plants Growing in Gutter @ Signature Offices

The exterior of the structure was inspected first. The overall condition of this building is good and no damage was noted on wall cladding panels. The building envelope appears to be intact with no deficiencies noted at the windows and doors. However, several maintenance items need to be addressed for this building. The gutters are filled with debris and should be cleaned to prevent corrosion. In

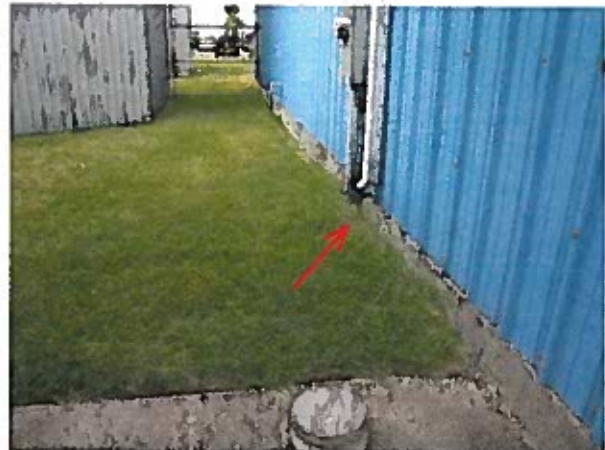
Downspout @ Signature Offices

addition, the gutter downspouts place water directly adjacent to the building foundation. Gutter extensions and splash blocks should be provided. If not corrected, this condition will cause damage to the foundation due to heaving of the underlying soils. General improvements to grading adjacent to the building should be performed to prevent the buildup of water adjacent to the foundation.

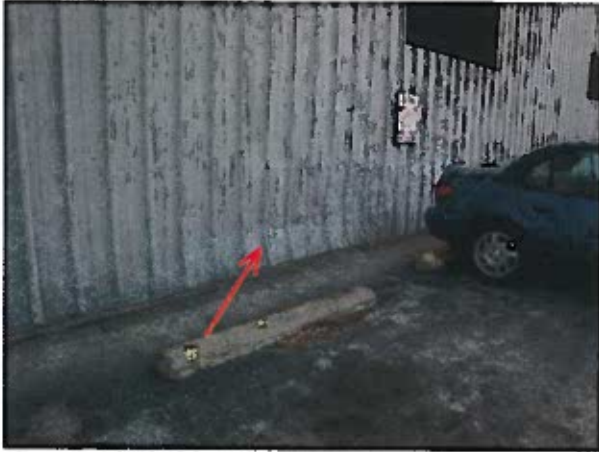
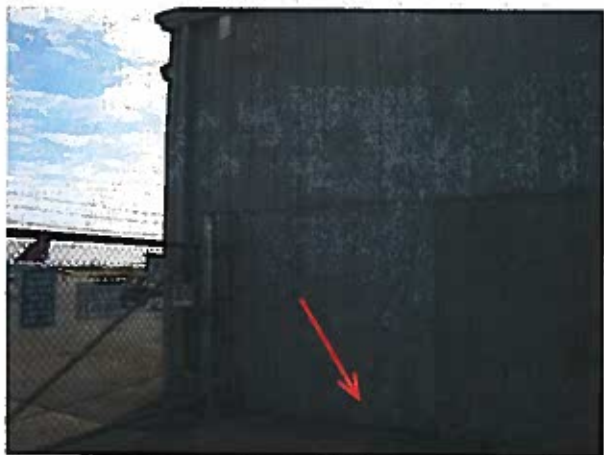
An inspection of the exterior portions of the building revealed some damage to the corrugated steel wall panels although this damage is not extensive. No other structural distress was noted from the outside of the building in this area at the time of inspection although building envelope issues are apparent. The eave trim and gutters are corroded and should be replaced. Downspouts were missing as well.

Cladding Damage @ Ocean Air Center

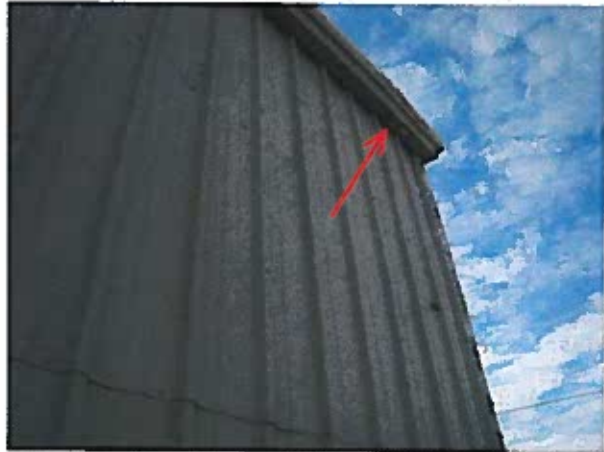
Missing Downspout @ Ocean Air Center

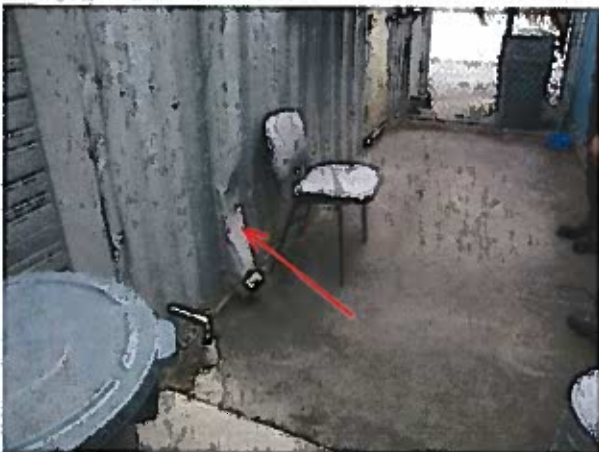
Downspout Damage @ Ocean Air Center

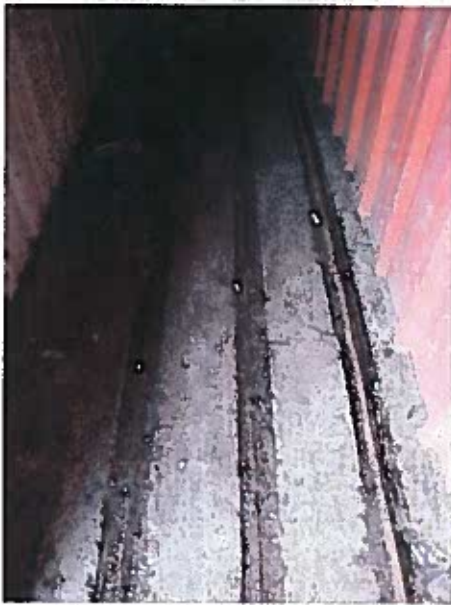
Corroded Door Tracks @ OAC

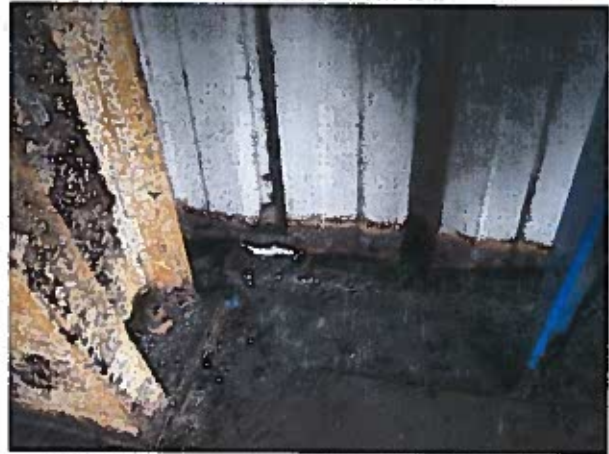
A few of the building cladding panels are perforated due to corrosion and the base angle is also corroded. There is generally poor drainage in some areas around the building. An inspection of the interior of Hangar 2 revealed the interior structure to be in fair condition. The primary structural members appeared to be in fair condition. There are several locations where the main baseplates have moderate to severe corrosion and which exhibit moderate section loss. These locations should be cleaned and repaired as needed. Secondary framing members adjacent to the doors are severely corroded with an estimated 50% section loss and should be repaired as soon as possible. The protective coating on these secondary members has reached its service life limit and painting should be considered. It is anticipated that the rate of corrosion will increase since the existing protective coatings are no longer fully functional. An inspection of the hangar doors revealed corrosion to the secondary door framing members. The hangar door tracks, both upper and lower, are corroded. There is minor mechanical damage to the hangar door frames and bumpers. All of the interior framing is in need of cleaning and painting to prevent further damage and this work should be integrated into an ongoing maintenance program. Failure to address these issues now will likely result in higher repair costs later.

Panel and Base Angle Corrosion @ OAC

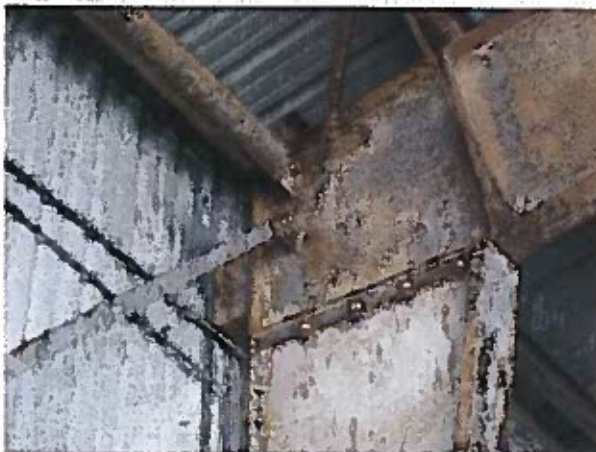
Primary Member Corrosion @ OAC

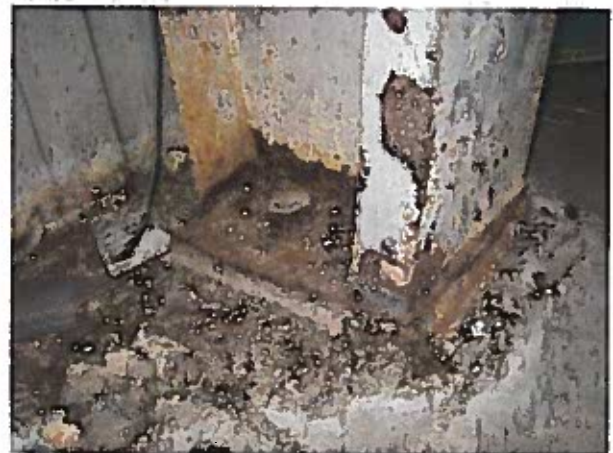
Baseplate Corrosion @ OAC

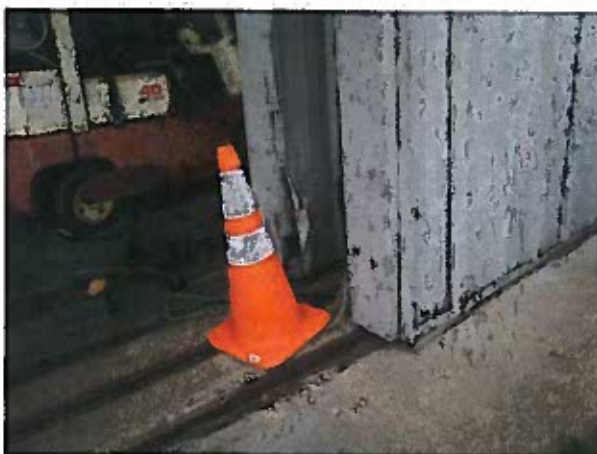
Door Damage @ OAC

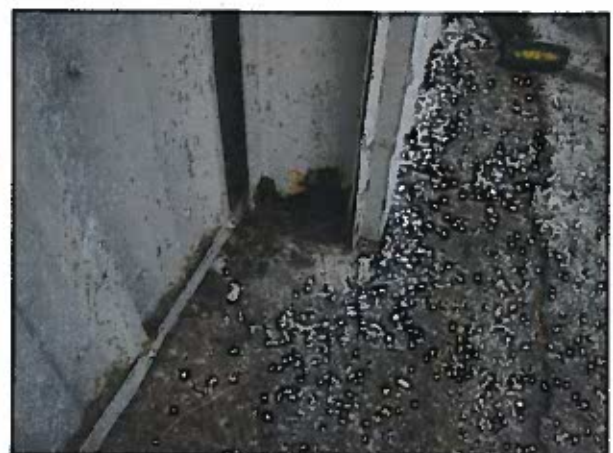
Severe Corrosion Damage @ OAC Doors

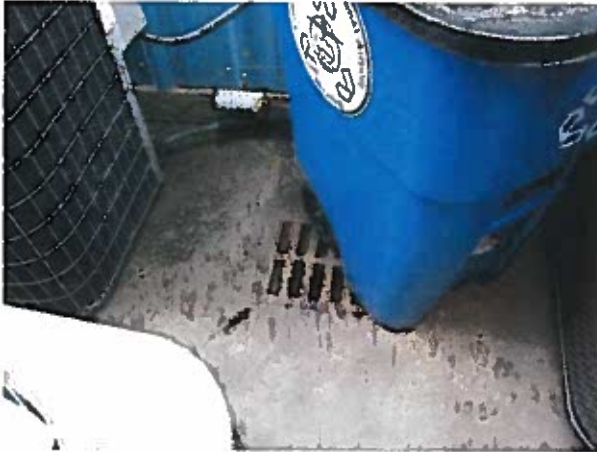
The floor slab of the Ocean Air Center Hangar appears to be in fair condition. There is minor to moderate cracking but the floor is generally serviceable at this time. There is poor drainage between the Ocean Air Center Hangar and the adjacent building although area drains are located here. These drains should be kept clean to prevent accumulation of water adjacent to the building foundations.

Partially Blocked Drain @ OAC

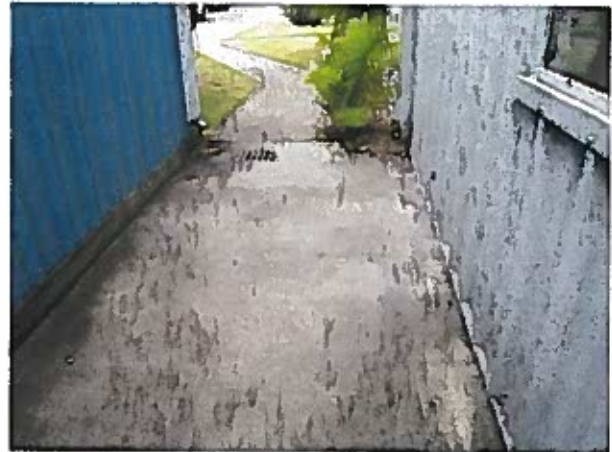
Drain in Good Condition @ OAC

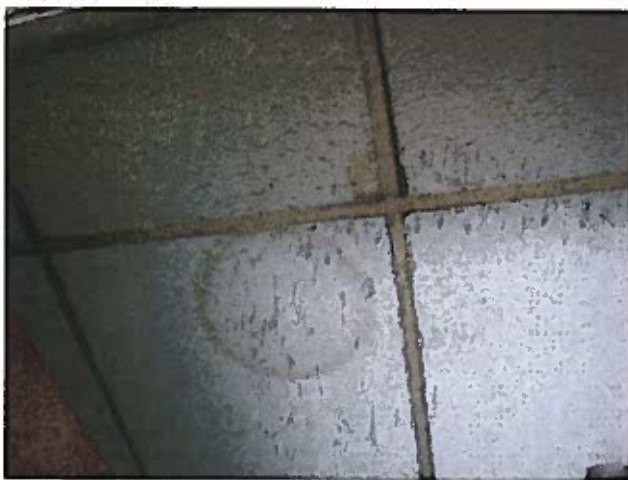
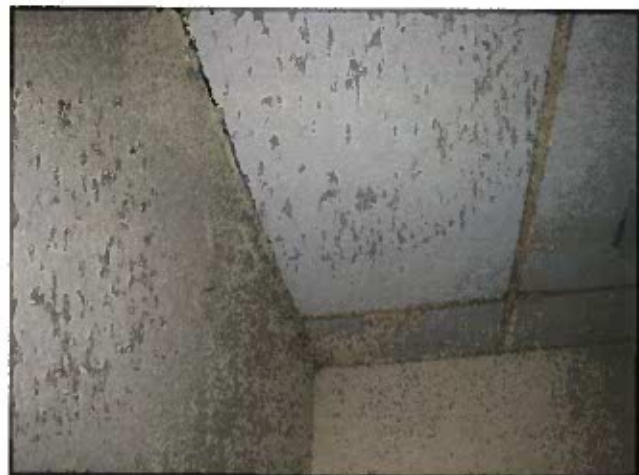
Stained Ceiling Tiles @ Dodd Aviation - 1

Stained Ceiling Tiles @ Dodd Aviation - 2

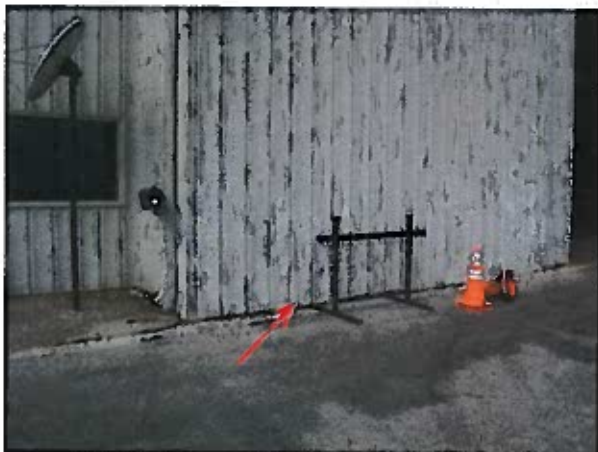
Panel Damage @ EGA 3

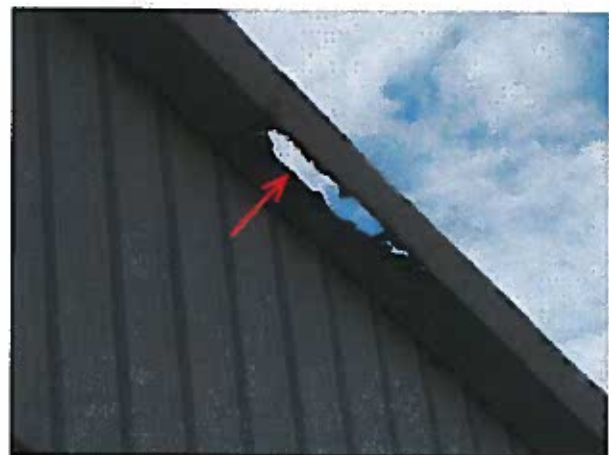
Gutter Damage @ EGA 3

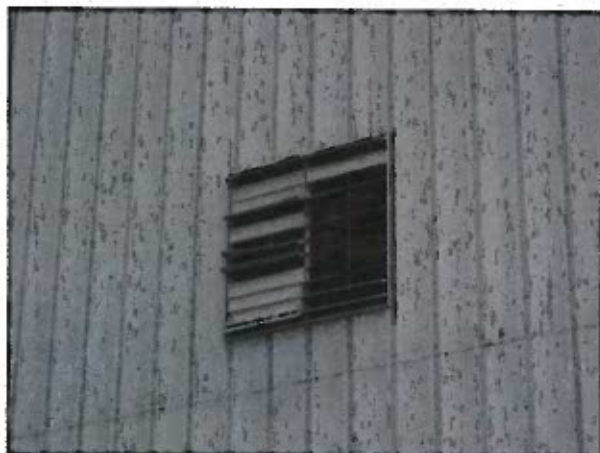
Fan Louver Damage @ EGA 3

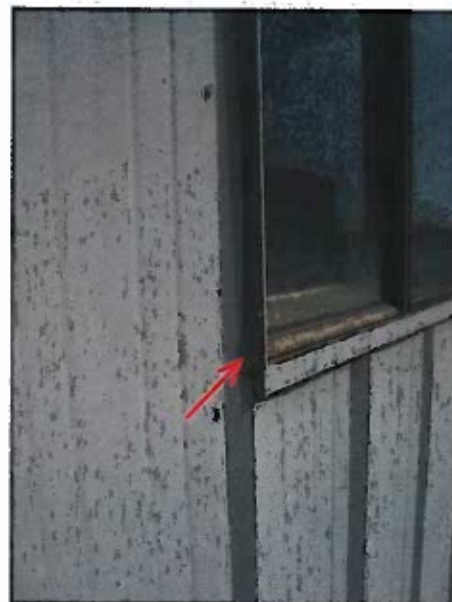
Caulking Around Windows is Missing

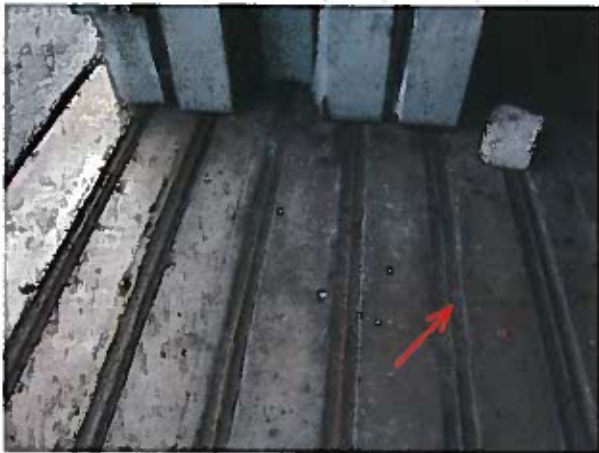
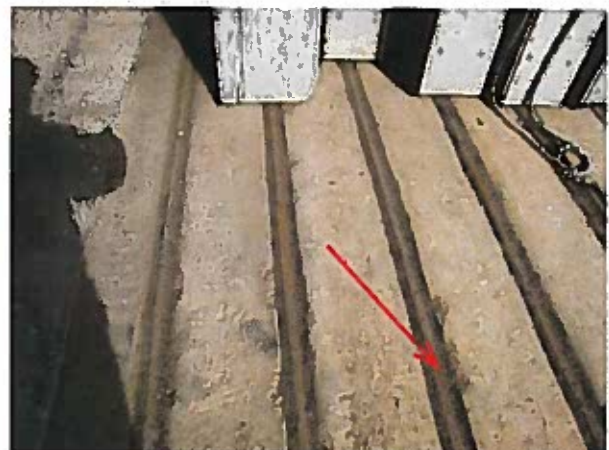
The hangar door system is in moderate to poor condition. The doors cannot be operated normally and require the use of an aircraft tug to open and close them. There is minor mechanical damage to the hangar door frames and bumpers and corrosion damage to the doors and door pockets as well as corrosion of the door tracks and running gear. The secondary door framing is corroded although with minimal section loss observed. The protective coating on these secondary members has reached its service life limit and painting should be considered. It is anticipated that the rate of corrosion will increase since the existing protective coatings are no longer fully functional. The problems with the hangar door system do not appear to affect the overall structural integrity of the building but do present a serious serviceability issue.

Door Track Corrosion @ EGA 3

Lower Door Track Corrosion @ EGA 3

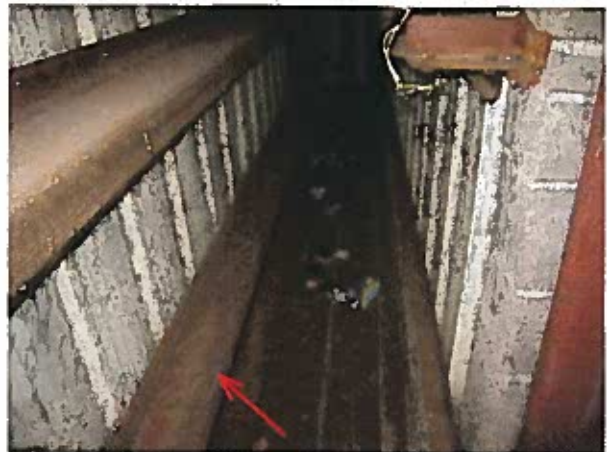
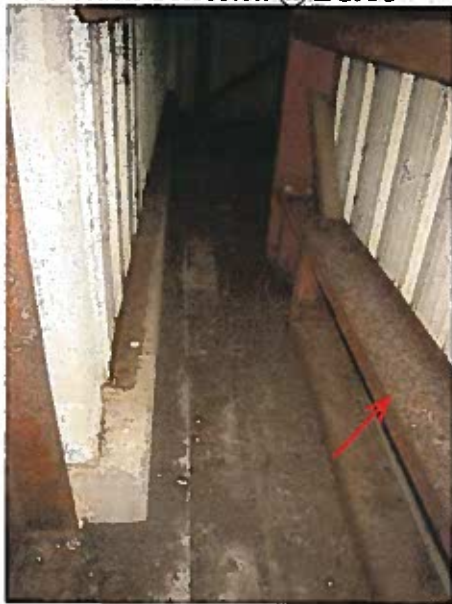
Door Pocket Corrosion @ EGA 3

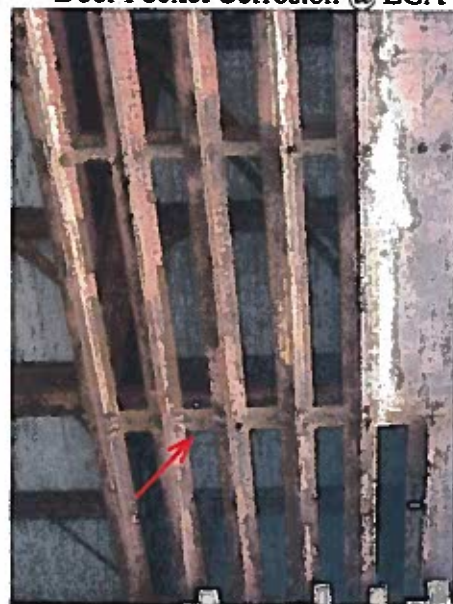
Upper Door Track Corrosion @ EGA 3

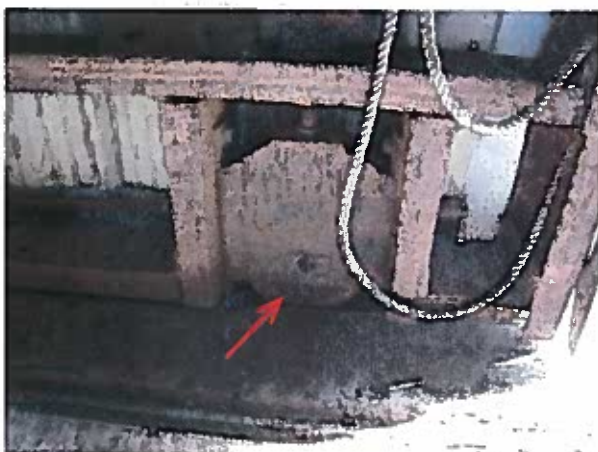
Running Gear Corrosion @ EGA 3 Doors

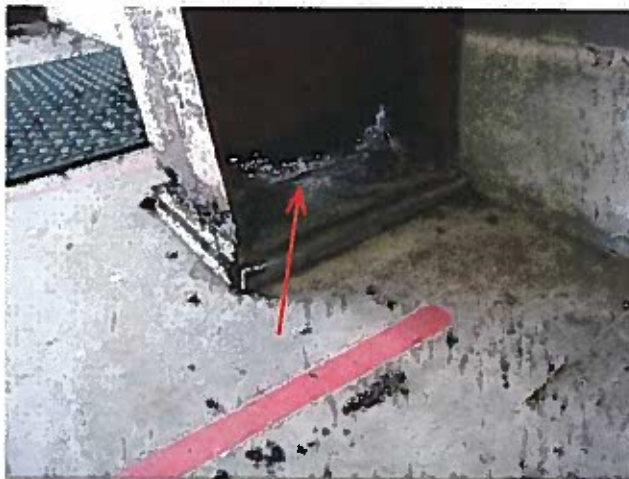
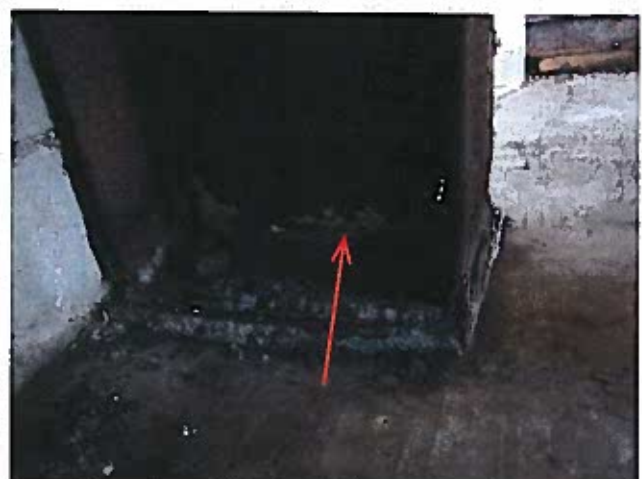
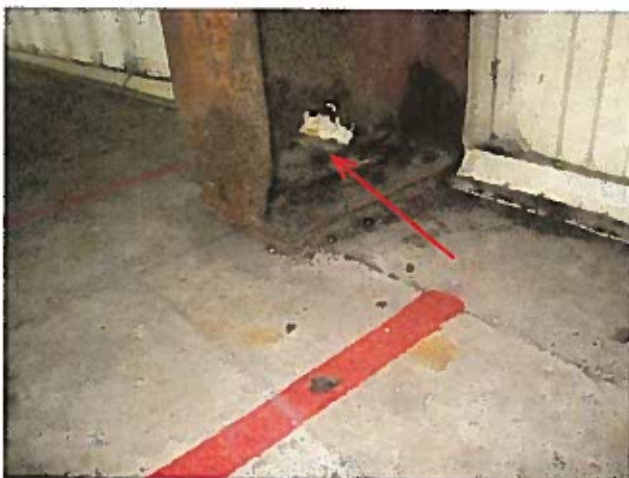
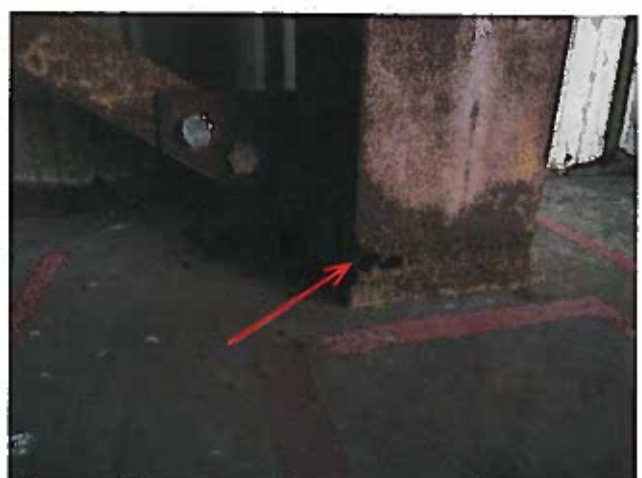
The baseplate and column base corrosion is the most serious issue observed during the structural condition assessment. There are three out of six baseplates on the south wall that have more than 50% section loss and two of six baseplates along the west wall which have more than 50% section loss. A full structural load and capacity analysis is beyond the scope of this report. However, based on the observed condition of these baseplates and due to their location in proximity to one another, **it is our opinion that the building in its current condition will not be able to withstand its full original intended design loads.** These baseplates should be repaired as soon as possible. Failure of one of the column locations would likely cause damage to propagate further into the structure potentially leading to costly repairs.

Severe Corrosion Damage @ EGA 3 South Wall

Severe Corrosion Damage @ EGA 3 West Wall

As stated above, there repairs to the column bases and fire sprinkler riser should be completed as soon as possible to prevent further and more costly damage. Failure of these components has the potential to cause injury or property damage.

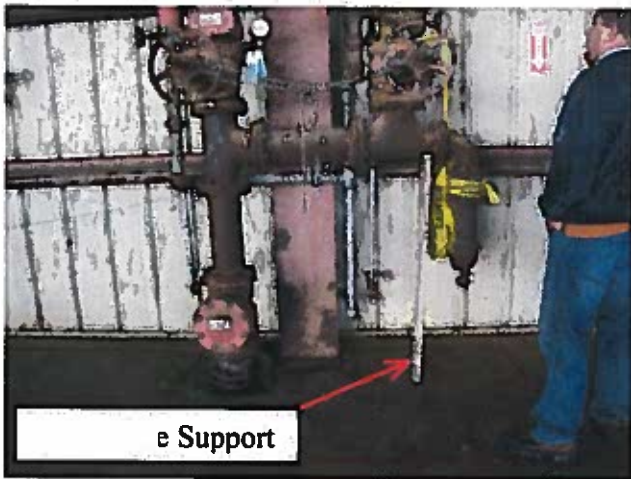
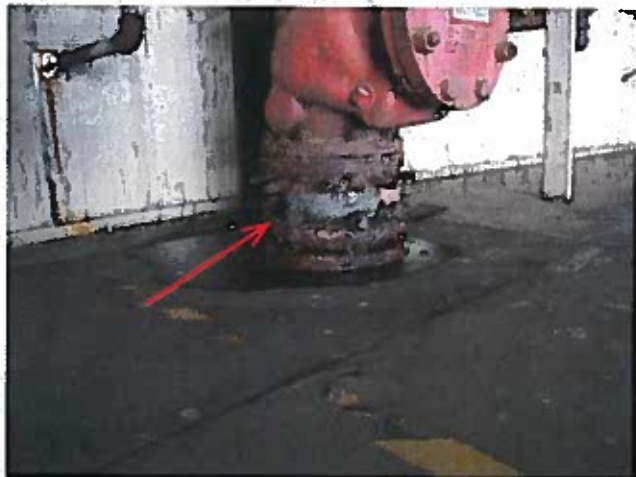
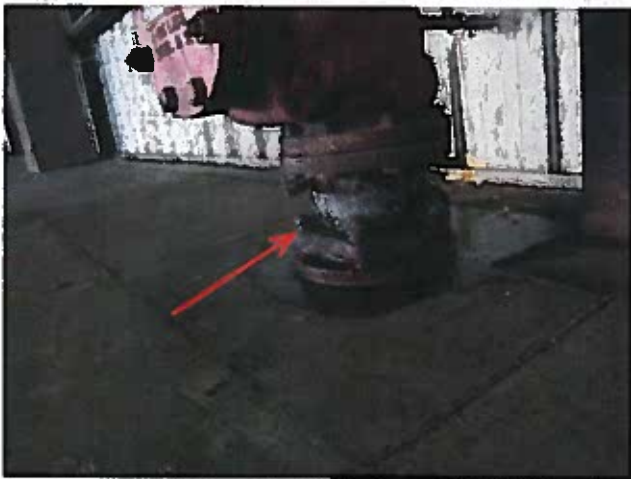
The interior inspection also revealed corrosion damage to the fire sprinkler riser pipe. The lower portion of this 6 inch line is corroded and is currently leaking. The supports for the remaining riser piping are also inadequate. This riser supplies all of the sprinkler piping and is under constant pressure. An accidental bump from a tug or other equipment could cause this line to fail. Such a failure could lead to damage to the structure or to the aircraft stored within the structure in addition to leaving the building and its contents unprotected from fire. It is also possible that this corrosion damage extends below the floor slab as well and failure there could undermine the floor slab leading to costly repairs. It is recommended that this fire sprinkler riser be thoroughly inspected and then repaired as soon as possible due to the potential consequences of a failure of this system.

Fire Sprinkler Riser Damage @ EGA 3

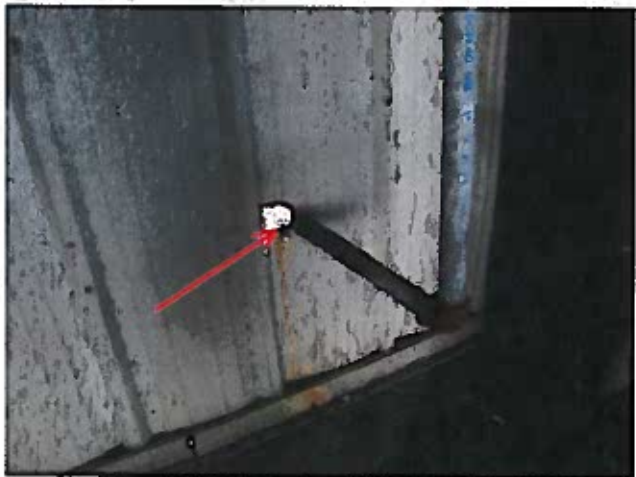
Overflow Corrosion Damage @ EGA
