September 23, 2015

**GPM Engineering**

**RE: GORDON STREET APARTMENT COMPLEX BUILDING  
CURSORY STRUCTURAL WALK-THROUGH ASSESSMENT**

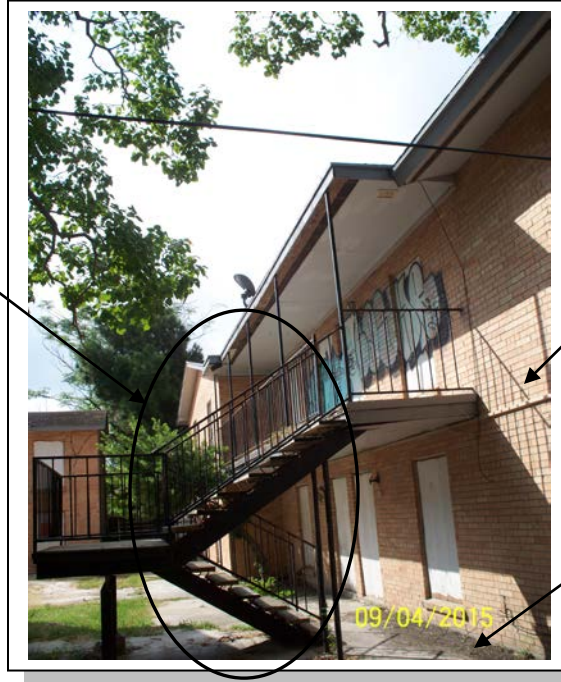
Photograph No. 3 – Front Face of Building, Exterior Walkway and Stairs

Original stair  
treads no  
longer present.  
Replaced with  
wood  
members.

Building  
structure in  
good general  
condition

Dirt and debris  
indicate site  
drainage toward  
building  
foundation

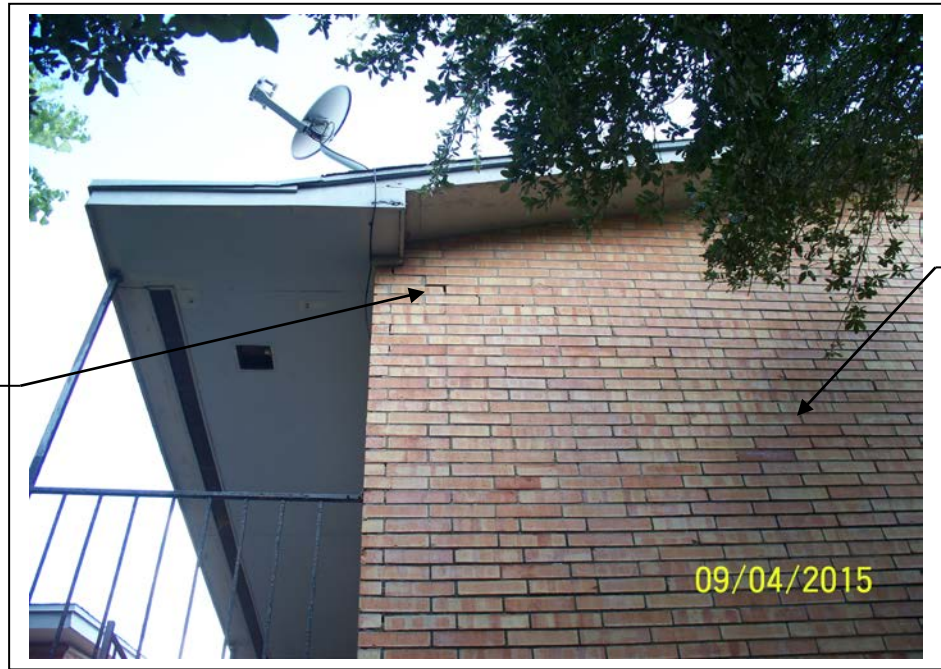
Photograph No. 5 – Typical Cracking Seen in Brick Veneer

Crack in brick veneer indicating differential movement of the foundation system

Building end wall

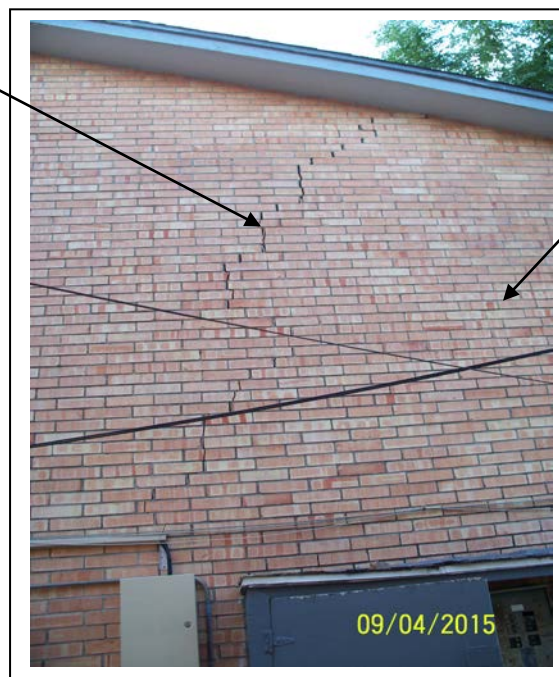
Photograph No. 6 – Cracking in Brick Veneer

Crack in brick veneer indicating differential movement of the foundation system

Building end wall
