# Packery Channel Restoration (H17019) Preliminary Design Report

Corpus Christi, Texas

November 26, 2018

*Prepared for the City of Corpus Christi*

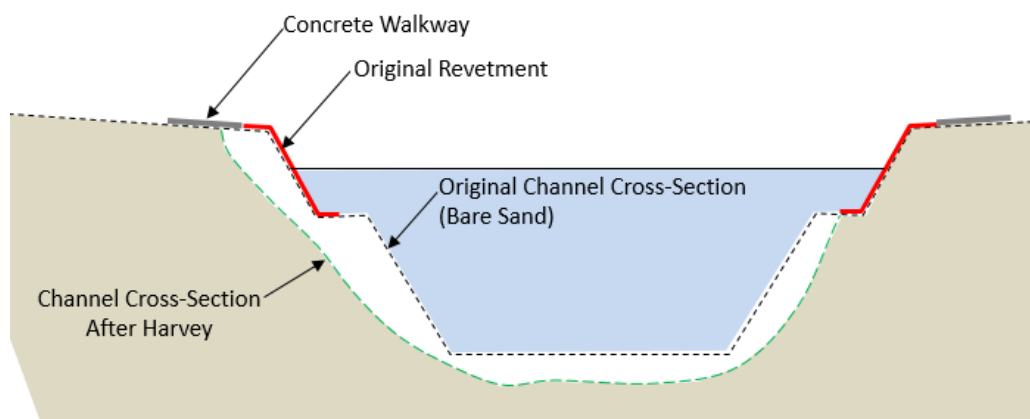
Figure 7 – Channel Cross-Section After Harvey.

Figure 7 provides a schematic comparison of the channel cross section before and after Harvey, illustrating the significant loss of foundation soils under the walkway and revetment that appears to have resulted in their collapse as depicted in Figure 8. The updated damage assessment in Appendix B provides evidence of continued loss of foundation soils from waves and rainwater runoff that has led to additional undermining and collapse of the walkway since Hurricane Harvey.

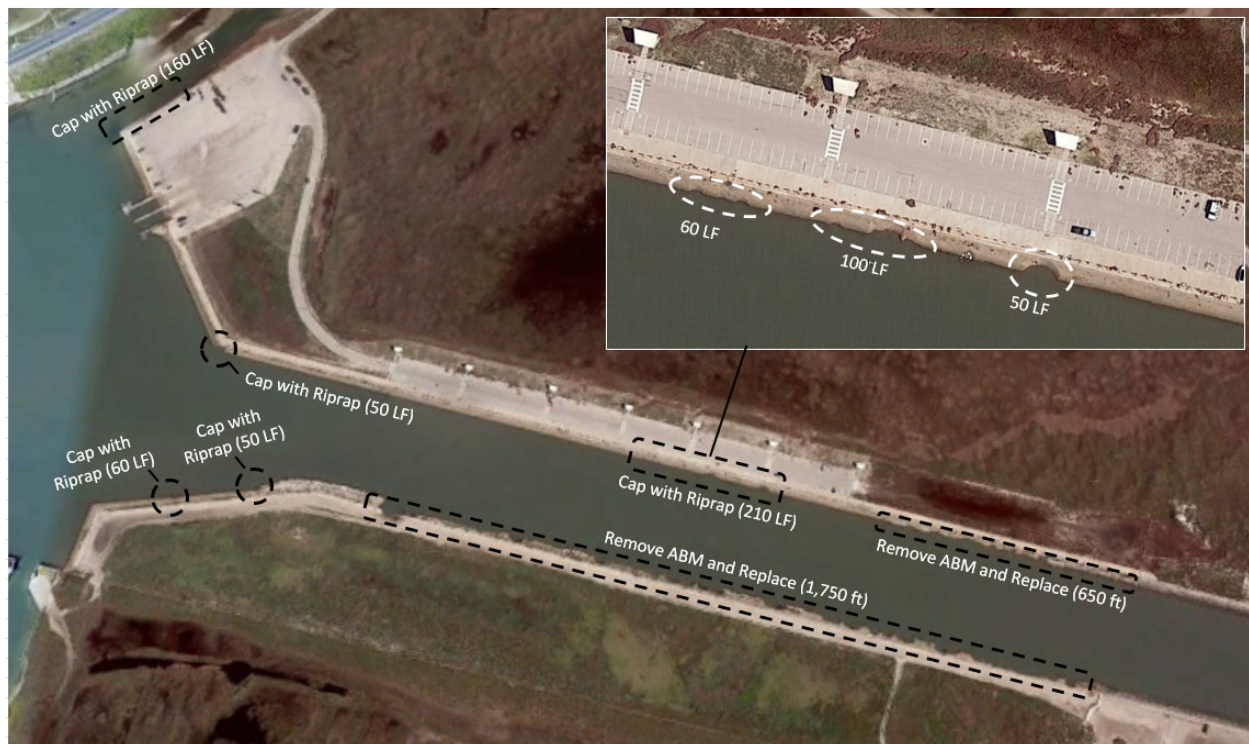
Figure 9 – ABM Damage Areas and Repair Classifications in Reach 3.

The design alternatives and/or recommendations for each repair category are presented below. In Reach 3, the ABM damage areas were divided into two general types as shown in Figure 9 and described below.

1. Smaller, more isolated damage areas, and damage along areas that are less exposed to daily wave and current action, are recommended to be repaired by capping the damaged ABM in place with riprap. This repair approach has been successful for previous repairs to short sections of the ABM revetment by the USACE and the City (for example, see Figure 10). This approach should include placement of geotextile fabric and riprap along the exposed slope below the ABM to help prevent future toe scour and undermining.

2. Longer sections of damaged ABM, and/or damaged ABM in areas more exposed to daily wave and current action, are recommended to be repaired by removing the ABM and replacing it with either new ABM (for the Harvey Repair category), or with other alternative bank stabilization methods (for the Hazard Mitigation category).

| <b>Table 4 – Harvey Repair Recommendations (Return Project to Approximate Pre-Harvey Condition).</b> | | |
|---|---|---|
| Reach 3<br>(Figure 9) | - Cap damaged ABM in-place with riprap. Also place riprap on geotextile fabric along exposed slope below bottom edge of damaged ABM to approximate elevation -8 ft NAVD. | 530 LF |
| | - Replace ABM Revetment<br>- Extend new ABM downslope to approximate elevation -8 ft NAVD (see Figure 13). | 2,400 LF |

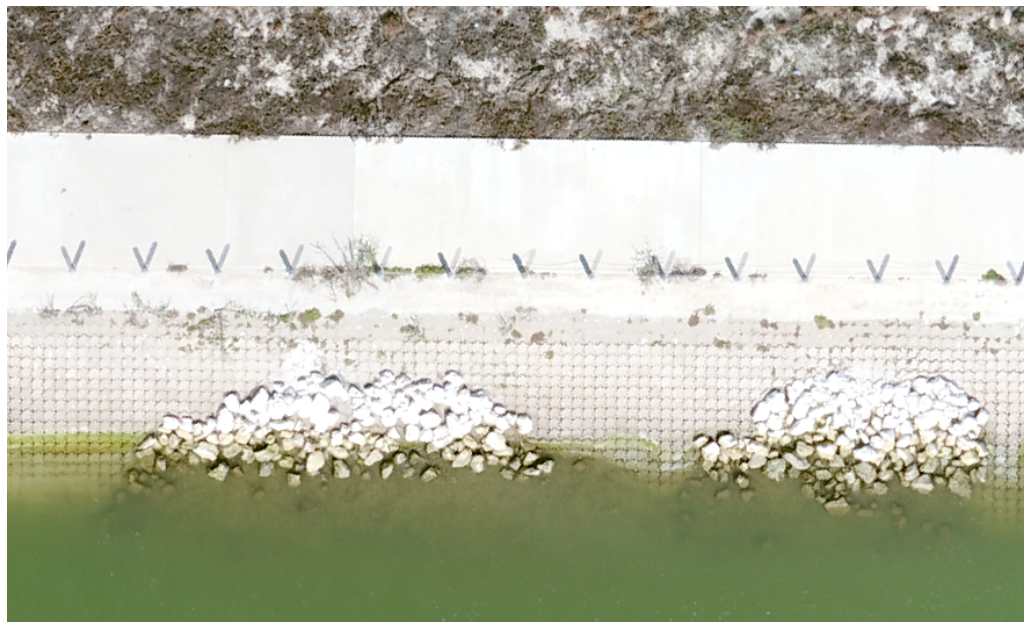
Figure 10 – Example of previous repairs constructed by capping damaged ABM in-place with riprap.

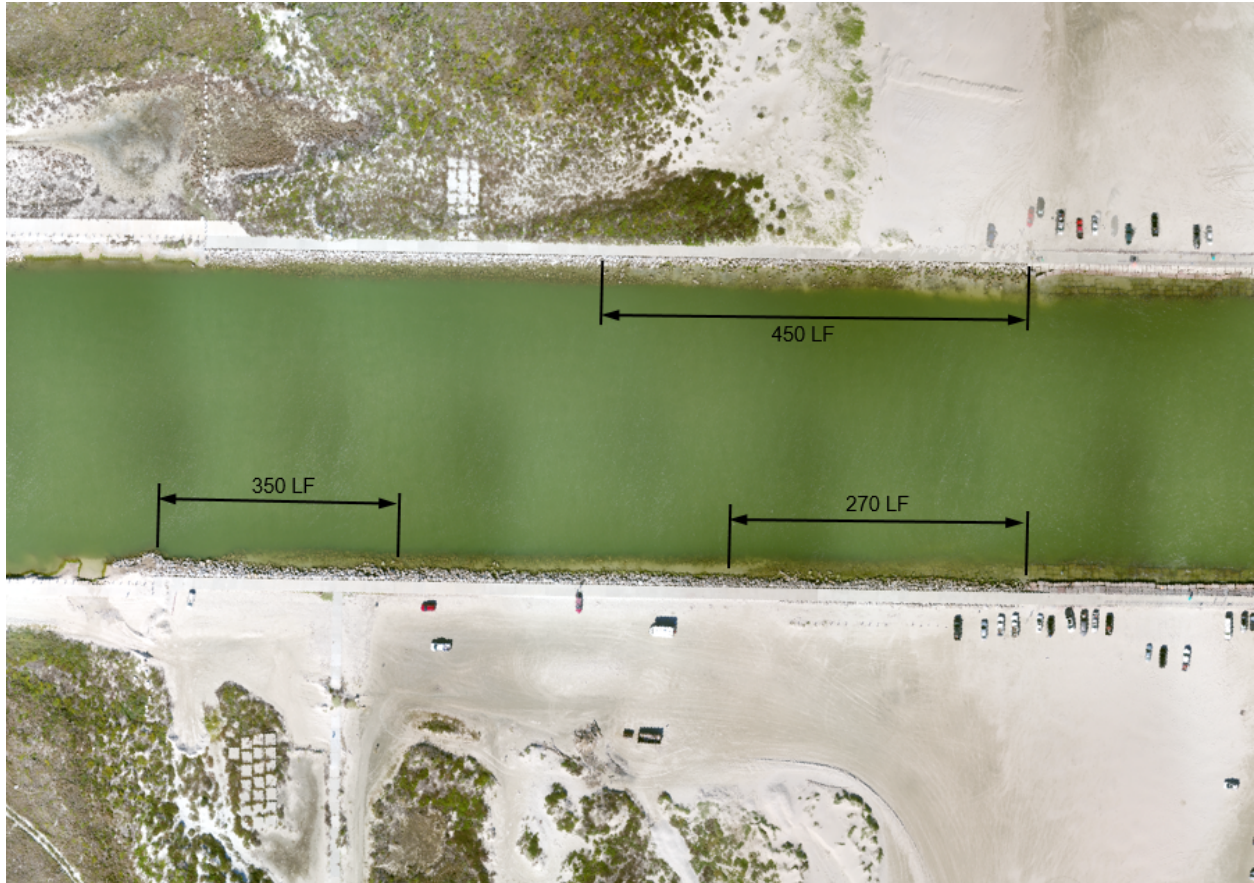
Figure 15 – Landside Jetty Damage Areas in Reach 2.

During original project construction, the stone in Reach 2 was placed on a sand bench at -6 ft NAVD, but the bench eroded to elevations of approximately -8 ft NAVD during Hurricane Harvey. The improved template would provide a larger toe apron designed to help prevent undermining to a depth of -14 ft NAVD, which is the full channel depth.
- *Reach 3 – Revetment Repairs*

| Location | Repair Description | Approximate Quantity |
|---|---|---|
| Reach 2 | <p>Landside Jetty Repairs</p> <ul style="list-style-type: none"> <li>- Re-set/replace quarrrystone along landside jetty (see Figure 15 for location and limits).</li> <li>- Extend quarrrystone downslope and provide improved toe to accommodate scour to elevation -14 ft NAVD (see Figure 16).</li> </ul> | 1,070 LF |

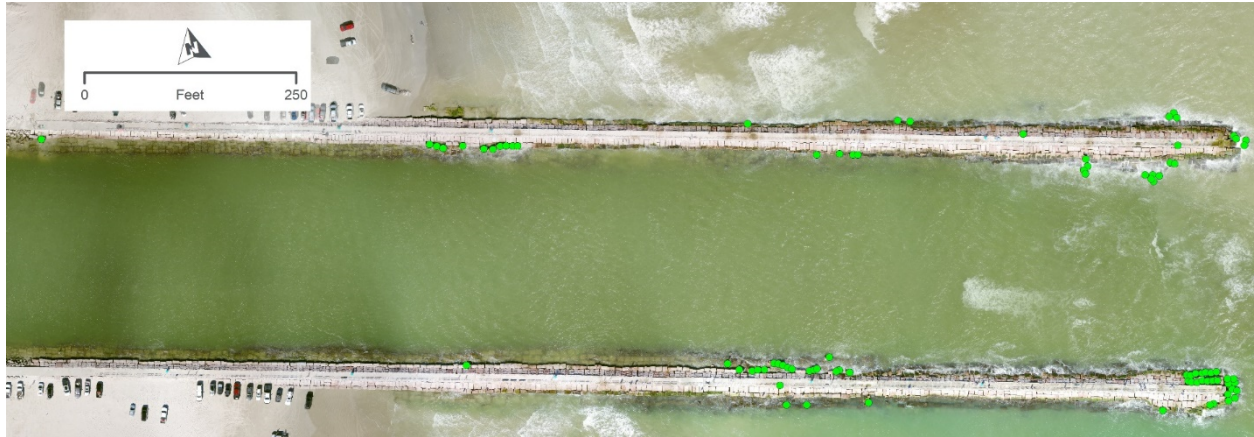
Figure 26 – Maintenance Repairs in Reach 1: Re-Set Jetty Armor Stone.

- Reach 1: Observed damage primarily consisted of displaced armor stone blocks along the outer portion of the jetties extending into the Gulf. Although most of this damage appears to have been a result of cumulative impacts from previous hurricanes, re-setting all of the stones is recommended to prevent more significant damage during future storms.
