JC Elliot Office Deterioration

07.20.2021

The Issue

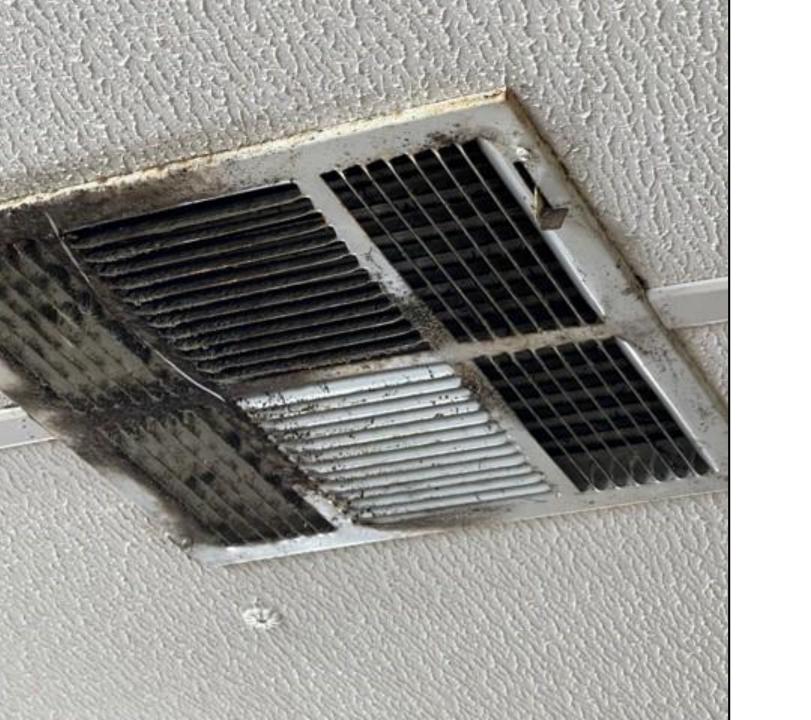
Interior Mold

Multiple A/C vents have sustained mold.

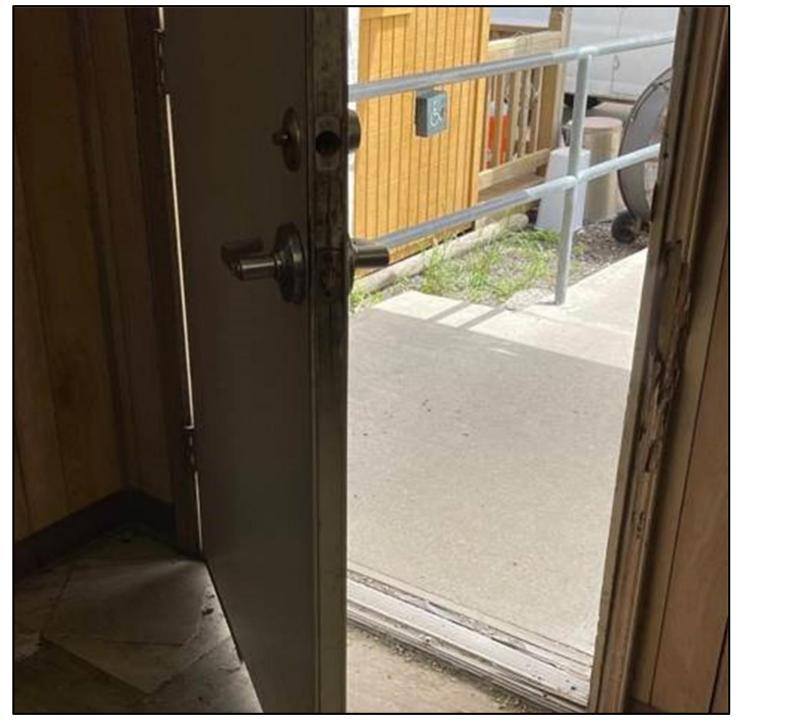
Interior Issues

Exterior door has gap issue causing difficulty to close door.

Door frame has sustained damage.

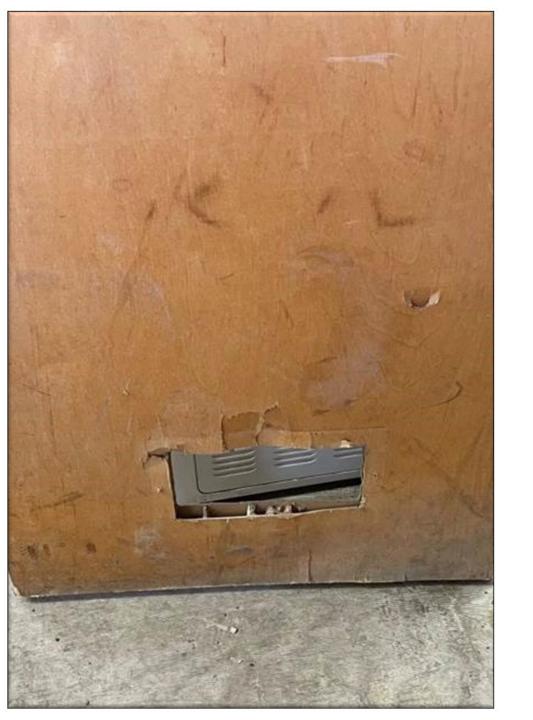
Interior Issues

Holes in interior doors.

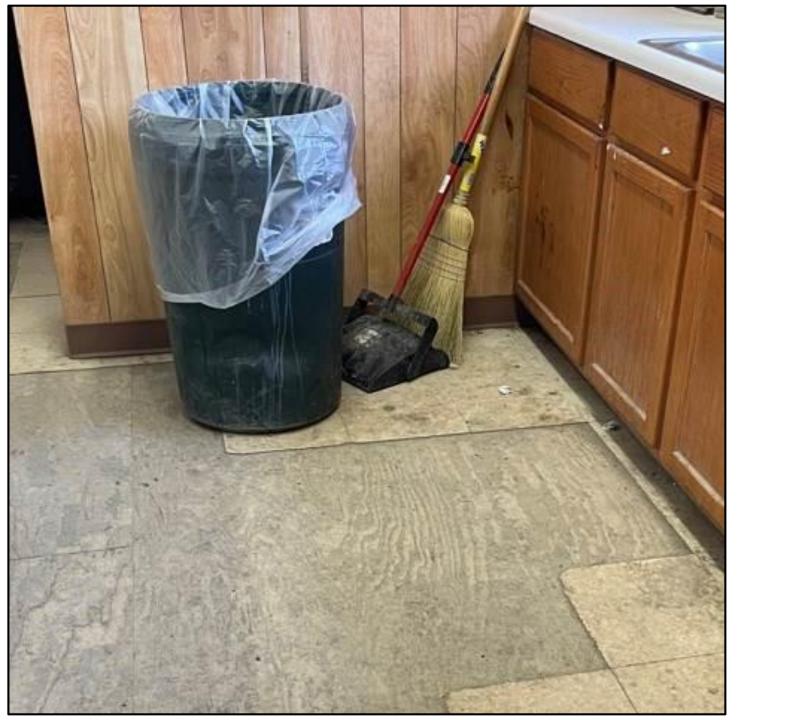
Interior Issues

Missing floor tiles.

Possible moisture problem won't allow tiles to stick.

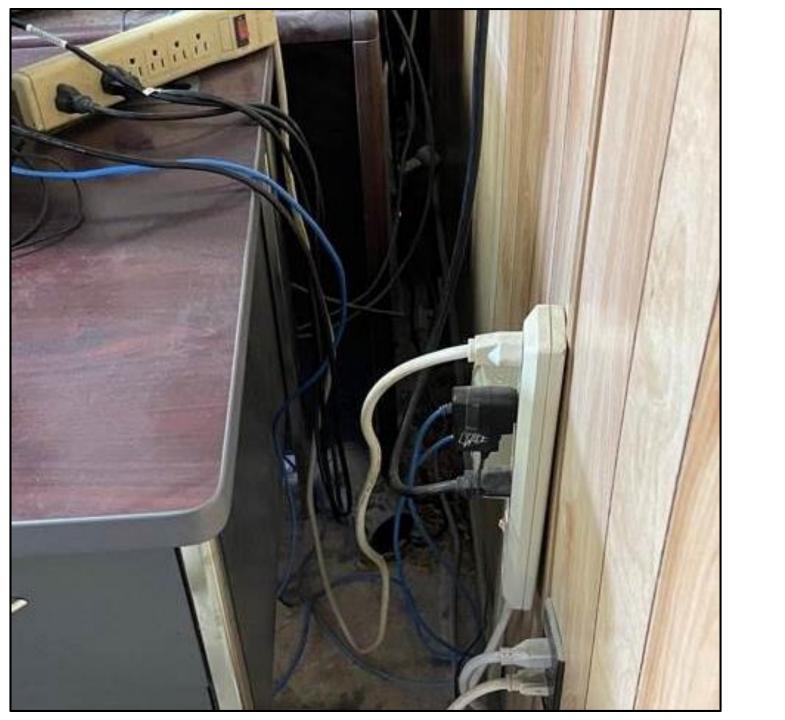
Electrical Issues

Building's electrical wiring is not suited for multiple computers and electronics.

Heavy reliance on loaded power strips

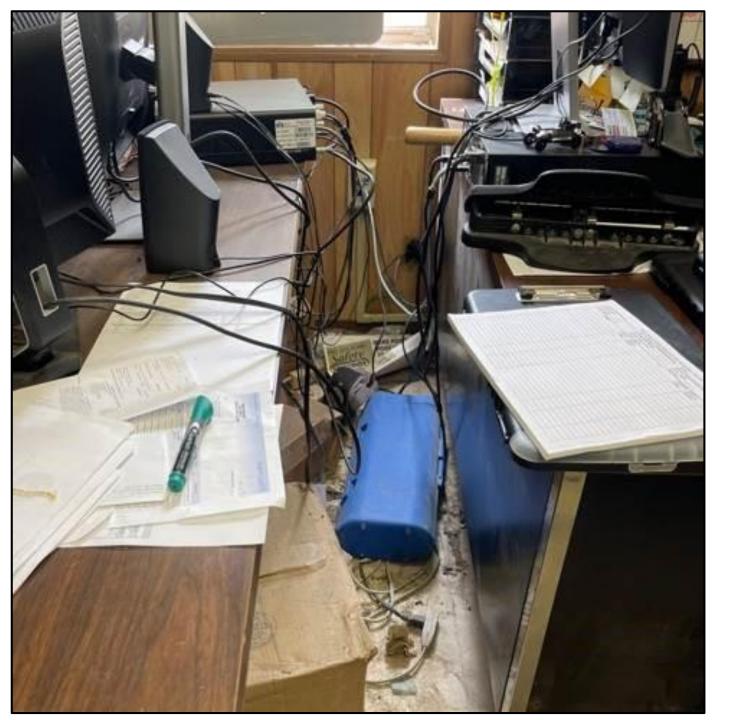
Electrical Issues

Building's electrical wiring is not suited for multiple computers and electronics.

Space is too small for the number of staff housed.

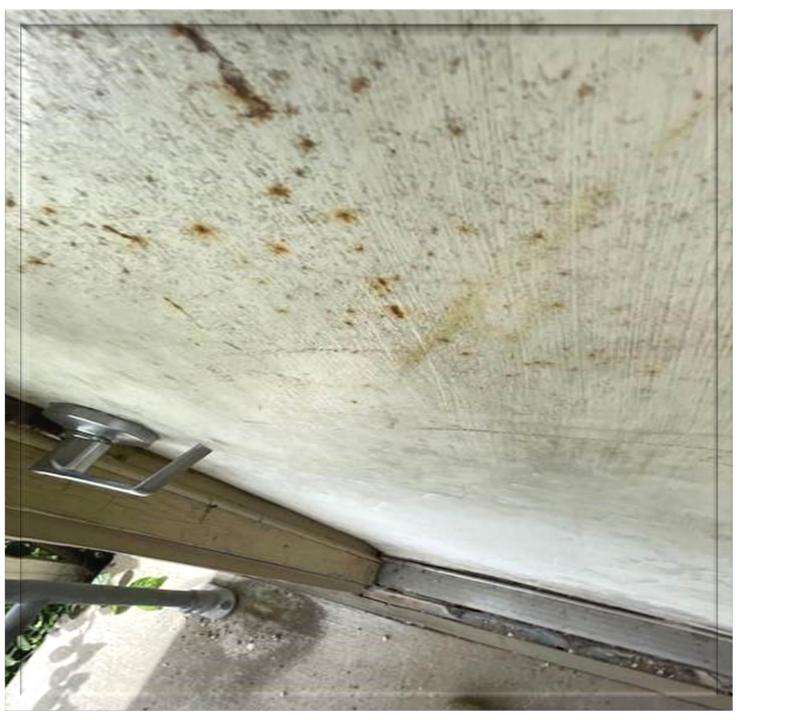
Exterior Rusting

Rusting on exterior doors.

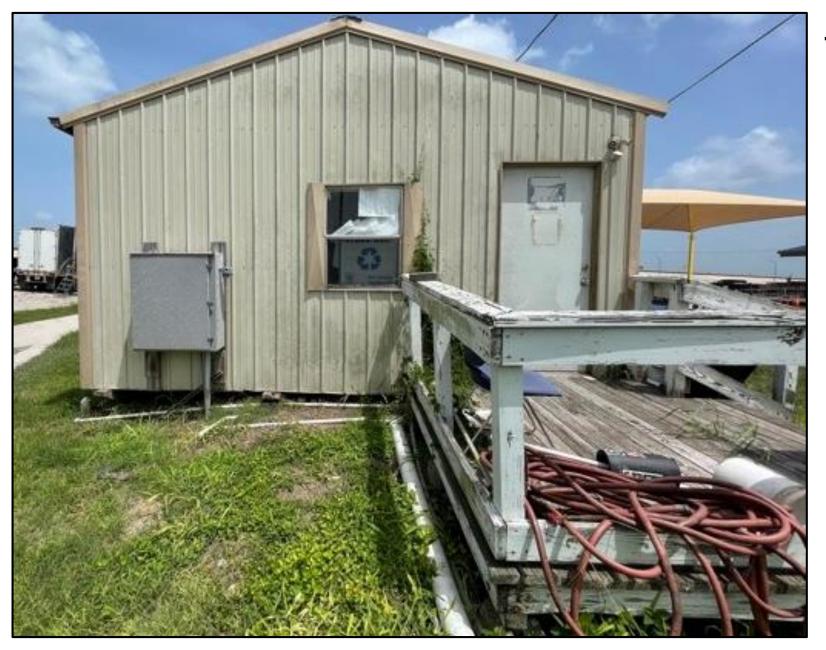
Exterior Deterioration

- Wood on ramp is rotting.
- Wood supports for building are rotting.
- Rusting under electrical box (not pictured here).
