## Technical Memorandum

McGee Beach Breakwater  
Improvements (E15219)

Seawall Type A Board – Seawall  
Maintenance

Corpus Christi, Texas  
May 3, 2016

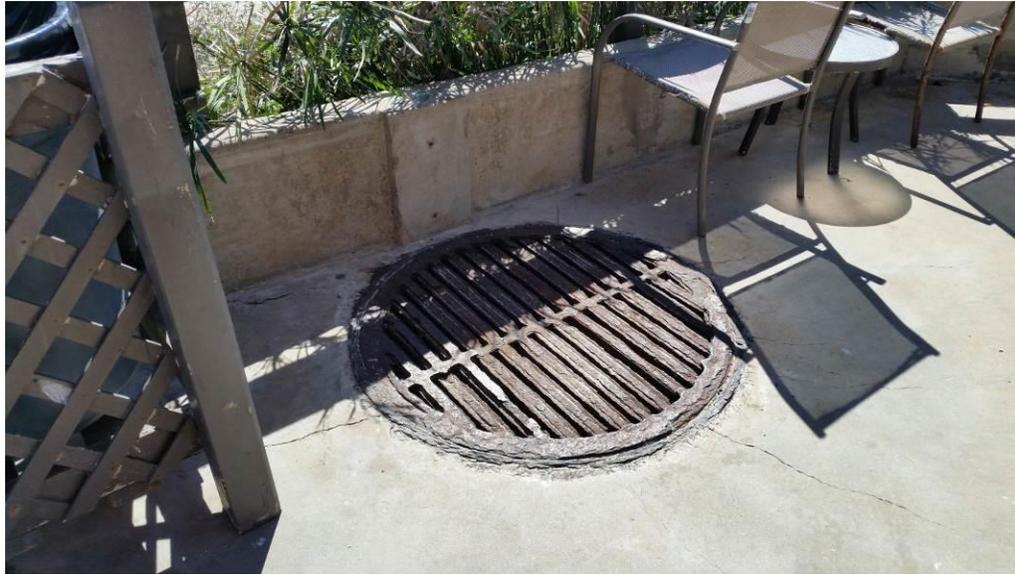
The foundation slab appears to be in good condition when observed from the top outside of the building. Few cracks were observed on the top of the slab. The top side of the slab was not sounded. The drainage grate and frame in the slab are severely corroded and there are cracks in the slab radiating from the grate frame (Figure 4). It appears that the grate drains water through the slab and into the sand. The City's historical record drawings show no piping from the drain. There is a lift station beneath the slab for the pumping of sewage. The hatch for the pump station was not opened and the pump station condition was not observed.

Figure 4 – Top View of Foundation Slab

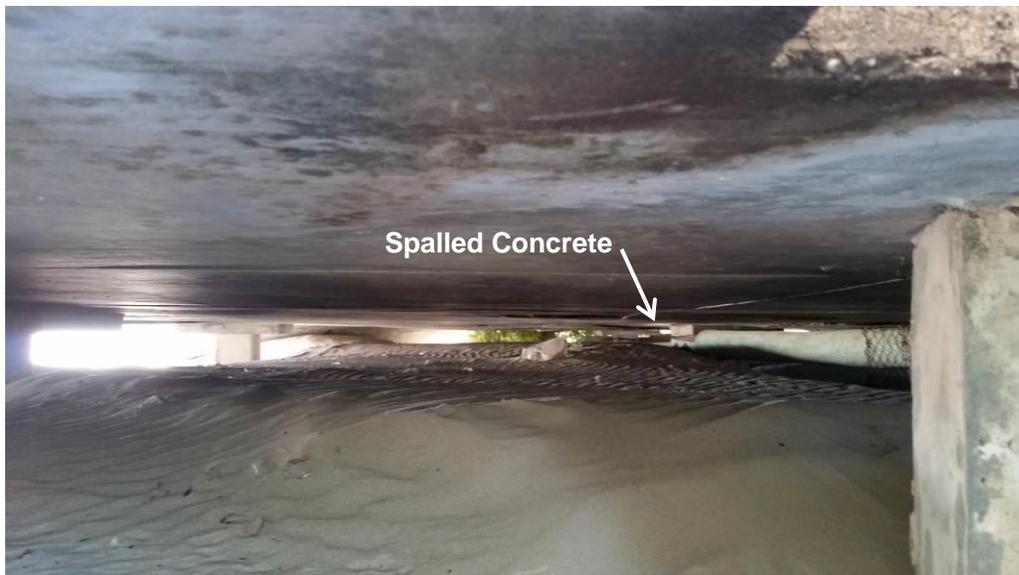
Although at first glance the underside of the slab also appeared to be in good condition, there is at least one large area (approximated at 8 to 10 feet in diameter) of spalling concrete. The spalled concrete has not fallen from the slab, but is loose, and the edge of the spalled concrete appears to be hanging 2 or 3 inches from the slab (Figure 5).

Figure 5 – View of Underside of Slab

Viewed from the edge of the foundation, it was difficult to see if there were any other spalled areas. The underside of the slab was not sounded. Based on the portions of the foundation that were observed, it was estimated that approximately 30% of the overall underneath side of the slab may have areas that are spalling (not all of the slab was visible at the time of this survey).

- **Building Foundation:** The bottom of the building foundation should be sounded to determine the limits of the deteriorated spalling concrete; these areas should be repaired.
- **Breakwater Extension:** The existing elevated cap is recommended to be demolished and replaced with a new rock breakwater and concrete cap.

- **Building Foundation**
  - Repair the underside of the foundation slab by removing the deteriorated concrete and replacing with a corrosion resistant concrete patching material.
  - Remove deteriorated column/pile concrete top and replace with a corrosion resistant concrete patching material.
  - Replace concrete drainage grate. Further examine grate frame and, if required, remove by saw cutting the cracked concrete around the frame and replace the frame and concrete.
  - Provide a wall or other barrier along the foundation slab to lessen blowing sea air and sand from further deteriorating the underside of the foundation slab, and to

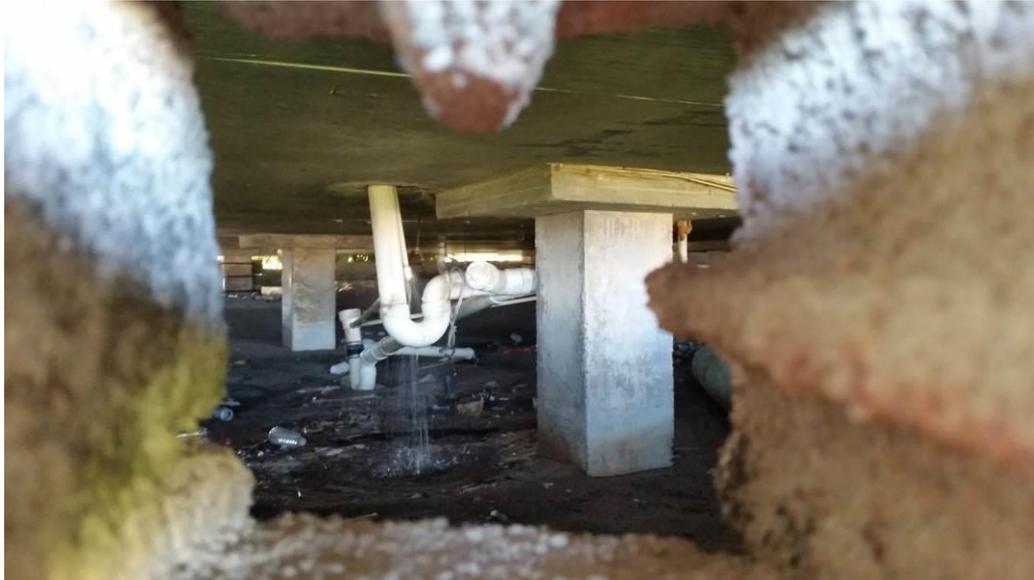
The foundation slab to column/pile connection consists of a 4-inch thick by 3-foot square drop panel at the top of each pile/column (Figure 6).

Figure 6 – View of Column/Pile Connection Under Slab

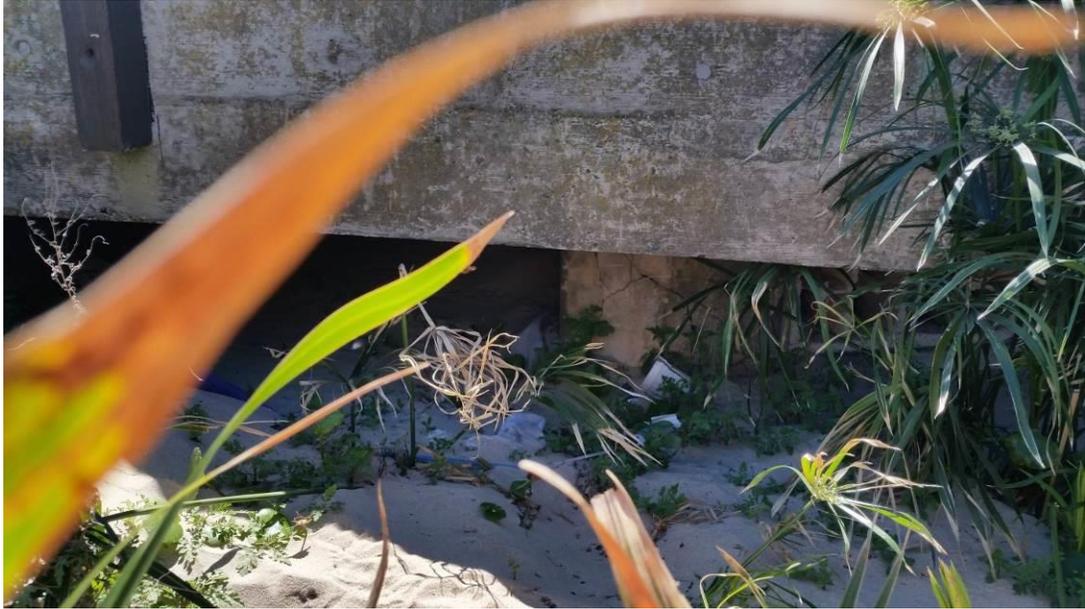
Of those panels that were visible, no corrosion was observed. The tops of the column/piles that were visible appeared to be in good condition with the exception of one. The portion visible (top 2 feet) was observed to be in poor condition, exhibiting severe cracking (Figures 7 and 8).

Figure 7 – Column/Pile with Severe Cracking

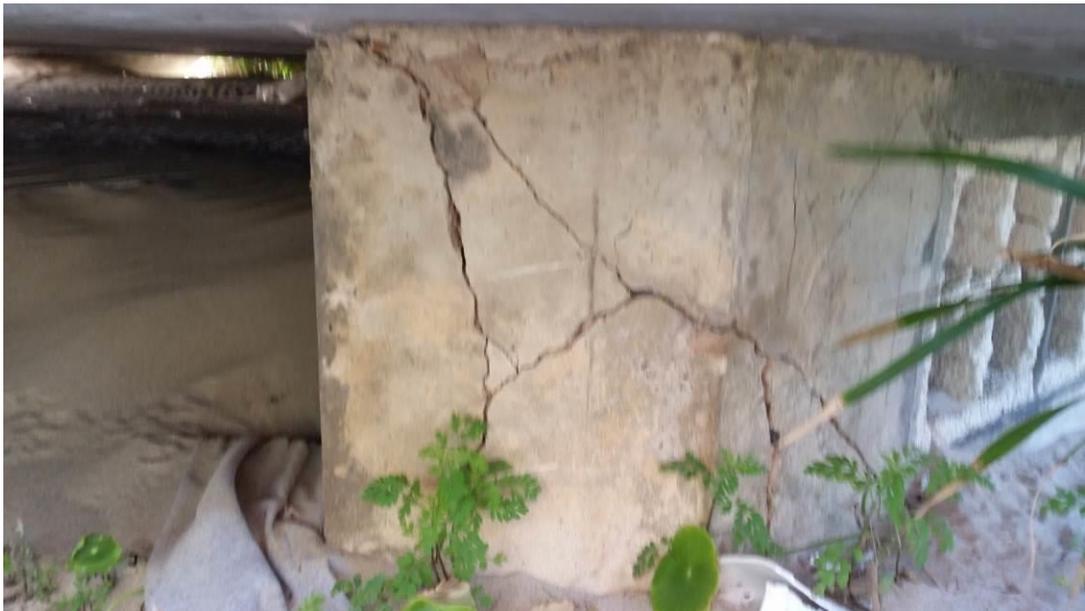
Figure 8 –Column/Pile with Severe Cracking

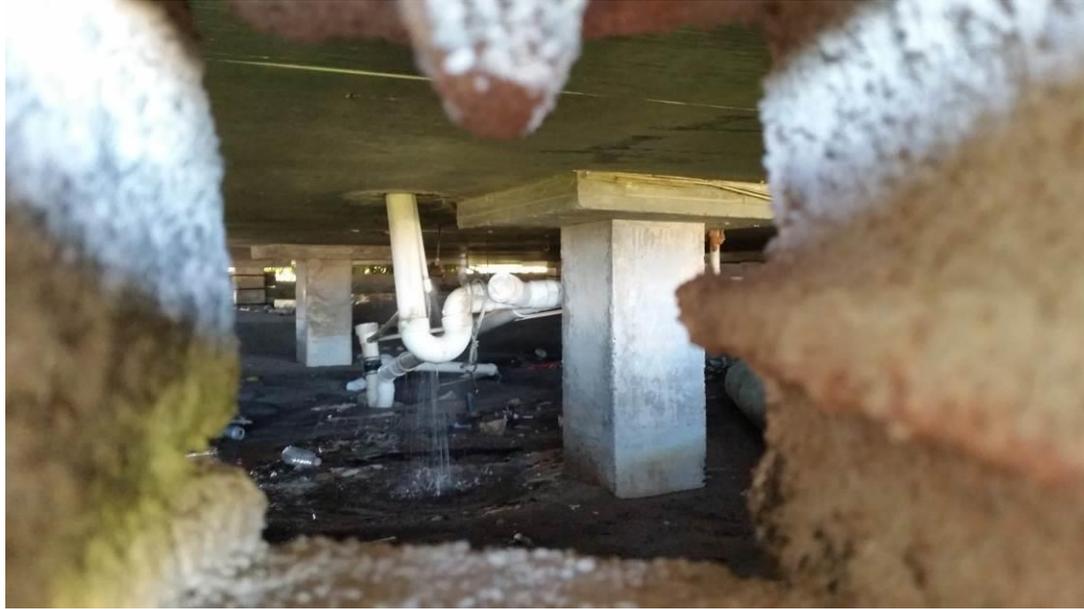
A PVC water pipe under the slab was observed to have a leak at a 90 degree joint. Water was flowing from the leak and draining into the sand at the time of the site visit (Figure 9). It appeared that the line was for supply water. No apparent structural damage was observed associated with the leak.

Figure 9 – Water leaking from Pipe Under Slab

- help prevent uncontrolled/unauthorized access and associated vandalism under the foundation slab.
- Repair plumbing and electrical lines as required.
- Breakwater Extension

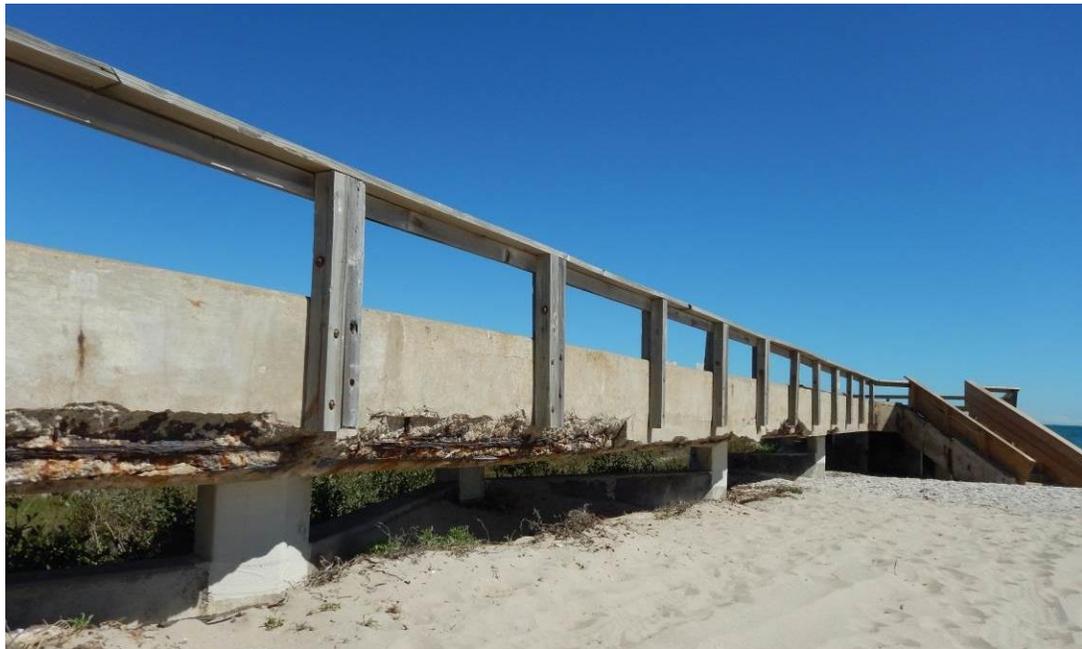
The foundation slab is connected to an elevated concrete cap that extends to the rock section of the breakwater. As previously observed during the 2009 survey, the cap structure shows signs of severe deterioration, including spalled concrete and exposed rebar, large cracks, damaged stairs and handrails (Figure 10).

Figure 10 – Damage along elevated cap extending to the rock breakwater. Also note the gap below the cap, which allows sand to be blown from McGee Beach into the marina.

In addition the lighting, lighting poles and electrical conduit is missing, as are sections of handrail and the previous fish-cleaning stand. Continued degradation of the concrete deck and foundation will eventually lead to more significant structural damage, creating a gap in the breakwater that would leave a portion of the seawall more susceptible to potential wave damage during severe storms. In addition, collapse of the cap could occur during a severe storm, causing structural debris to damage the seawall, marina, boats, and landward infrastructure.

As a secondary concern, the opening under the cap allows sand from McGee Beach to be blown into the marina. Loss of sand from McGee Beach increases exposure of the adjacent seawall (south of the breakwater) to wave impacts, increasing potential for undermining and/or damage during severe storms. In addition, loss of wind-blown sand under the cap increases the requirements for periodic renourishment of McGee Beach.

- Demolish the elevated cap and concrete sheet pile from the damaged steps seaward of the building foundation to the existing rock breakwater.
  - Extend the existing rock breakwater approximately 200 ft landward to the building foundation.

- Construct a 6-ft wide, 200-ft long concrete cap along the crest of the new breakwater.
  - Replace the steps between the breakwater and McGee Beach.

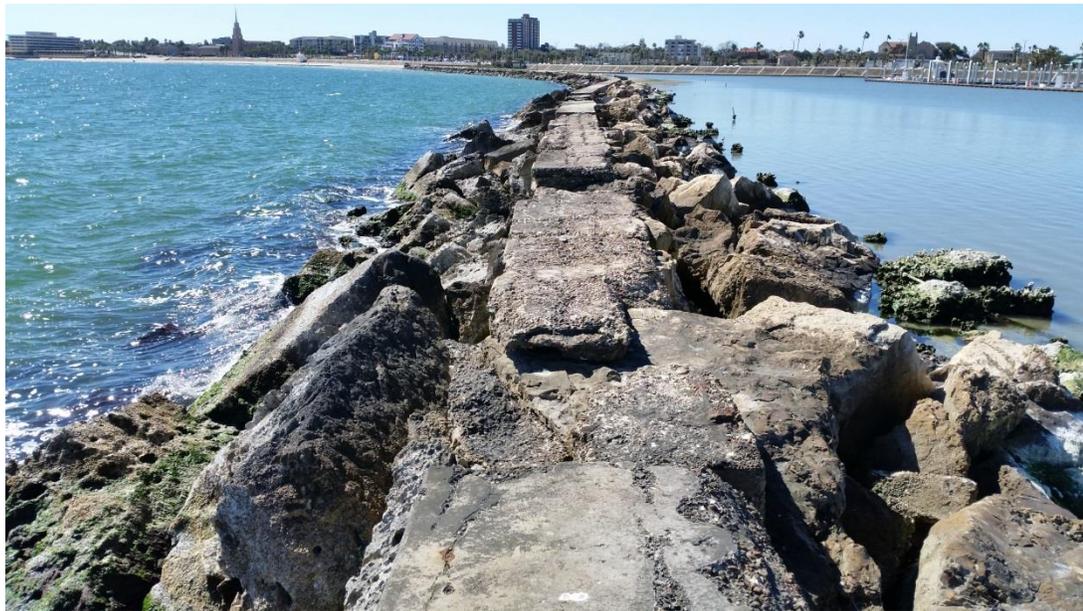
The rock breakwater extends northward from the elevated concrete cap and around the City marina. The breakwater is approximately 5,800 ft long, with the southern approximate 1,800 ft having a 4-ft wide concrete cap. Deterioration of the cap has progressed since the 2009 survey, with severe spalling, cracking, and rebar exposure over its entire length, and some sections of the cap completely missing (Figure 11). The handrails, lighting, and electrical conduit are gone, and the cap is frequently subjected to wave spray and overtopping.

Figure 11 - Missing sections of concrete breakwater cap.

- Breakwater Cap
  - Repair/replace entire 1,800-ft concrete cap along existing rock breakwater.
  - All of the existing cap is recommended to be either partially or fully replaced. Broken sections of cap should be removed. Because it is recommended that the new cap be constructed higher and wider than the existing cap, the sound portions of the existing cap could possibly be left in place with the new sections cast over the existing sections. The viability of leaving sections of the existing cap in place depends on how soon the repairs are performed.

- Construct/place rock ballast (smaller stones) to fill gaps between larger stone and provide a base for the new concrete cap.
  - Build new cap wider (assumed here to be 2 ft wider) and higher (assumed here to be 1 ft higher) than original. This would make the new cap approximately 6 ft wide.

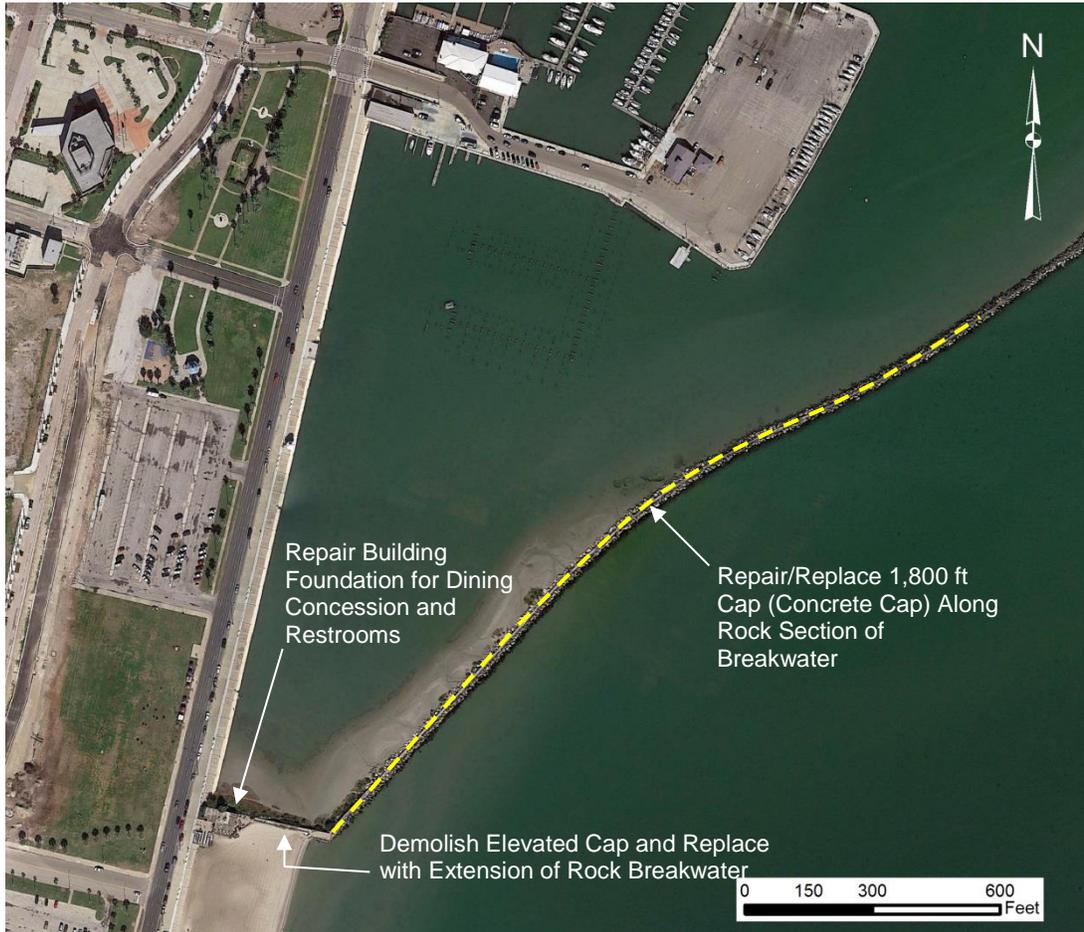
Figure 12 – Locations of Proposed Improvements

- **Breakwater Cap:** The concrete cap along the existing rock breakwater is recommended to be repaired/replaced, and possibly raised.
