Water Supply Update

Including a review of the Mary Rhodes Pipeline and Pumping System

August 19, 2025

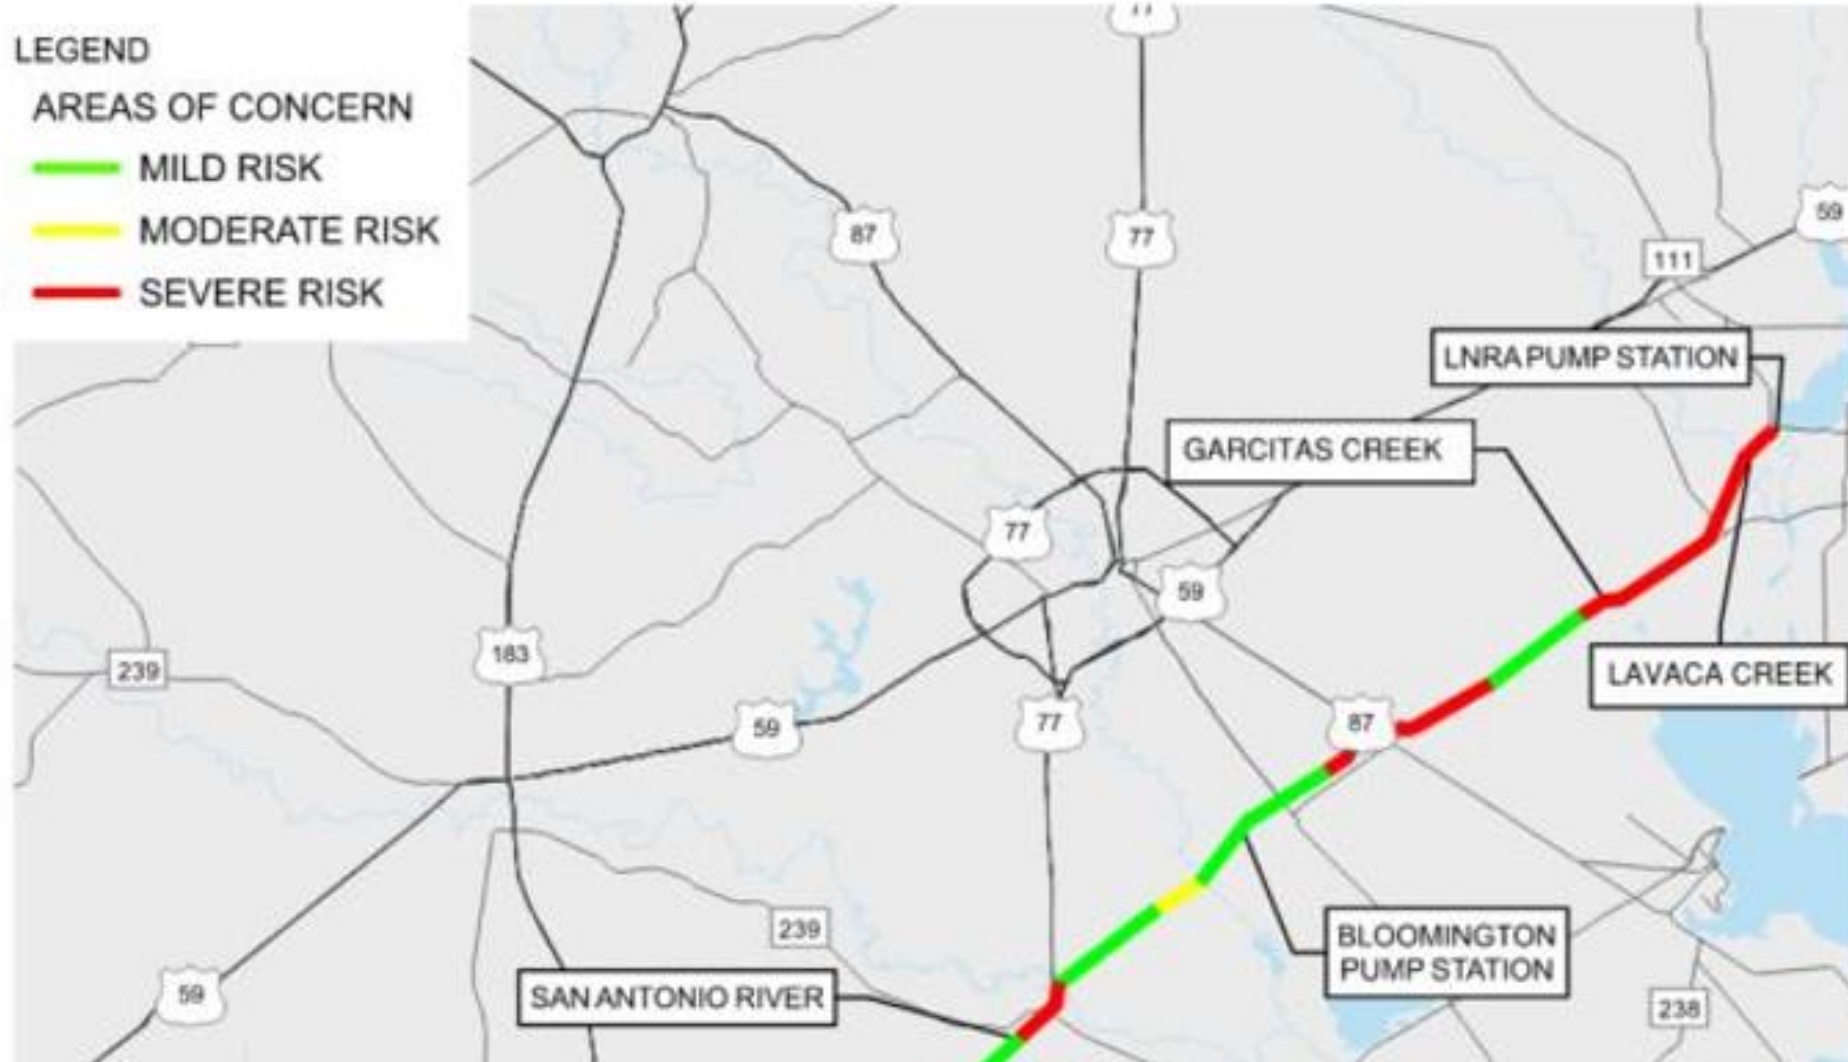
CONDITION ASSESSMENT IDENTIFIED AREAS OF PRESSURE EXCEEDANCE

- Pressure Exceedance Areas increase risk of MRP failure
- Predicted in model based on observed flow
- Field verified by remote pressure monitors
- Suspected to be caused by debris, sediment or other obstructions

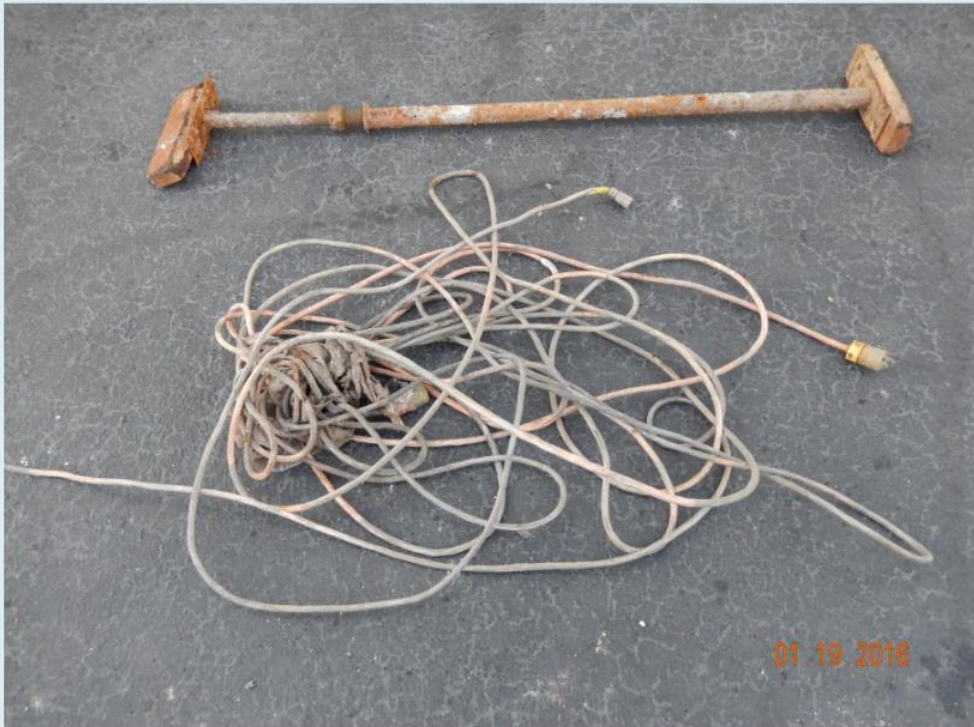
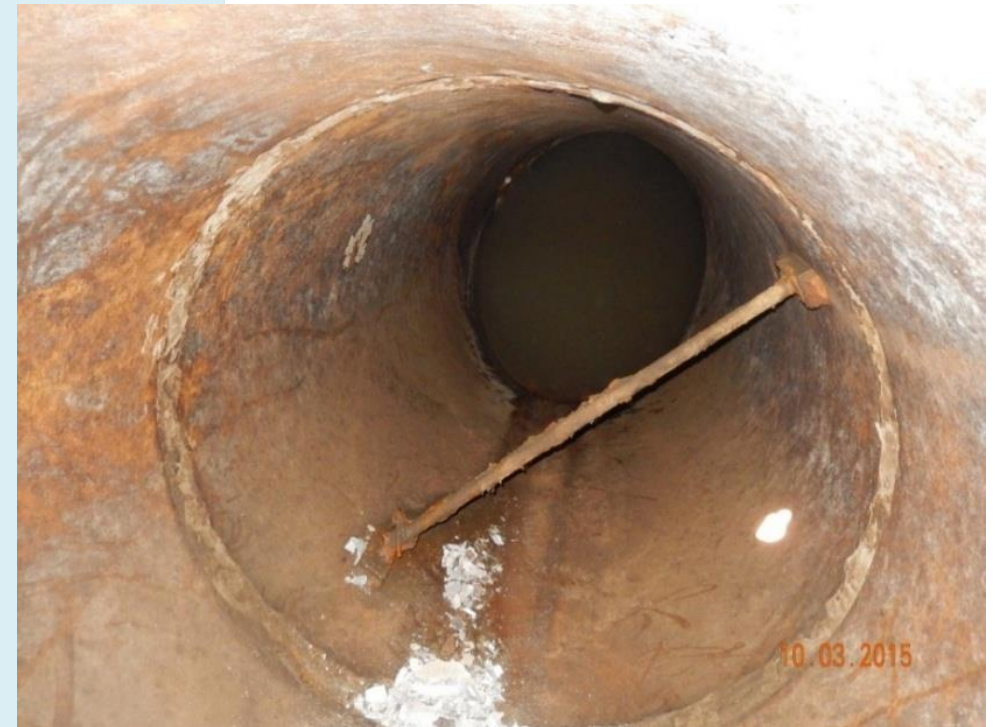
Trash that was left inside of pipe during the pipe installation. They were removed during the repair. (*spreader bar & Electrical extension cord*)
