September 23, 2015

**RE: GORDON STREET APARTMENT COMPLEX BUILDING  
CURSORY STRUCTURAL WALK-THROUGH ASSESSMENT**

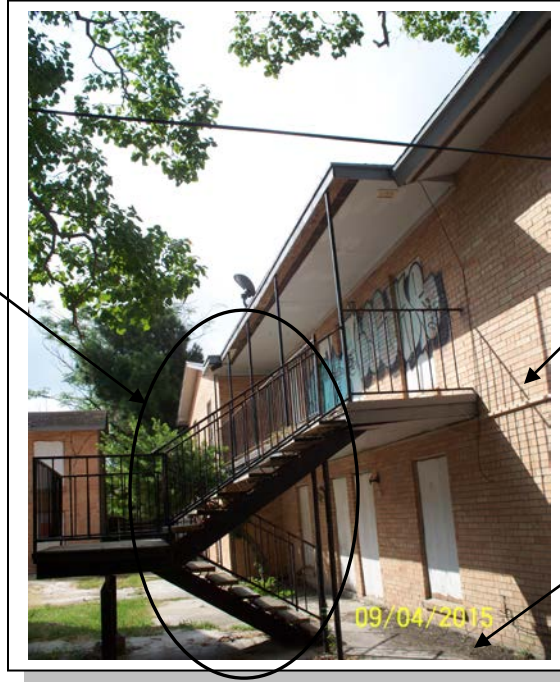
Photograph No. 3 – Front Face of Building, Exterior Walkway and Stairs

- Differential foundation movement evident by cracking in the exterior brick veneer.
- Site drainage appears to be directed toward the building foundations at several structures.

- Apparent fire damage outside first floor unit of southeastern most structure.
- Exterior stairs accessing the second floor units are in poor condition.

Original stair treads no longer present. Replaced with wood members.

Building structure in good general condition

Dirt and debris indicate site drainage toward building foundation

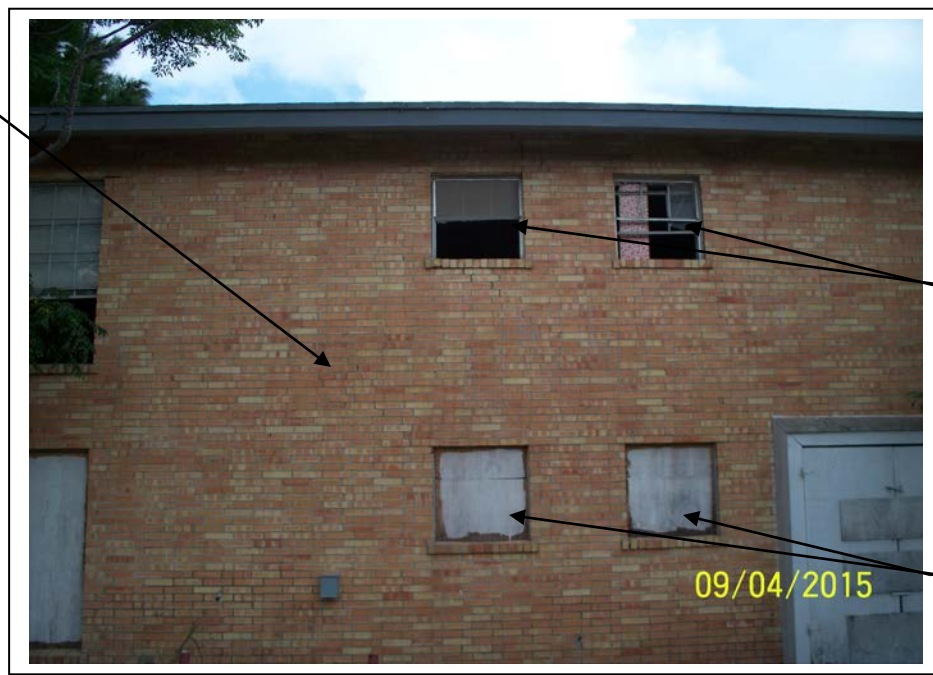
Photograph No. 4 – Rear Face of Building

- Broken window glass at windows not covered with plywood.
- First floor unit in northernmost structure had previously sustained fire damage
  - Fire damage appeared to be somewhat contained and limited to the finishes on the interior of the unit rather than the framing system.

Building structure in good general condition

Open and broken window glass

Covered openings

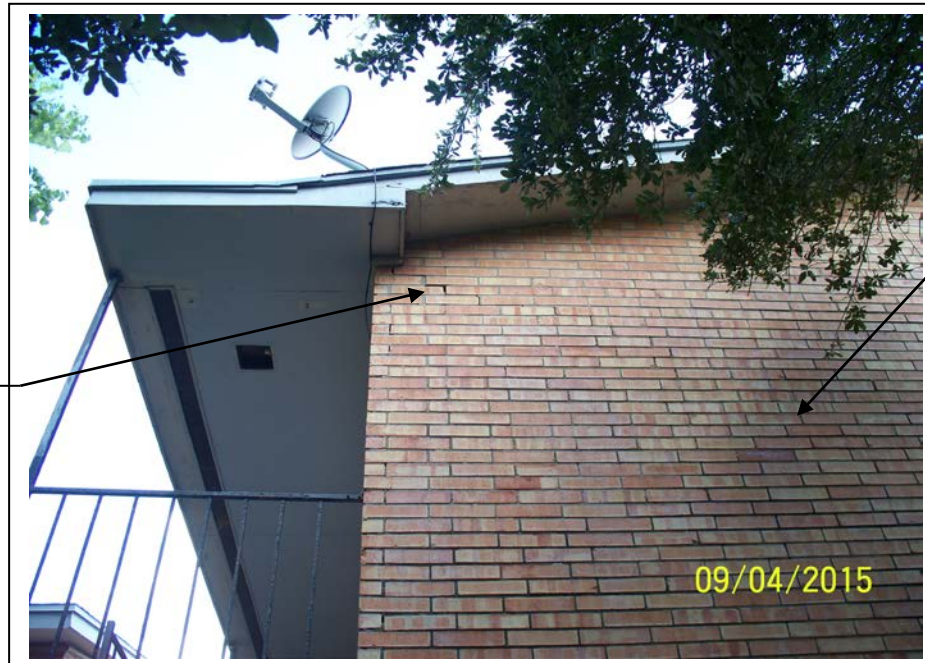
Photograph No. 5 – Typical Cracking Seen in Brick Veneer

Crack in brick  
veneer  
indicating  
differential  
movement of  
the foundation  
system

Building end  
wall

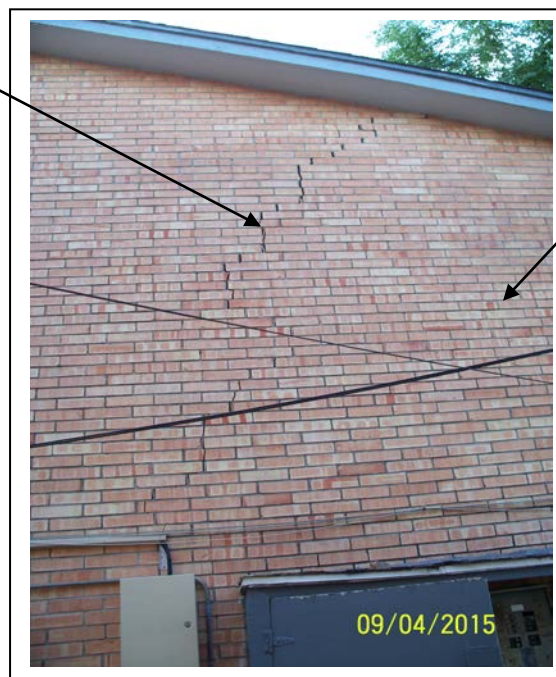
Photograph No. 6 – Cracking in Brick Veneer

Crack in  
brick veneer  
indicating  
differential  
movement of  
the  
foundation  
system

Building end  
wall

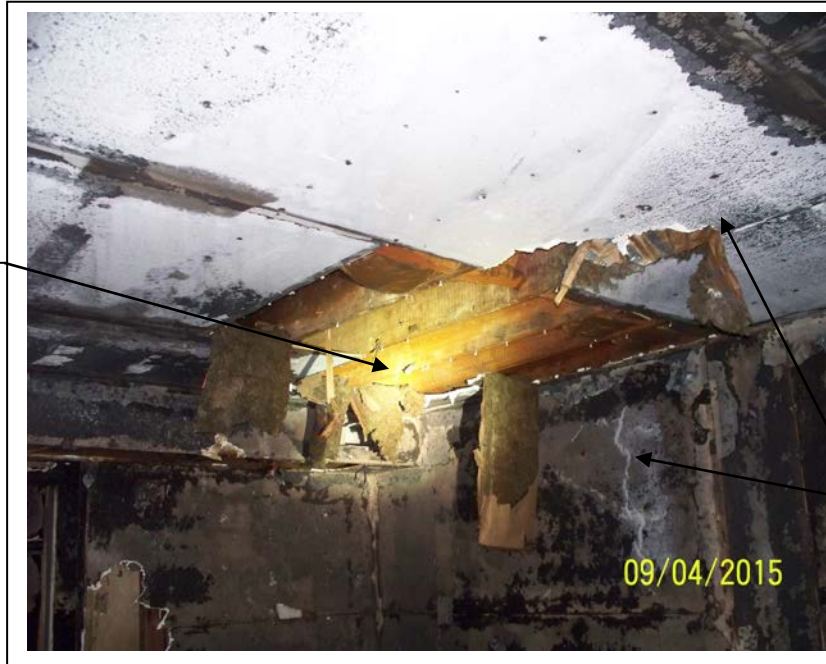
Photograph No. 7 – Fire Damaged Apartment Unit

Ceiling/second  
floor framing  
system with  
minimal  
discoloration  
and no fire  
damage

Fire damaged  
drywall/gypsum  
board

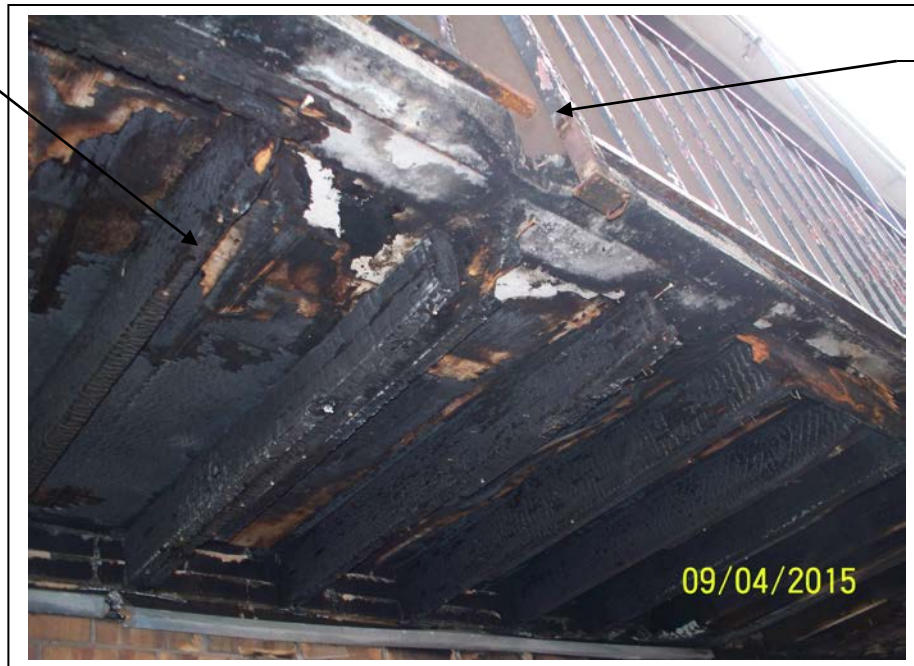
Photograph No. 8 – Fire Damage at Exterior Walkway

- Exterior walkway framing above this unit was severely damaged, requiring replacement.
  - Possible water damage to adjacent units from firefighting efforts.

Fire damaged  
exterior walkway  
framing  
members

Damaged exterior  
walkway handrail  
system

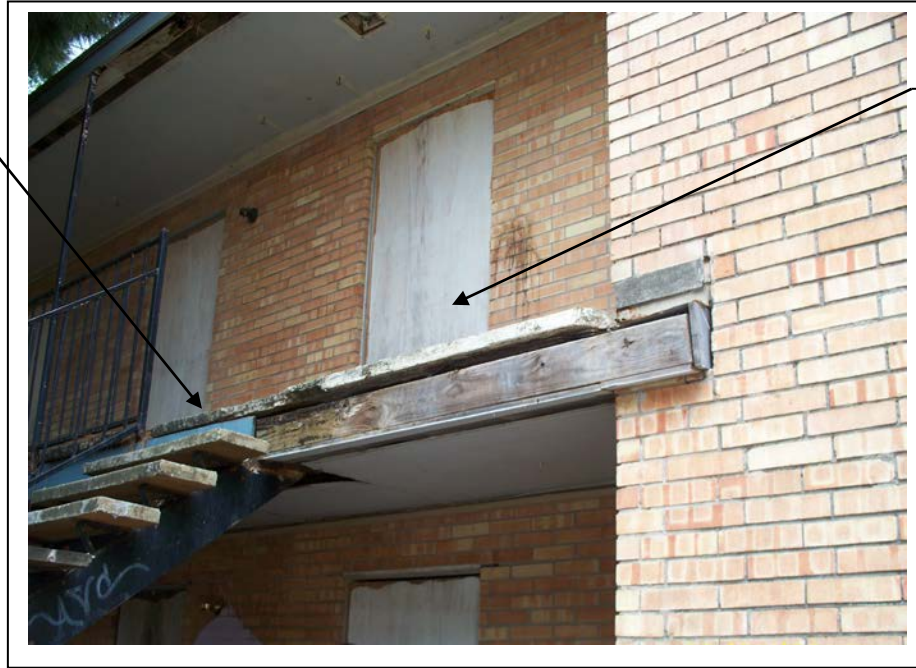
Photograph No. 9 – Exterior Walkway

- Handrails on the exterior second floor walkway are in poor condition.
- Detached/deteriorated fascia board in isolated areas at exterior second floor walkway.

Deterioration  
present at edge  
of walkway

Missing  
handrail at  
edge of  
walkway

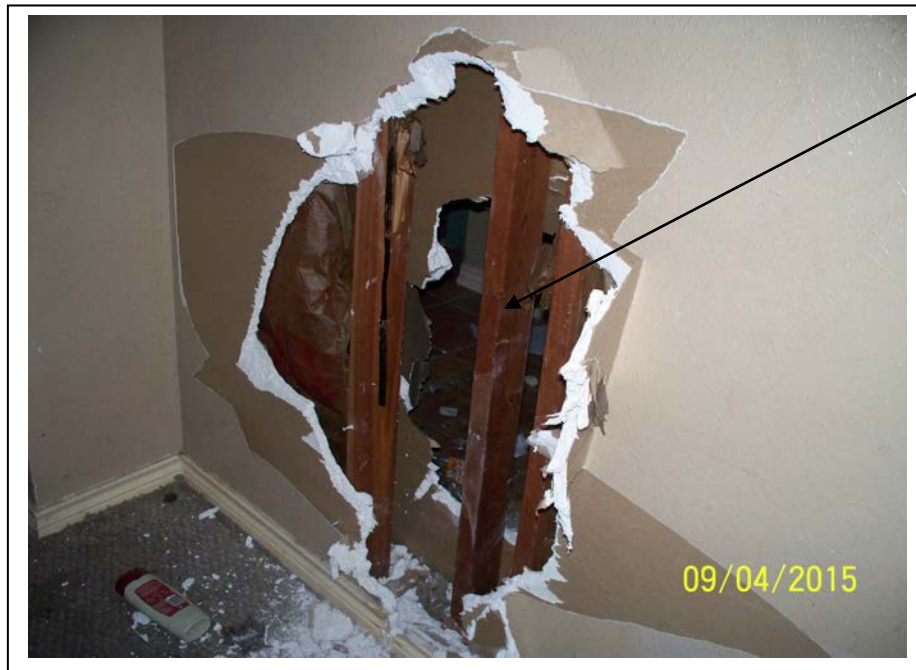
Photograph No. 10 – Typical Interior Framing

Interior  
framing  
between units  
in good  
general  
condition
