# Draft Technical Memorandum

McGee Beach Breakwater  
Improvements (E15219)

Seawall Type A Board – Seawall  
Maintenance

Corpus Christi, Texas  
March 29, 2016

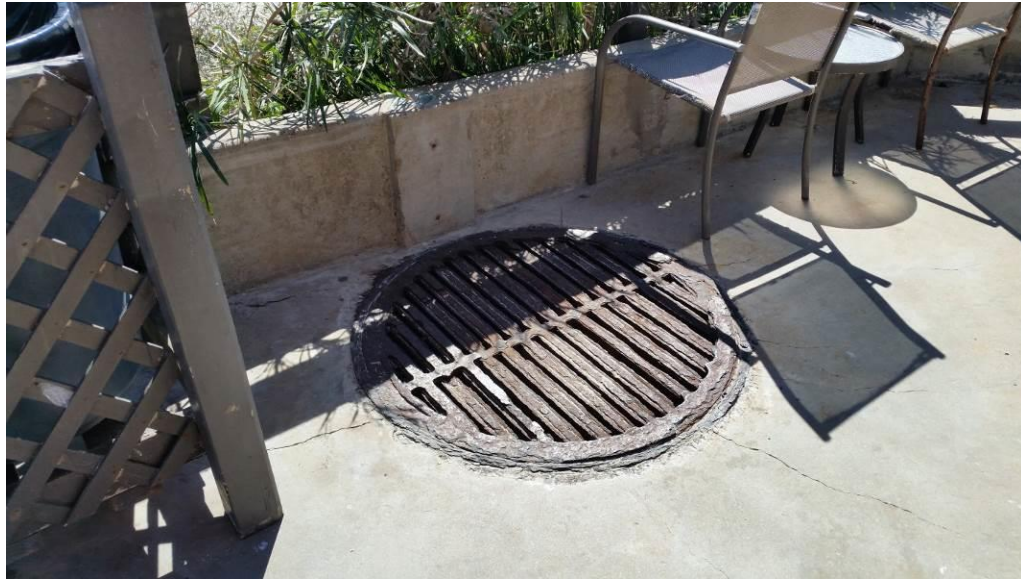
The foundation slab appears to be in good condition when observed from the top outside of the building. Few cracks were observed on the top of the slab. The top side of the slab was not sounded. The drainage grate and frame in the slab are severely corroded and there are cracks in the slab radiating from the grate frame (Figure 4). It appears that the grate drains water through the slab and into the sand. The drawings show no piping from the drain. There is a lift station beneath the slab for the pumping of sewage. The hatch for the pump station was not opened and the pump station condition was not observed.

Figure 4 – Top View of Foundation Slab

- Building Foundation
  - Repair the underside of the foundation slab by removing the deteriorated concrete and replacing with a corrosion resistant concrete patching material.
  - Remove deteriorated column/pile concrete top and replace with a corrosion resistant concrete patching material.
  - Replace concrete drainage grate. Further examine grate frame and, if required, remove by saw cutting the cracked concrete around the frame and replace the frame and concrete.

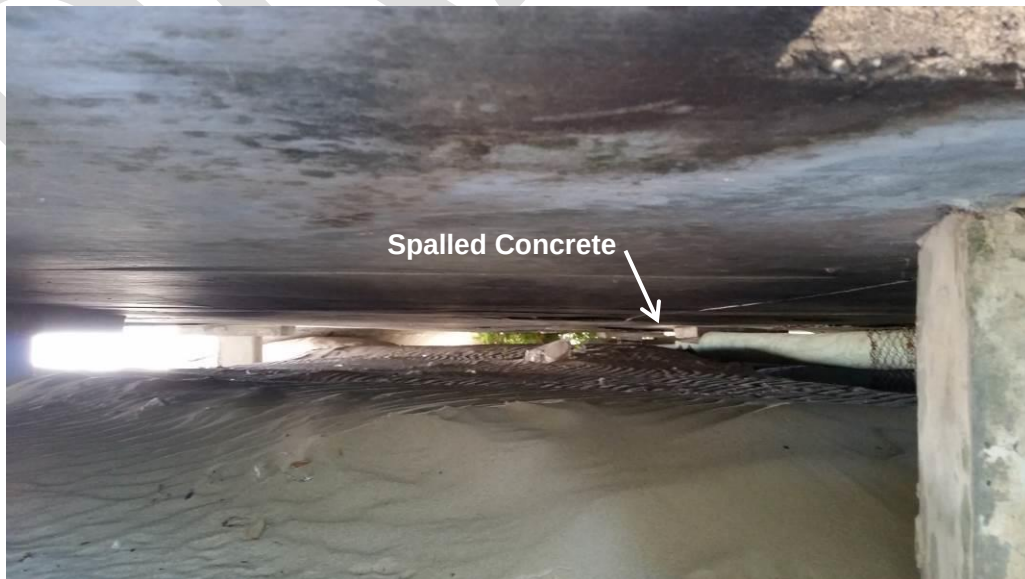
Although at first glance the underside of the slab also appeared to be in good condition, there is at least one large area (approximated at 8 to 10 feet in diameter) of spalling concrete. The spalled concrete has not fallen from the slab, but is loose, and the edge of the spalled concrete appears to be hanging 2 or 3 inches from the slab (Figure 5).

Figure 5 – View of Underside of Slab

Viewed from the edge of the foundation, it was difficult to see if there were any other spalled areas. The underside of the slab was not sounded. Based on the portions of the foundation that were observed, it was estimated that approximately 30% of the overall underneath side of the slab may have areas that are spalling (not all of the slab was visible at the time of this survey).

- **Building Foundation:** The bottom of the building foundation should be sounded to determine the limits of the deteriorated spalling concrete; these areas should be repaired.

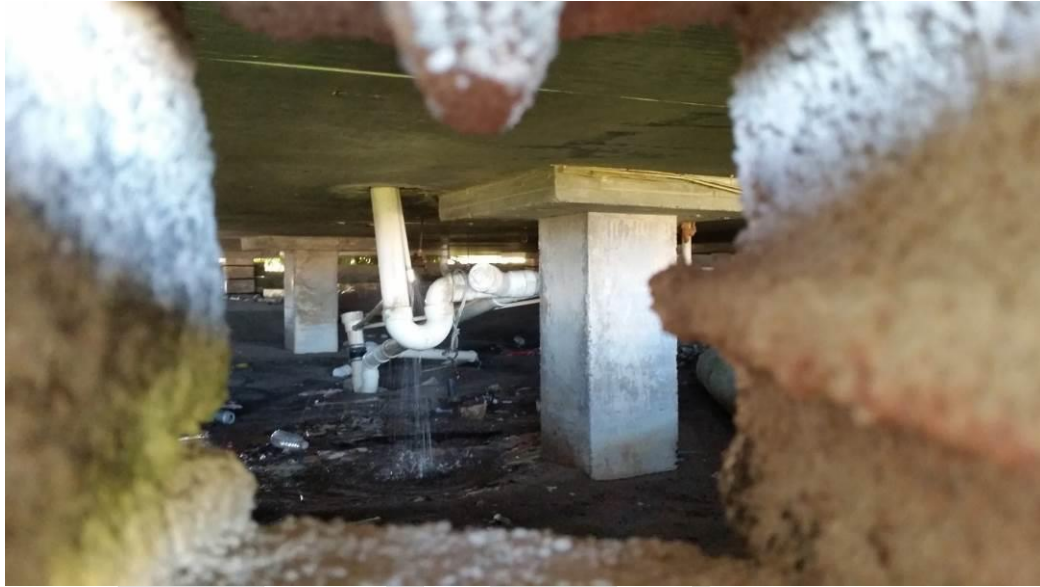
The foundation slab to column/pile connection consists of a 4-inch thick by 3-foot square drop panel at the top of each pile/column (Figure 6).

Figure 6 – View of Column/Pile Connection Under Slab

Of those panels that were visible, no corrosion was observed. The tops of the column/piles that were visible appeared to be in good condition with the exception of one. The portion visible (top 2 feet) was observed to be in poor condition, exhibiting severe cracking (Figures 7 and 8).

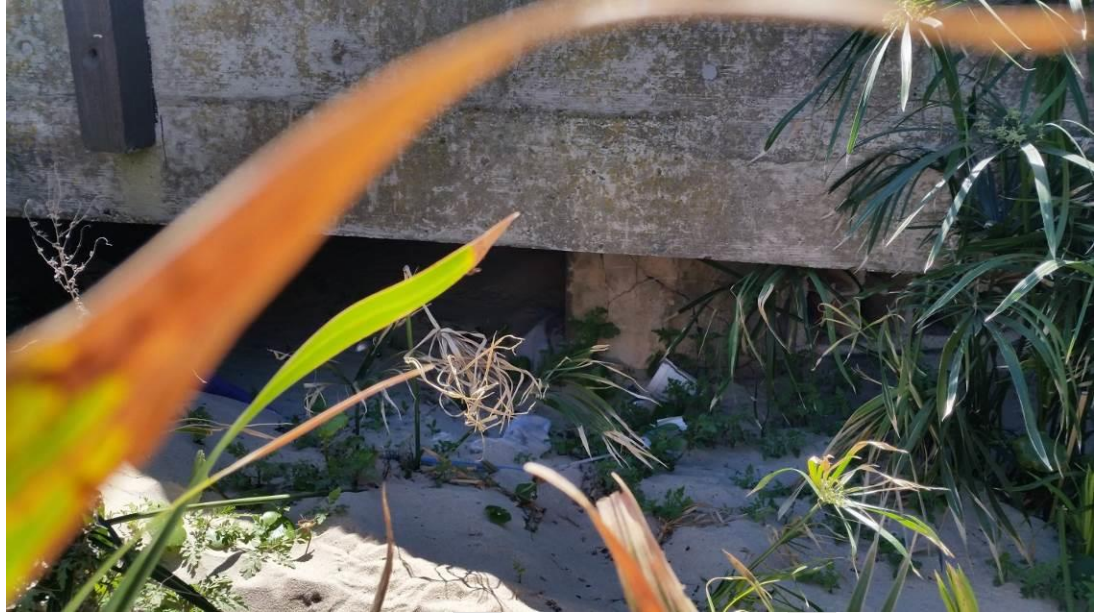
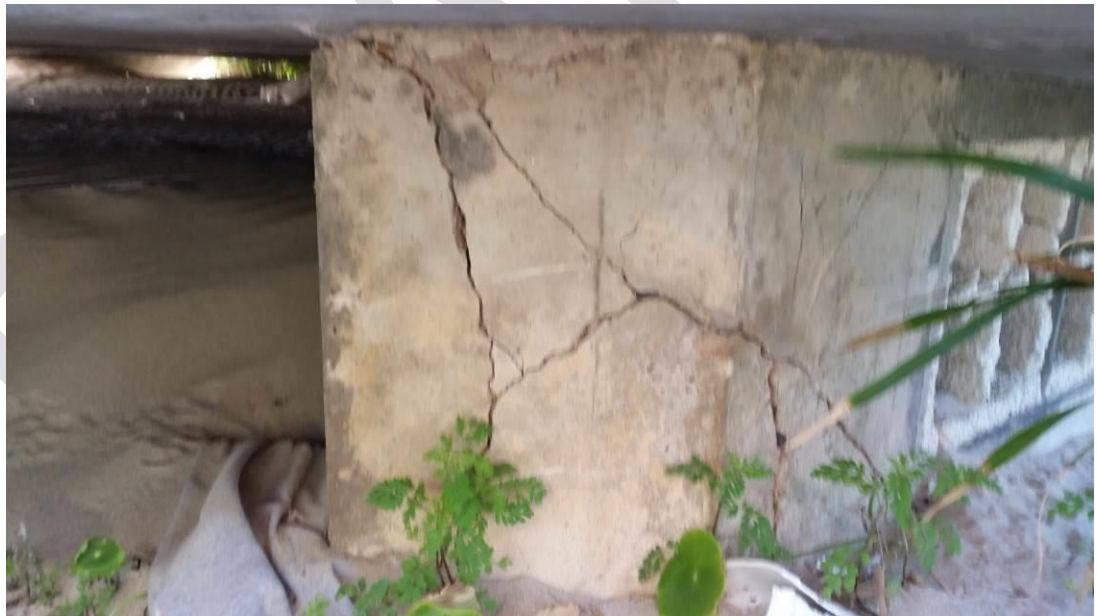
Figure 7 – Column/Pile with Severe Cracking

Figure 8 –Column/Pile with Severe Cracking

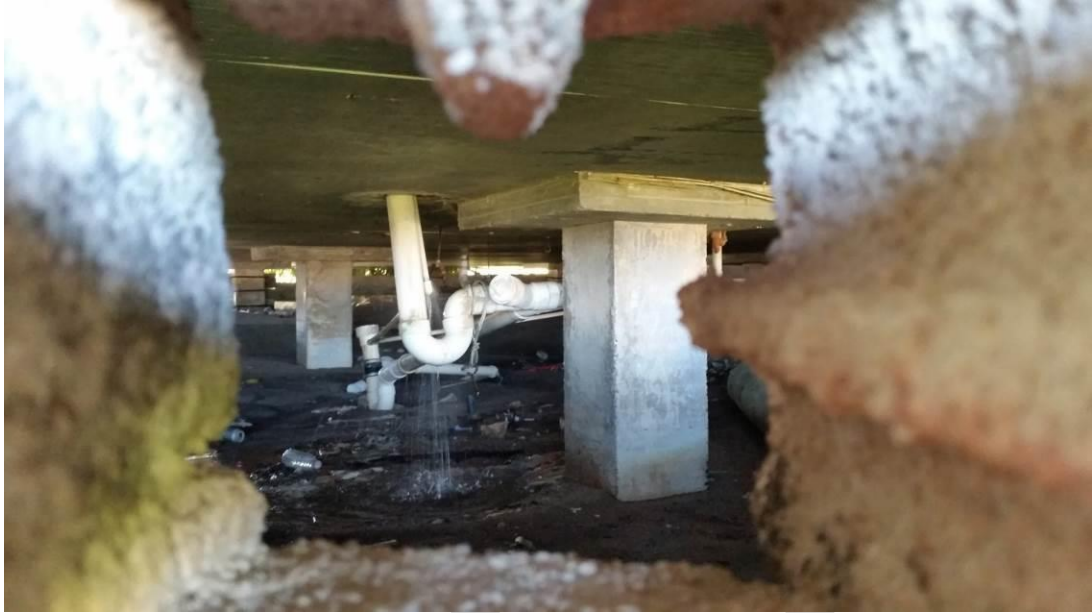
A PVC water pipe under the slab was observed to have a leak at a 90 degree joint. Water was flowing from the leak and draining into the sand at the time of the site visit (Figure 9). It appeared that the line was for supply water. No apparent structural damage was observed associated with the leak.

Figure 9 – Water leaking from Pipe Under Slab

- Repair plumbing and electrical lines as required.
- Breakwater Extension
  - Demolish the elevated walkway and concrete sheet pile from the damaged steps seaward of the building foundation to the existing breakwater.

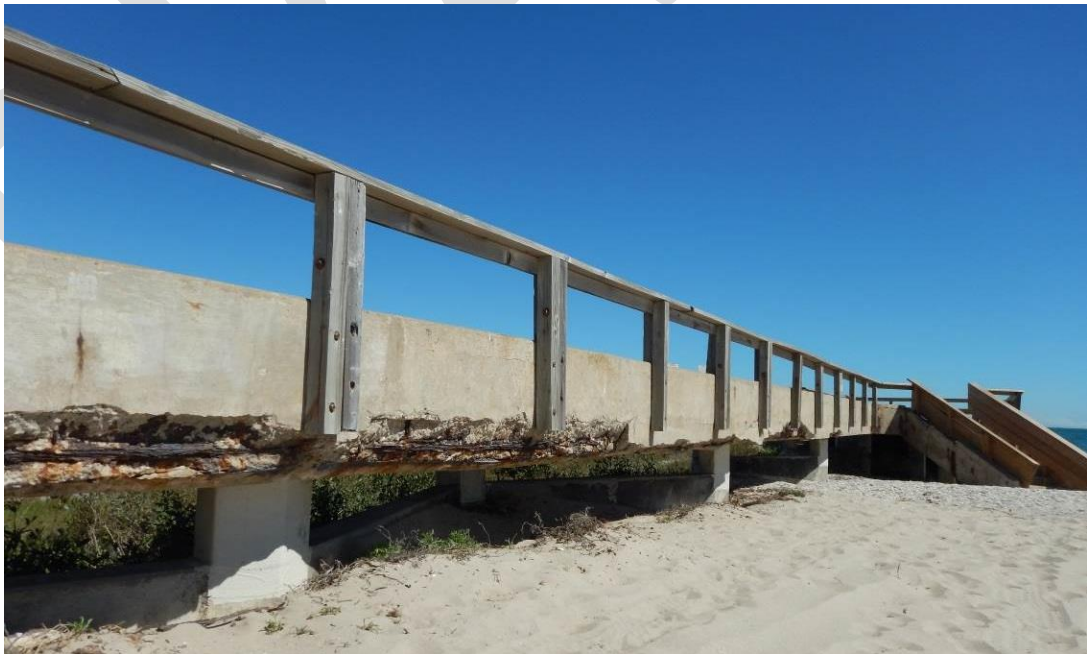
The foundation slab is connected to an elevated concrete walkway that extends to the rock section of the breakwater. As previously observed during the 2009 survey, the walkway structure shows signs of severe deterioration, including spalled concrete and exposed rebar, large cracks, damaged stairs and handrails (Figure 10).

Figure 10 – Damage along elevated walkway extending to the rock breakwater. Also note the gap below the walkway, which allows sand to be blown from McGee Beach into the marina.

In addition the lighting, lighting poles and electrical conduit is missing, as are sections of handrail and the previous fish-cleaning stand. Continued degradation of the concrete deck and foundation will eventually lead to more significant structural damage, creating a gap in the breakwater that would leave a portion of the seawall more susceptible to potential wave damage during severe storms. In addition, collapse of the walkway could occur during a severe storm, causing structural debris to damage the seawall, marina, boats, and landward infrastructure.

As a secondary concern, the opening under the walkway allows sand from McGee Beach to be blown into the marina. Loss of sand from McGee Beach increases exposure of the adjacent seawall (south of the breakwater) to wave impacts, increasing potential for undermining and/or damage during severe storms. In addition, loss of wind-blown sand under the walkway increases the requirements for periodic renourishment of McGee Beach.

- Breakwater Extension: The existing elevated walkway is recommended to be demolished and replaced with a new rock breakwater and walkway (concrete cap).
- Breakwater Walkway: The concrete walkway along the existing rock breakwater is recommended to be repaired/replaced, and possibly raised.

- Extend the existing breakwater approximately 200 ft landward to the building foundation.
  - Construct a 6-ft wide, 200-ft long concrete walkway along the crest of the new breakwater.

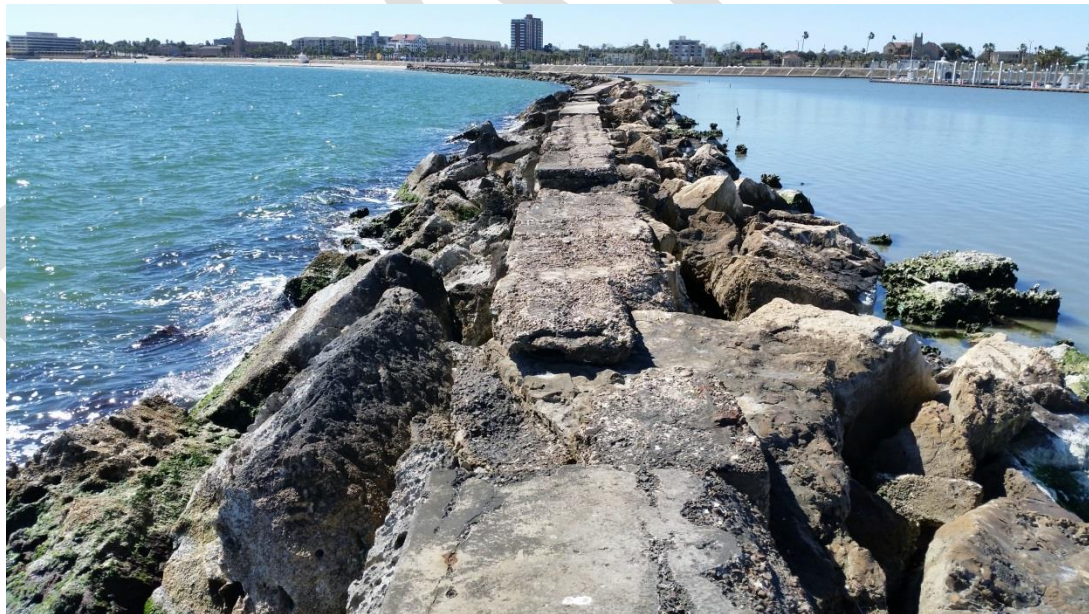
The rock breakwater extends northward from the elevated concrete walkway and around the City marina. The breakwater is approximately 5,800 ft long, with the southern approximate 1,800 ft having a 4-ft wide concrete cap (walkway) for pedestrian access. Deterioration of the walkway has progressed since the 2009 survey, with severe spalling, cracking, and rebar exposure over its entire length, and some sections of the cap completely missing (Figure 11). The handrails, lighting, and electrical conduit are gone, and the walkway is frequently subjected to wave spray and overtopping, which can create a slippery walking surface

Figure 11 - Missing sections of concrete breakwater cap.

- Replace the steps between the breakwater and McGee Beach.
- Breakwater Walkway
  - Repair/replace entire 1,800-ft concrete walkway (concrete cap) along existing rock breakwater.

- All of the existing walkway is recommended to be either partially or fully replaced. Broken sections of walkway surface should be removed. Because it is recommended that the new walkway be constructed higher and wider than the existing walkway, the sound portions of the existing walkway could possibly be left in place with the new sections cast over the existing sections. The viability of leaving sections of the existing walkway in place depends on how soon the repairs are performed.

- Construct/place rock ballast (smaller stones) to fill gaps between larger stone and provide a base for the new concrete walkway.
  - Build new walkway wider (assumed here to be 2 ft wider) and higher (assumed here to be 1 ft higher) than original. This would make the new walkway approximately 6 ft wide.
