Preliminary Technical Memorandum

Improvement Concepts for Salt Flats Levee

Salt Flats Levee System, Phase 2, Task Order 4

City Project Number: E12070
HDR Project Number: 10026049

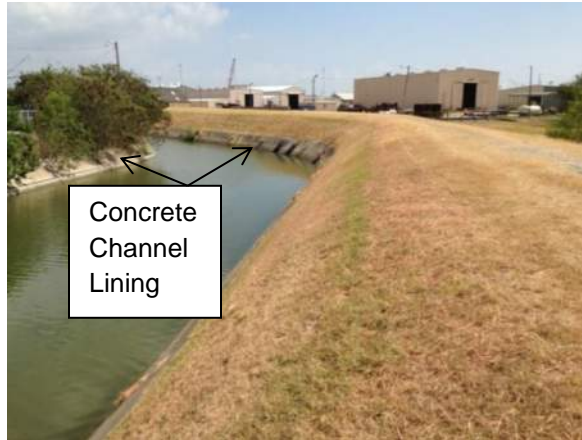
Figure 6 – Interior Slopes (August, 2016)

to 2.6H:1V. The exterior slopes within the study area typically vary between 2.8H:1V to 3.7H:1V, except at the headwall, where the exterior slope is approximately 2.1H:1V. Both the interior and exterior slopes are grass covered, with the condition of the grass generally good, except during prolonged dry spells as illustrated in photographs provided in Figures 6 and 7. No slope movement or sloughing was noted during the recent site observations.

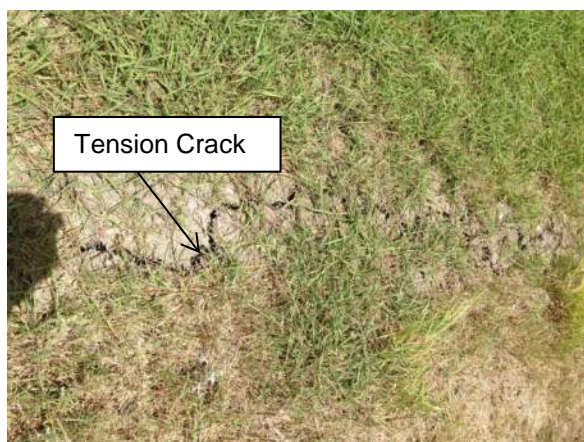
Figure 8 – Tension Crack (July, 2016)

A series of discontinuous tension cracks were noted near the top of the levee slopes during the site observations. Based on limited measurements, the tension cracks on the east edge of the crest typically ranged from 0.5 to 1.0 feet in depth. The tension cracks on the west edge of the crest (channel) were deeper, typically ranging from 1 to 3 feet and in places over one-inch wide at the surface. The tension cracks were noted during the driest and warmest time of the year (late summer), when tension cracks are likely to be most visible and reach their maximum depths. Some self-healing of these cracks may occur during wetter periods, though they will become more apparent again during a subsequent warm/dry periods. Tension cracks were not observed on the face of the slopes, except on the channel side where tension cracks were noted one- to two-feet downslope. Figures 8 and 9 provide examples of the tension cracks.

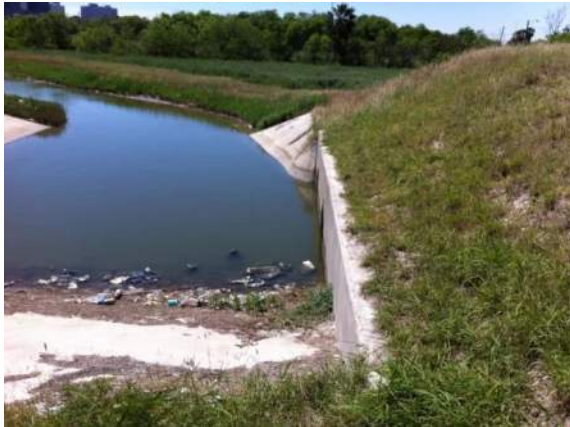
Figure 10 – Concrete Headwall and Basin

Based on limited observations, the headwall and associated concrete-lined basin appear to be in good condition and functioning properly. Based on recent topographic survey data, the top of headwall is at El. +5.33 NAVD. The two drain pipes have an invert elevation of approximately -0.35 feet.

The headwall and associated basin represent a discontinuity because the levee slope in this particular area is essentially vertical below approximate El. +5.33 feet. Figures 10 and 11 provide recent photographs of the headwall and basin area.

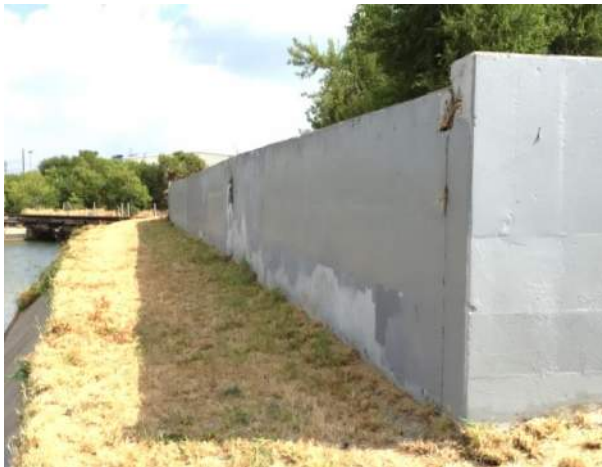
Many of the expansion joints no longer have joint material in the gaps, and open gaps exist between many sections of the wall. In several of the gaps, there are small shrubs and vegetation growing in and through the expansion joint. The wall is no longer plumb with noticeable small bulges and distortions. Examples of the observed conditions of the wall are shown in the Figures 21 through 26.

Figure 21 – Front Face (spalls/exposed rebar)

Based on this assessment, the existing crib wall is recommended to be replaced with an inverted concrete T-Wall. The base slab of the T-Wall would be founded on existing embankment material and the stem portion would structurally tie into the adjacent concrete storage bunker to the south and concrete wingwall to the north. As conceptualized, the wall would extend approximately 6.5 feet above the supporting base slab to coincide with a top elevation of +13 feet (NAVD88). Compacted cohesive material would be placed along the protected side to enhance stability of the T-Wall during a significant flood.

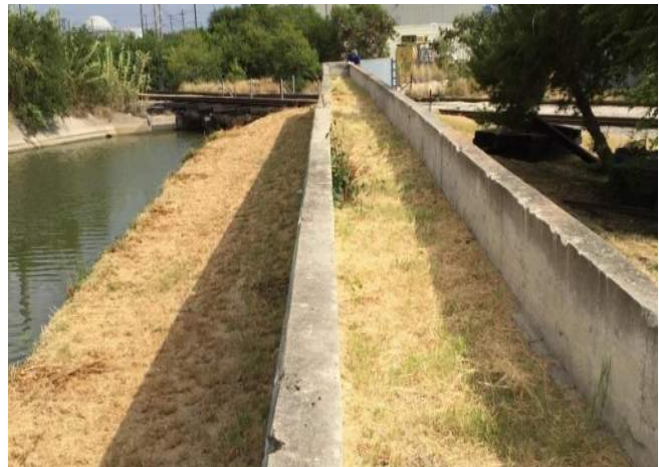
Figure 22 – Top of Wall (missing concrete)

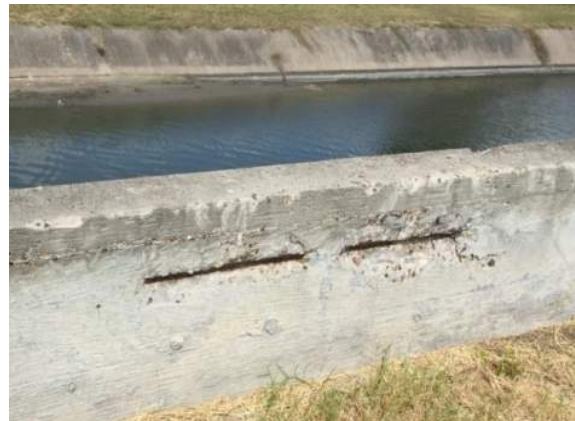
Figure 24 – Exposed Rebar (Front of Wall)

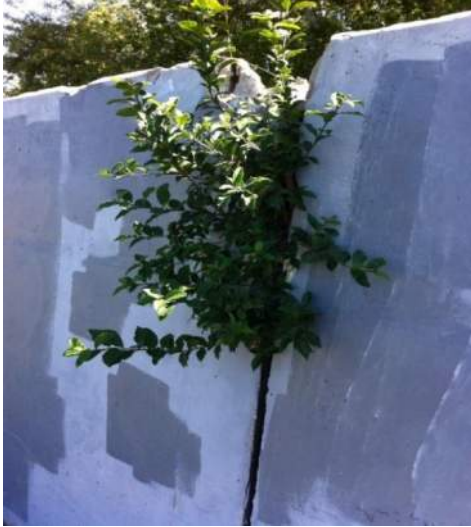
Figure 25 – Open Gap with Vegetation

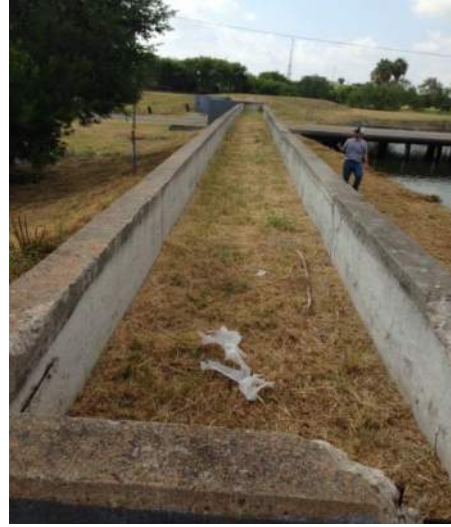
Figure 26 – Top View (Missing Concrete)

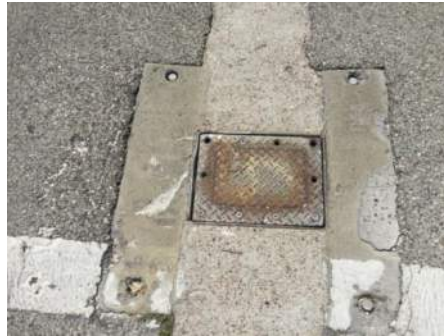
Figure 28 – Cover Plate

In the following figure, a cover plate is shown for the hole where the stop log support posts are placed during installation. There are missing bolts in some locations, and other locations contained bolts that were stripped and difficult to remove. Although there are enough bolts to keep the cover plate in place, water and debris are able to enter the openings. Eventually, debris and corrosion from water can prevent the bolts from being replaced. HDR recommends cleaning the holes and replacing the cover bolts.

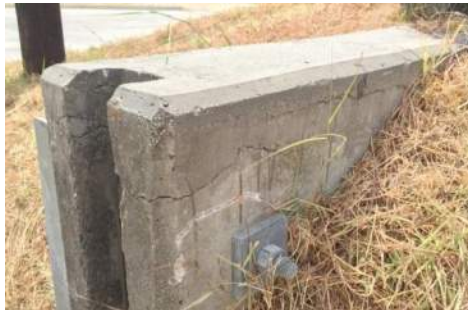
In addition to the stop log cover plates, the top of the closure structure on the south side of East Port Avenue showed signs of delaminated concrete, which can be seen in Figure 29. HDR recommends that the top of the closure structure be repaired to extend the service life of the structure.

Figure 29 – Delaminated Concrete Support

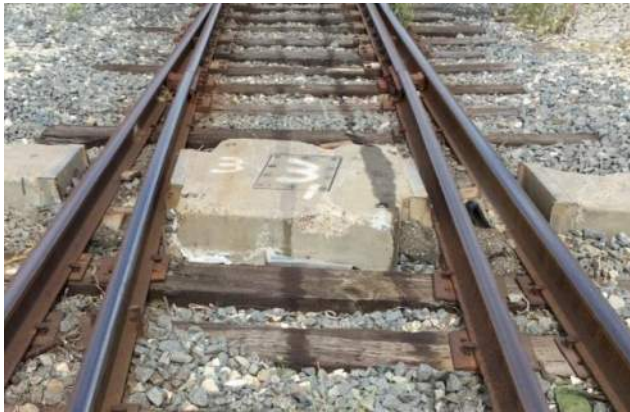
At each of the closure structures, the stop logs are intended to rest on a concrete foundation, which serves as the bottom seal for the closure system. Because there are rails that pass through the concrete foundations, there are gaps that would not be sealed when the stop logs and stop log support posts are in place. An example of one of these gaps is shown in Figure 30. The openings will allow flood waters to flow/leak underneath the stop log gate structure. There have been past attempts to “plug” these openings or gaps with infill material, as shown in Figure 31. HDR recommends neoprene-type plugs (or similar) be fabricated and placed in the openings to provide a better bottom seal for the stop-log gates. The plugs could be designed to be permanently secured in-place or inserted during installation of the stop-logs. The pros and cons of each approach should be evaluated during final design.

Figure 30 – Gaps Adjacent to Railroad Tracks

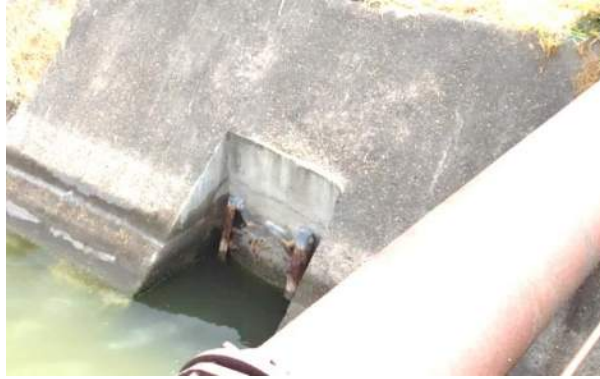
Figure 33 – Typical Flap Gate

In general, the metal flap gates are corroded and pitted, and likely no longer open and close as freely as desired. A photograph of a typical flap gate is provided as Figure 33.

A total of nine flap gates are currently attached to the discharge end of storm drains that penetrate the levee and empty into the Salt Flats Channel. The purpose of these gates is to prevent reverse flow from the channel, in particular during a high water condition within the channel. Eight of the gates are in marginal condition and should be replaced as part of routine maintenance. It is recommended these eight flap gates be replaced with duckbill-type check valves, which are generally considered more reliable.
