# Packery Channel Restoration (H17019) Preliminary Design Report

Corpus Christi, Texas

HDR Project 10130118

November 26, 2018

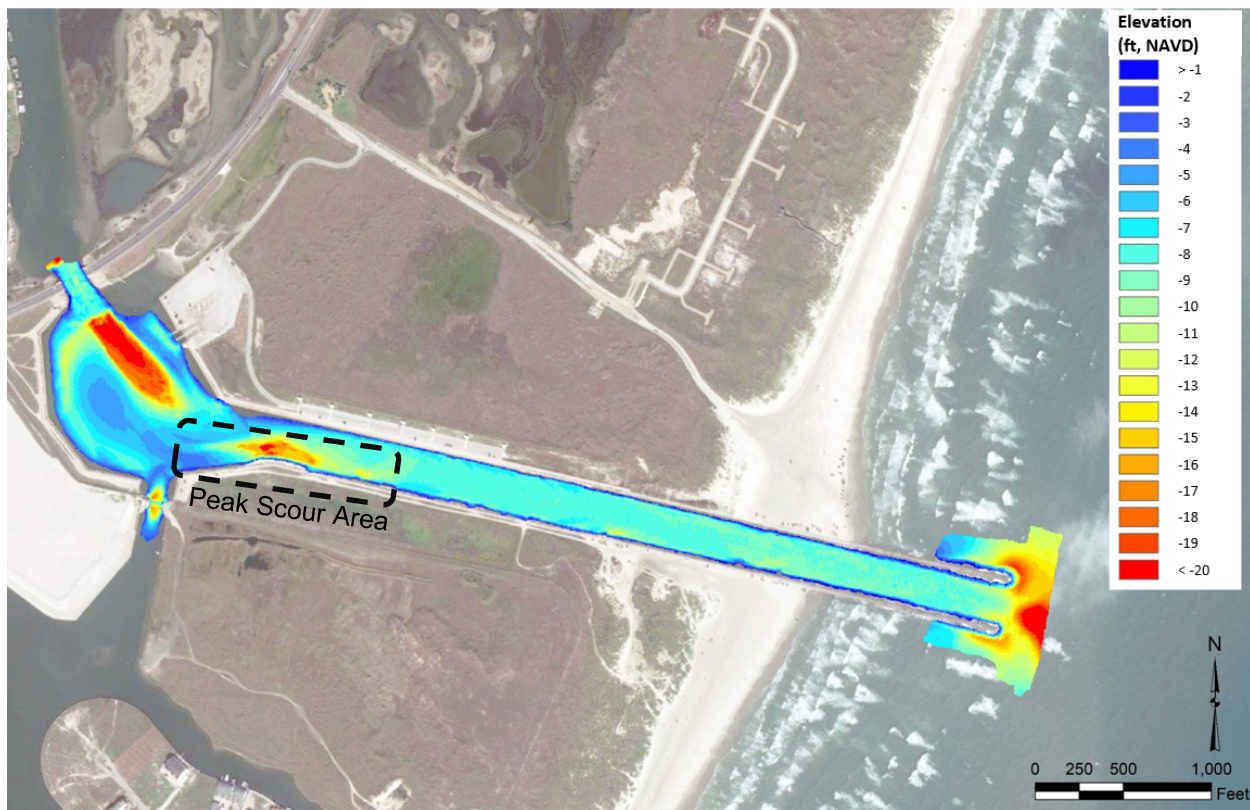
As depicted in Figure 4, Hurricane Harvey forced water into Corpus Christi Bay through Aransas Pass, creating elevated water levels (storm surge) in the bay. Strong north winds then pushed the storm surge towards Packery Channel, where the surge was rapidly forced out of the bay as the hurricane shifted inland. The discharging surge caused strong currents of approximately 5 fps in Packery Channel as water flowed from the bay to the Gulf (Williams and Tissot 2018). Based on review of post-Harvey bathymetric surveys performed by the City, these strong currents caused erosion and scour to depths exceeding -18 ft NAVD along the lower, unprotected portions of the channel (Figure 5), resulting in loss of the original bench that supported the toe of the ABM revetment, particularly along the south bank in Reach 3 where the strongest currents were focused. Erosion also occurred beneath the toe of the landside jetty in Reach 2, where currents caused erosion and scour of the bench to depths of approximately -8 ft NAVD.

Figure 5 – Survey Showing Bottom Elevations in Packery Channel after Hurricane Harvey (Survey performed by Naismith Marine Services, Inc. during September 2017).

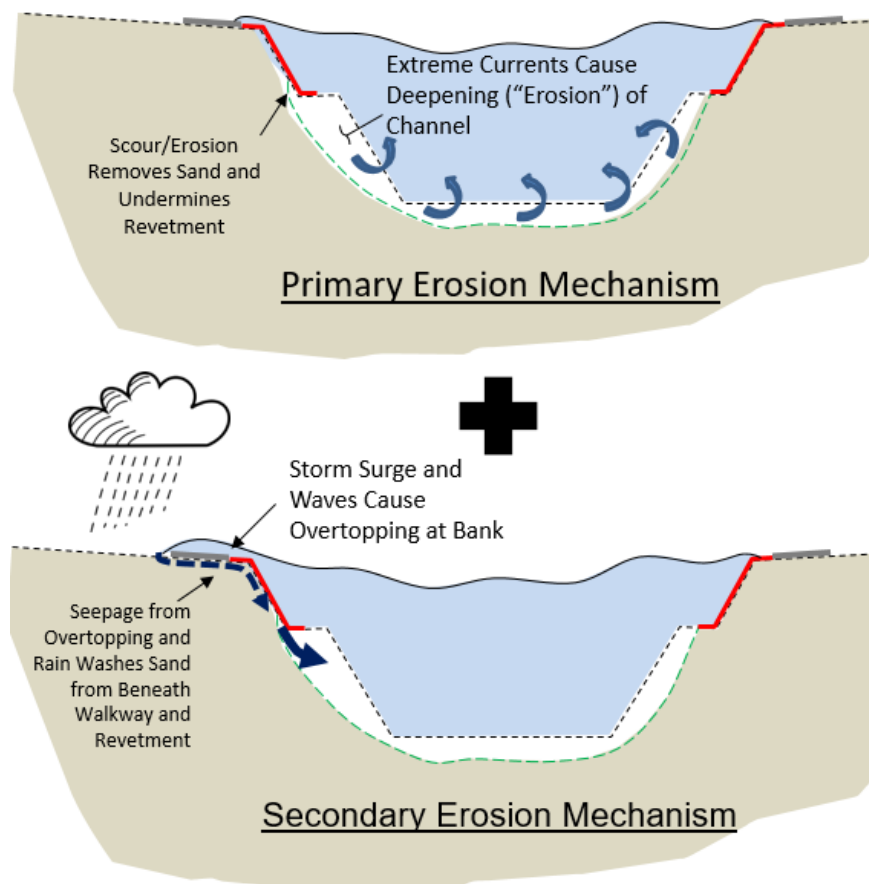
Tide measurements by the National Oceanographic and Atmospheric Administration at Station 8775792 showed that water levels in Packery Channel reached approximately +5.5 ft NAVD during Hurricane Harvey, exceeding the bank elevation of +5.25 ft in Reaches 2-4. Coupled with rainwater runoff, return flow of overtopped water back into the channel as the storm surge receded likely led to seepage through the bank and localized washouts. This seepage through, and flow across, the bank likely caused additional erosion of the bench and bank foundation, resulting in undermining of the walkway and revetment in Reach 1 (Figure 6) and displacement of stone in Reach 2.

Figure 6 – Erosion Mechanisms During Harvey.

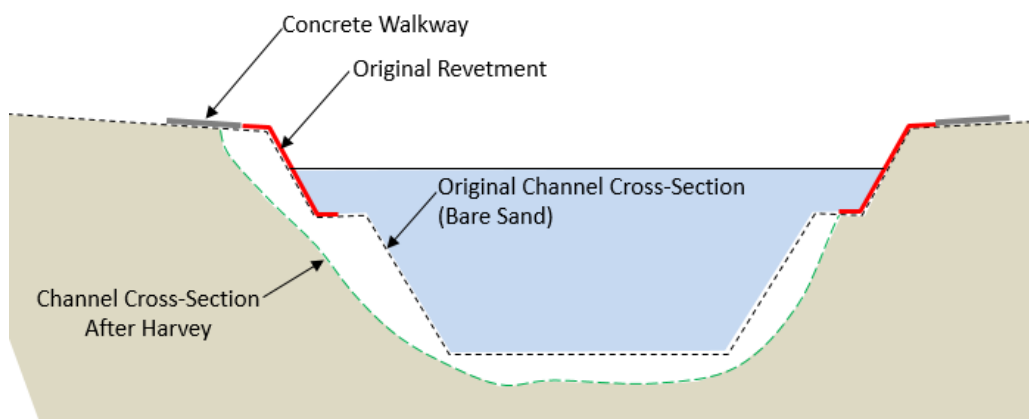
Figure 7 provides a schematic comparison of the channel cross section before and after Harvey, illustrating the significant loss of foundation soils under the walkway and revetment that appears to have resulted in their collapse as depicted in Figure 8. The updated damage assessment in Appendix B provides evidence of continued loss of foundation soils from waves and rainwater runoff that has led to additional undermining and collapse of the walkway since Hurricane Harvey.

Figure 7 – Channel Cross-Section After Harvey.

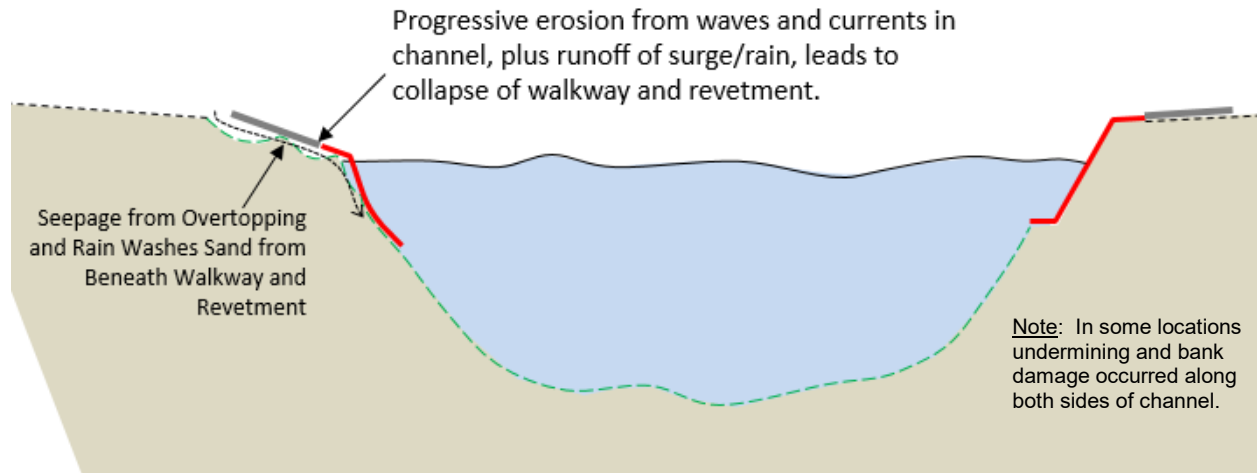
Figure 8 – Walkway and Revetment Failure after Harvey.

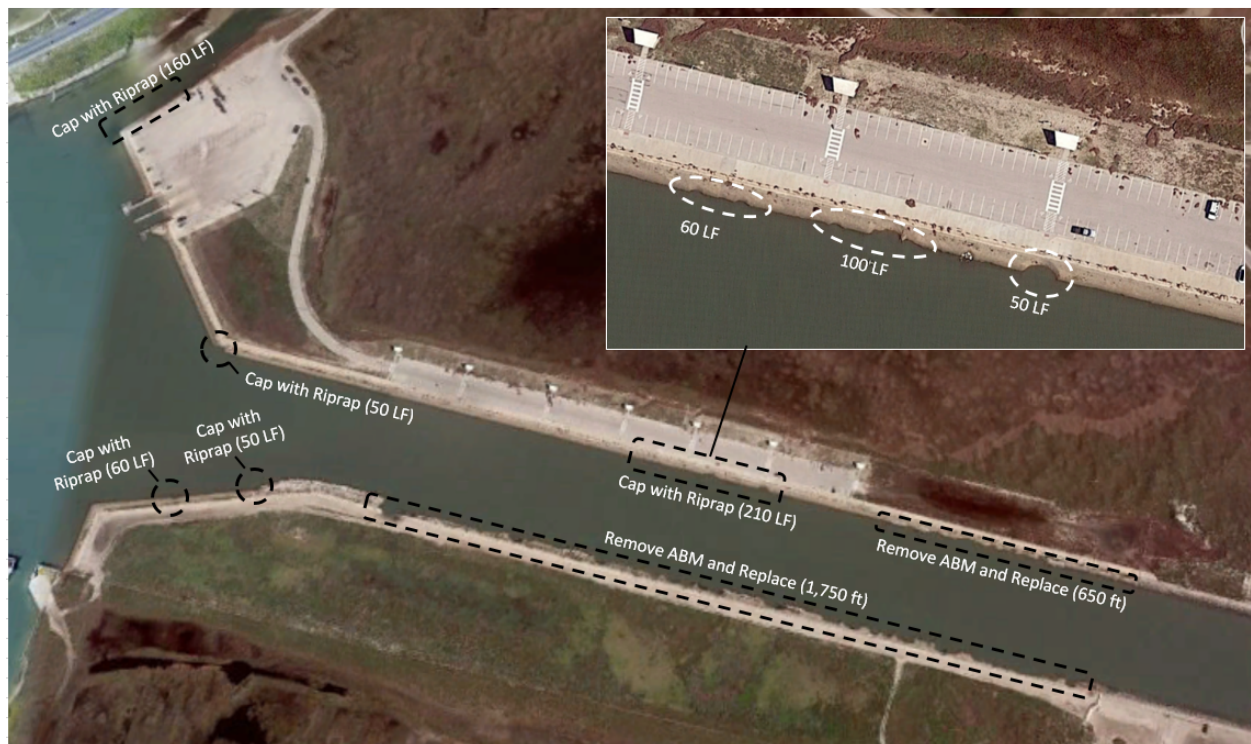
The design alternatives and/or recommendations for each repair category are presented below. In Reach 3, the ABM damage areas were divided into two general types as shown in Figure 9 and described below.

Figure 9 – ABM Damage Areas and Repair Classifications in Reach 3.

1. Smaller, more isolated damage areas, and damage along areas that are less exposed to daily wave and current action, are recommended to be repaired by capping the damaged ABM in place with riprap. This repair approach has been successful for previous repairs to short sections of the ABM revetment by the USACE and the City (for example, see Figure 10). This approach should include placement of geotextile fabric and riprap along the exposed slope below the ABM to help prevent future toe scour and undermining.

2. Longer sections of damaged ABM, and/or damaged ABM in areas more exposed to daily wave and current action, are recommended to be repaired by removing the ABM and replacing it with either new ABM (for the Harvey Repair category), or with other alternative bank stabilization methods (for the Hazard Mitigation category).

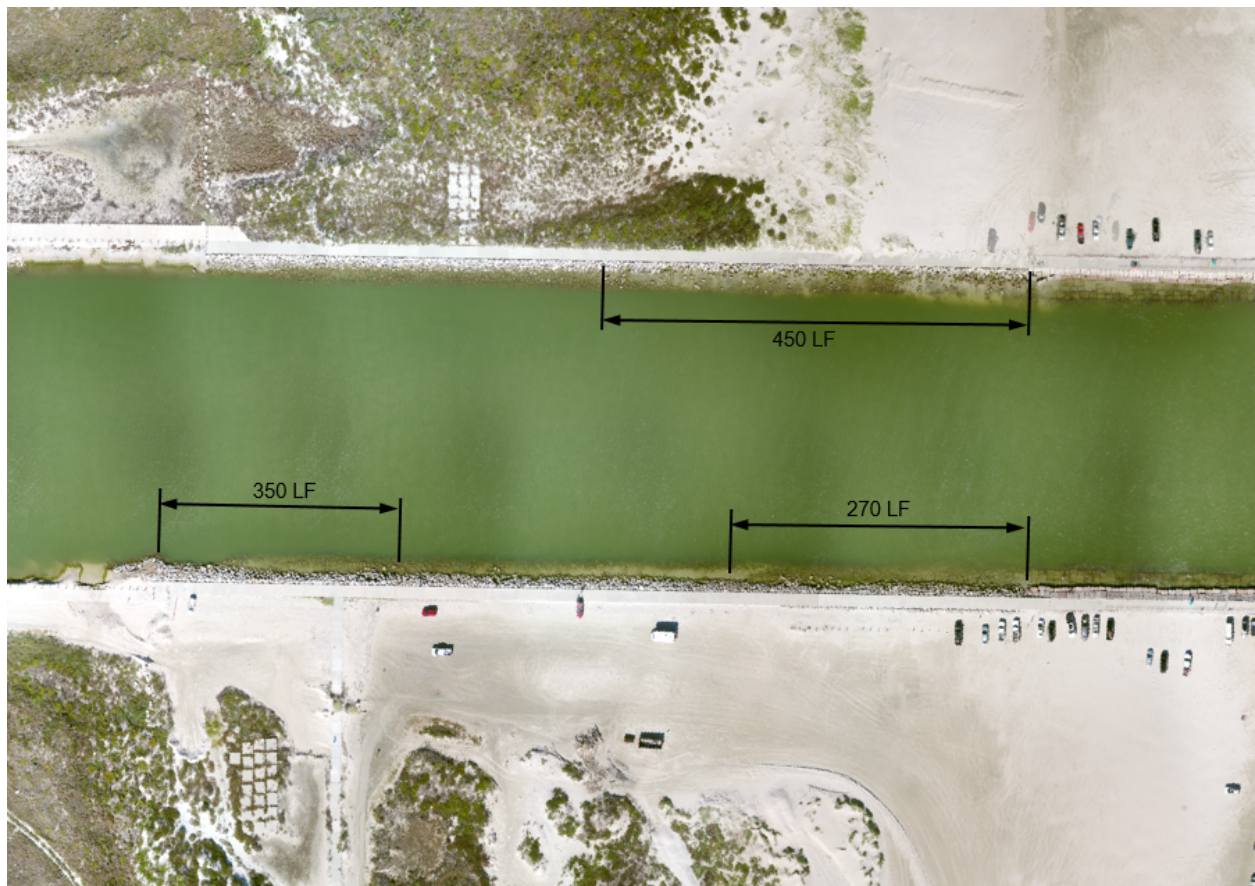
For repair of the landside jetties in Reach 2, review of aerial photography indicates that some of the damage along the upper slope occurred during previous storms such as Hurricanes Emily,

Katrina, and Rita in 2005 and Hurricane Ike in 2008. For estimating stone quantities, it was assumed that approximately one third of the observable damage along the upper slope was caused by Hurricane Harvey, with the remaining two thirds attributable to previous storms. This percentage was based on comparison of stone locations in high-resolution aerial photography taken before and after Hurricane Harvey.

Figure 11 – Landside Jetty Damage Areas in Reach 2.

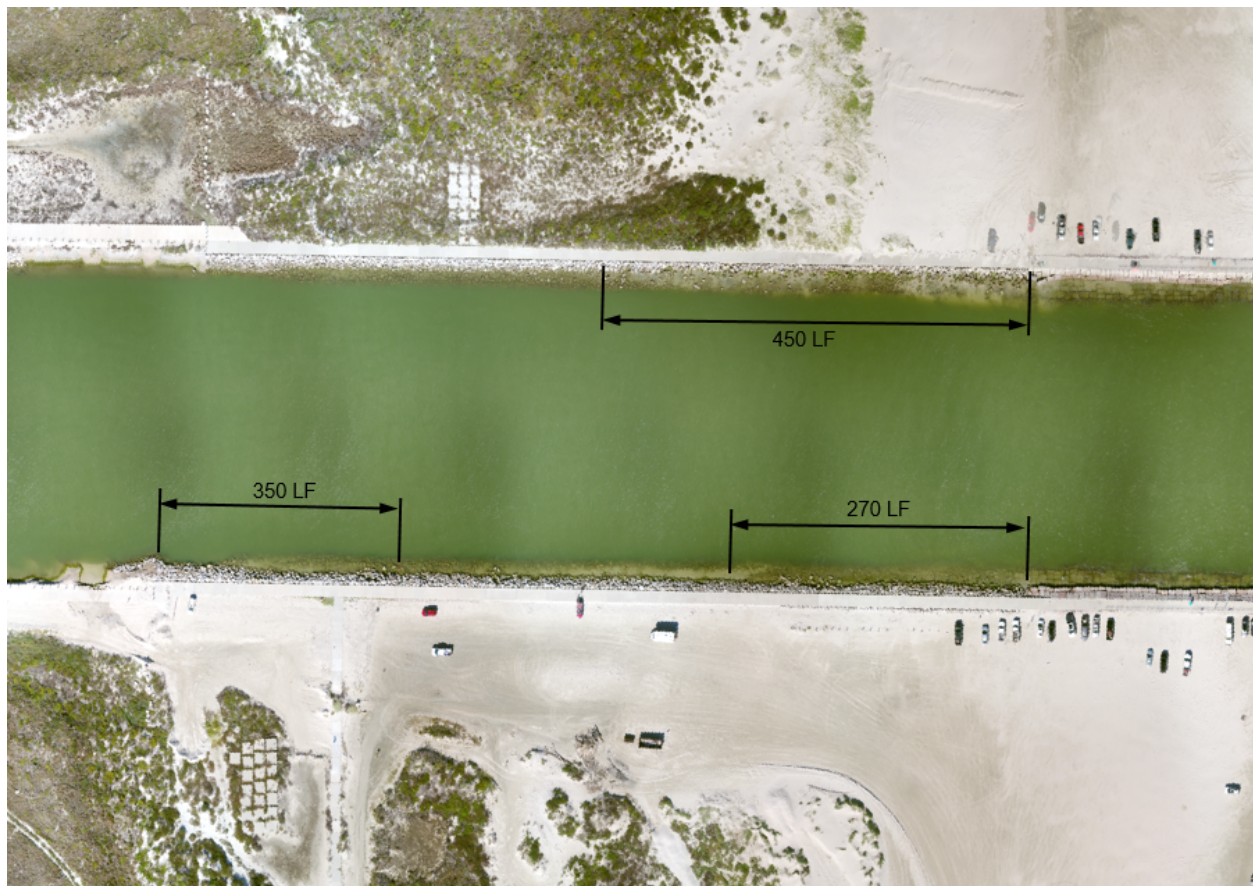
During original project construction, the stone in Reach 2 was placed on a sand bench at -6 ft NAVD, but the bench eroded to elevations of approximately -8 ft NAVD during Hurricane Harvey. The improved template would provide a larger toe apron designed to help prevent undermining to a depth of -14 ft NAVD, which is the full channel depth.
- *Reach 3 – Revetment Repairs*

Figure 15 – Landside Jetty Damage Areas in Reach 2.

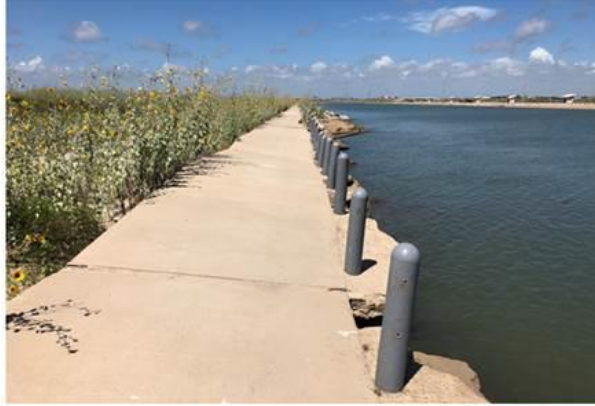
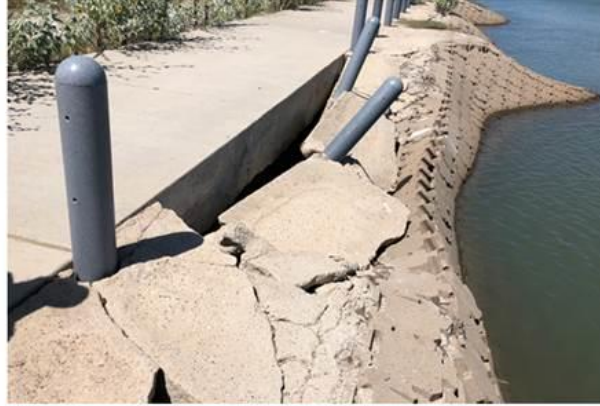
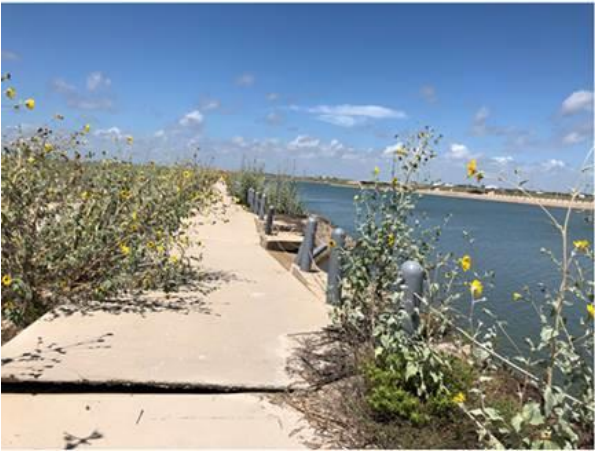
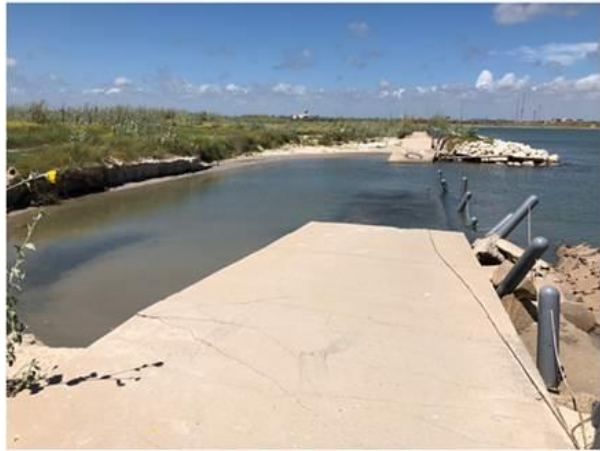
- Reach 3:
  - South side of channel: The damage along the south side of Reach 3 has progressed since previous site visits. Based on current conditions **the entire 1,720 LF section of ABM revetment extending west from the end of Reach 2, including the concrete walkway, will likely need to be completely repaired/replaced.** Sand in this area has continued to erode from the bank into the channel, further undermining the damaged revetment and walkway. Placement of fill material will be required to return the bank to grade. Although the channel bank in this area is expected to continue losing material until repairs are completed, interim/temporary measures to control the material loss are likely to be expensive and would require a USACE permit. Repairs to this area should be given a priority over other areas. Below are several photos showing the damage in this area.
