Mary Rhodes Pipeline Condition Assessment

DRAFT

Jerry Snead, P.E., HDR

May 21, 2024

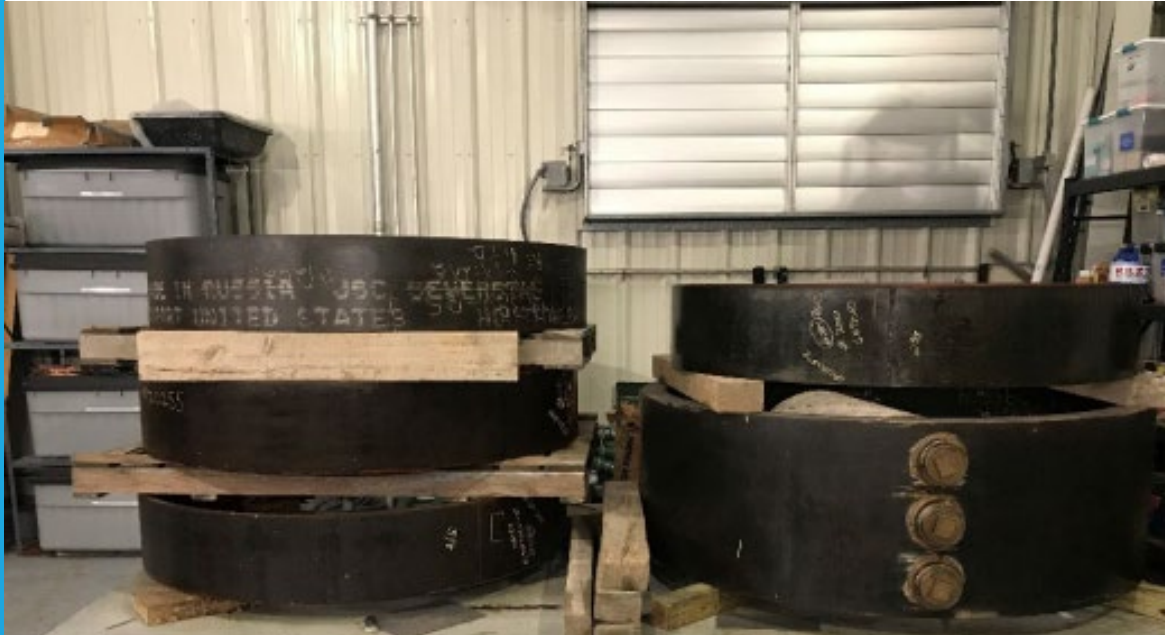
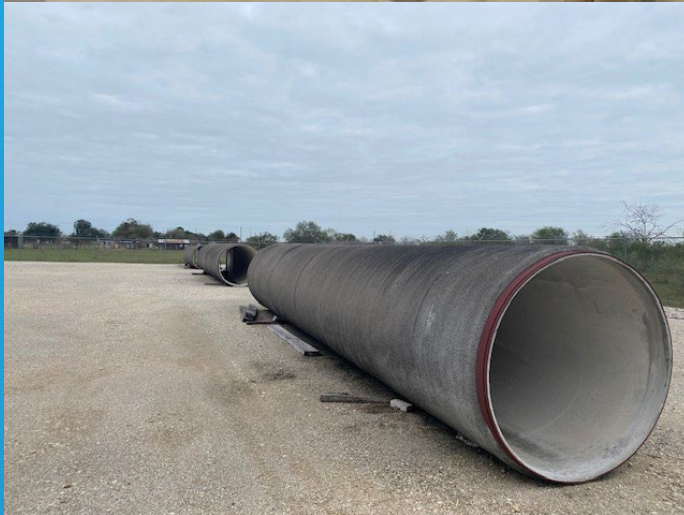
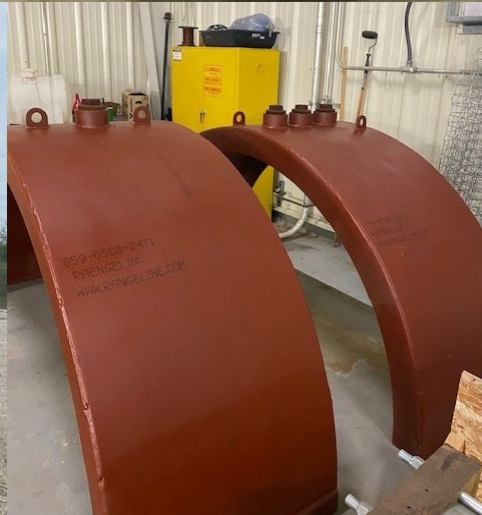
MRP Repair Parts Inventory

- Woodsboro Pump Station

- Repair parts are kept in the pump station and in a storage container unit
 - 2- Barrel clamps (steel)
 - 3- 5/16 Closure straps (steel)
 - 2- 1/2 Saddle (steel)
 - 2- 3/8 6' Pipe Pups cut up (steel)
 - 4- 80-pound Zinc anodes
 - 15- Diapers

- Bloomington Pump Station

- Repair parts are kept in the pump station
 - 1- Barrel clamp
 - 3- 1/2 Closure straps (steel)
 - 1- 1/2 Closure strap (steel)
 - 2- 1/2 Saddle (steel)
 - 3- 35' B303 joint (Located outside)
 - 16- Diapers
 - CCW in the process of ordering 1- 24" saddle manway and have ordered 3/8 mild steel rods

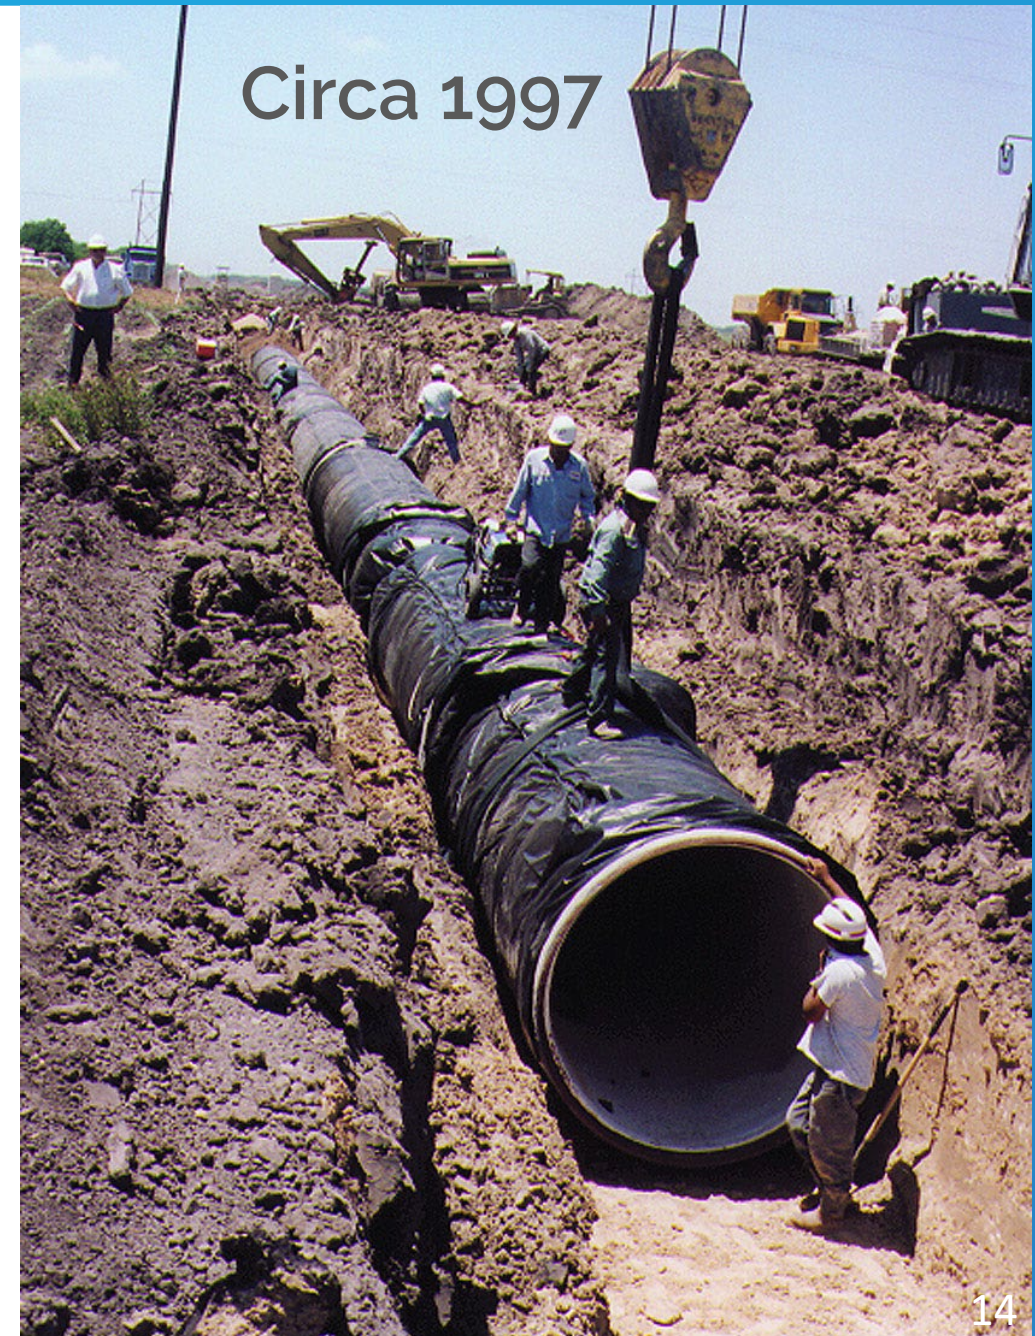
Findings and Observations

- MRP is performing satisfactorily at the current pumping rate
 - The overall integrity of the pipe is good
 - Acoustic ball inspections identified three small leaks which have been repaired
- Past failures are typically associated with access points, air relief valves, joints
- Erosion areas reducing the cover over the pipeline have been identified at various water crossings

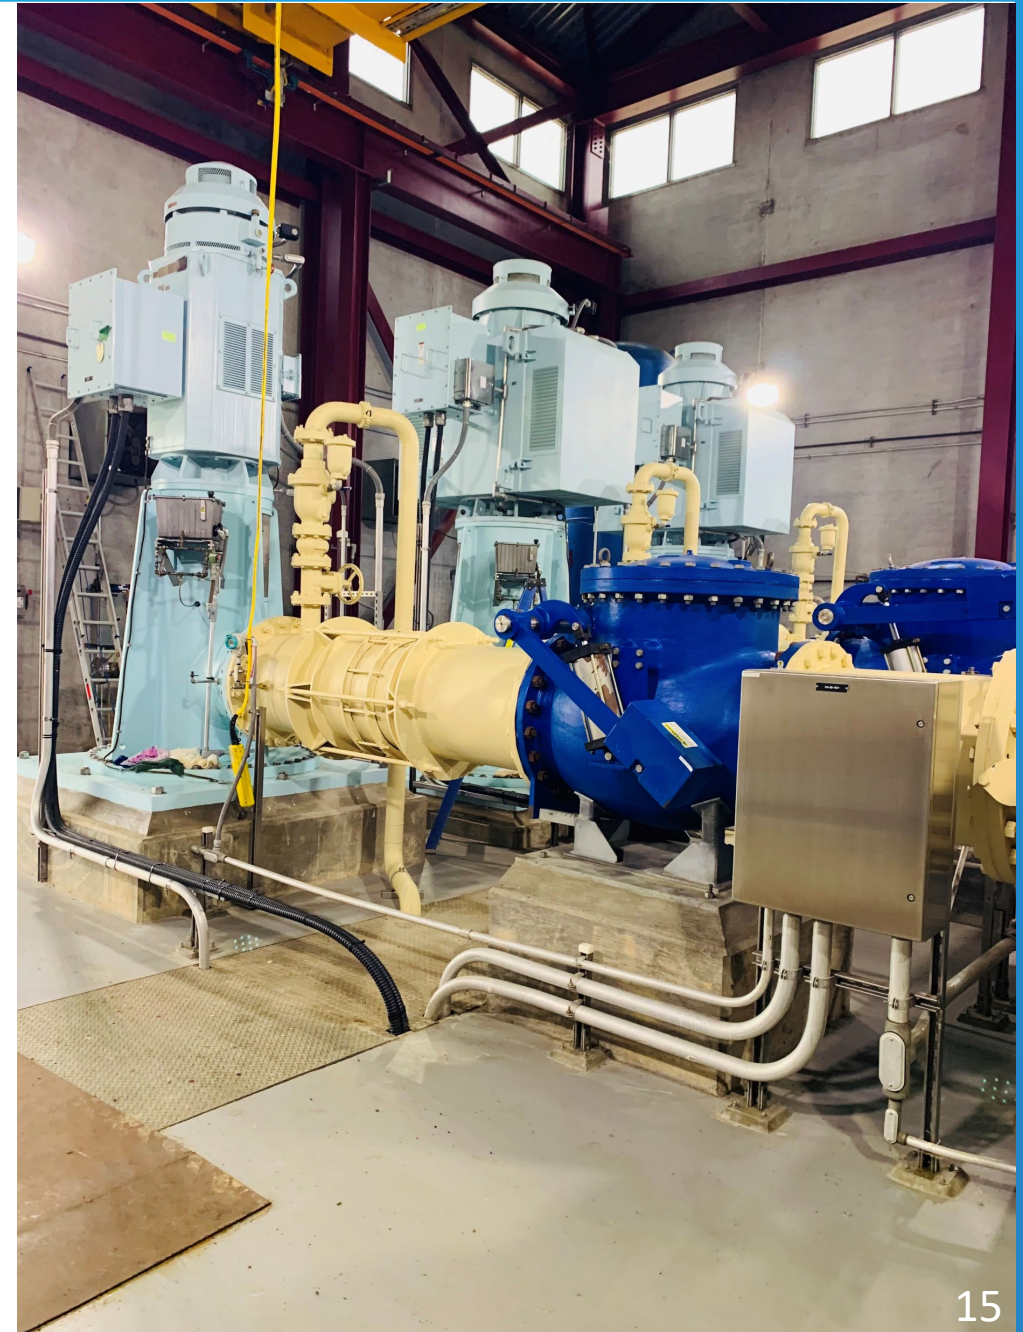
Findings and Observations

- Varying soil corrosivity conditions exist throughout the length of the pipeline and current cathodic upgrades should continue as planned
- Pump station upgrades are needed and should continue as planned
- Pipe pressure exceedance areas have been identified

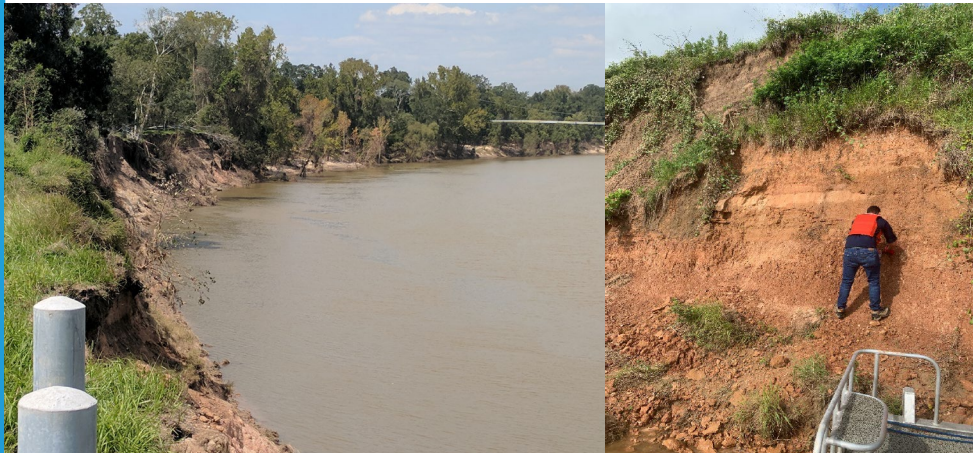
Erosion and Shallow Cover Areas

- The crossings that were surveyed and findings:
 - Lavaca River – possible shallow cover on west bank
 - Garcitas Creek – possible shallow cover on east and west banks
 - Victoria Barge Canal – possible shallow cover on west bank
 - San Antonio River – possible shallow cover on east bank
 - Mission River – possible shallow cover on east bank

- Continue existing CCW operation and maintenance programs (ARV replacement, mowing, etc.)
- Install pressure monitors at identified locations and review operational pressure data
- Stabilize erosion at identified locations
- Mary Rhodes Pipeline pump station system improvements – project no. E13037
- Maintenance and upgrade of cathodic protection system – project no. 23064
- Begin design and installation of parallel MRP at pressure exceedance areas - **Discussion and decision point**

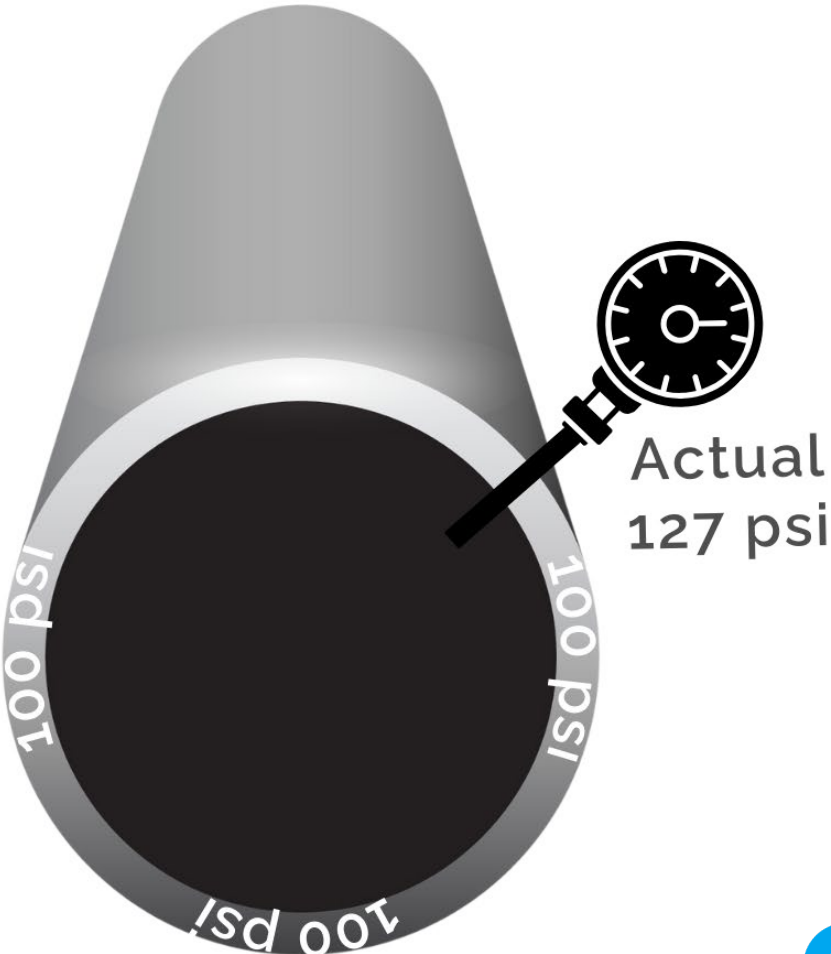
Pipe Rating and Actual Pressure

46 MGD (Sch. 2B) Garcitas Creek

58 MGD (Sch. 3) San Antonio River
