## SERVICE AGREEMENT NO. 4870

### Demolition of Aircraft East General Aviation Hangar One

Corpus Christi International Airport – Hangar 1 Demolition Photos

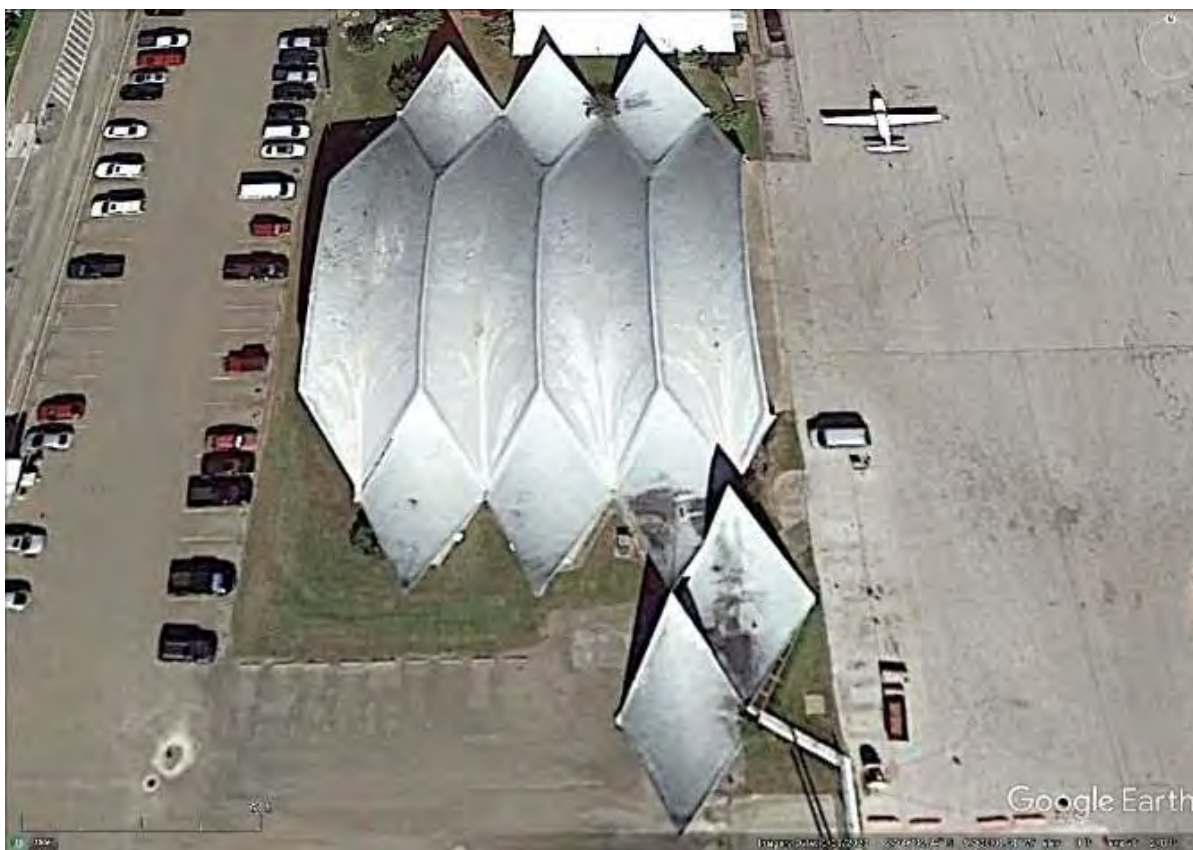
Photo 1

- Year Built – Early 1960's
- Single Story
- Reinforced Concrete Roof
- Concrete Foundation
- Total Size – Approx 28,000 SF (20,000 SF open hangar and 8,000 SF Admin office space.
- Membrane covering on roof.
- Metal Siding

- D. The Contractor shall demolish the entire structure including the foundation, associated signposts, and post foundations which are located on the south side of the hangar, and haul debris to an authorized disposal site. The building is approximately 28,000 square feet (SF). See **Attachment A-4** for photos of the building.
