ZONING CASE: ZN8420

314 Clifford St.

Rezoning for a Property at 314 Clifford Street From "RS-6" to "RS-6/H"

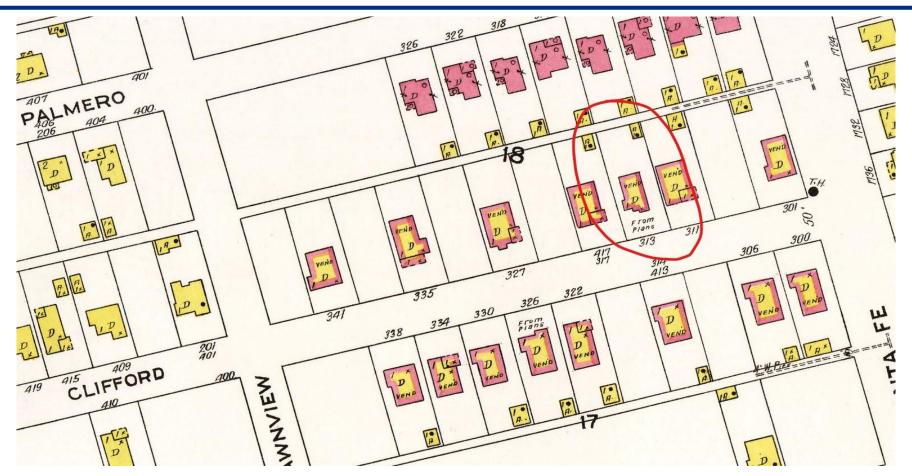
314 Clifford

1927 Sanborn map: "From Plans" written in.

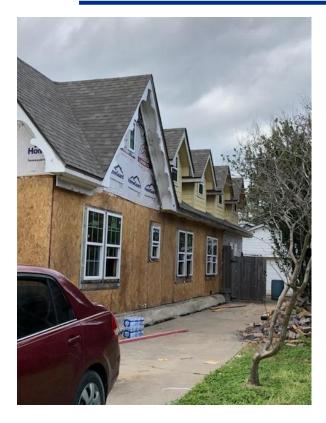
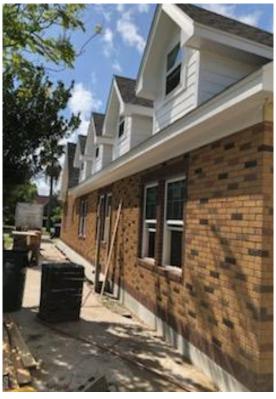
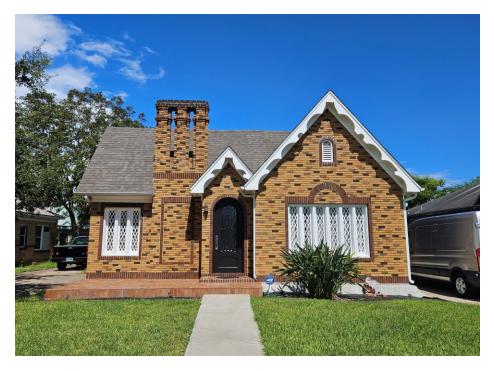
Addition of dormers does not take away from the façade and have been built with same roof pitch and wide fascia to compliment the style of the home.
