**PROJECT NO. 8**  
**MARINA BREAKWATER IMPROVEMENTS**

## VIII. Project Description

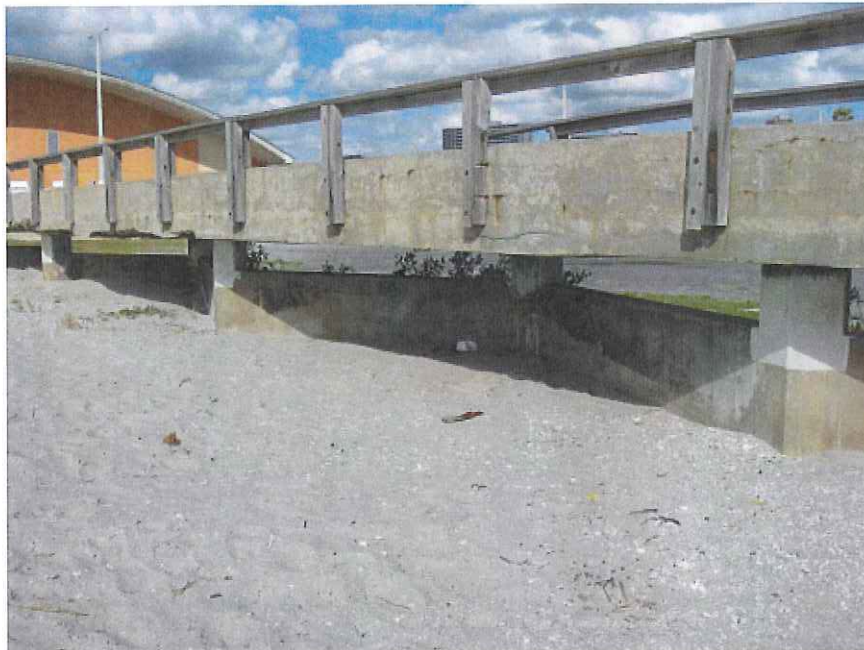
Figure VIII-2. Damage on the access walkway to the breakwater. Also note the gap below the walkway, which allows sand to be blown from McGee Beach into the marina.

As a secondary concern, the opening under the walkway allows sand from McGee Beach to be blown into the marina. Loss of sand from McGee Beach increases exposure of the seawall to the south of the breakwater to direct wave impacts, increasing potential for undermining and/or damage during severe storms.

- 2) Sealing the opening under the elevated approach walkway is recommended to reduce wind-blown sand transport from McGee Beach into the marina. Loss of sand at McGee Beach increases exposure of the southern portion of the seawall to undermining and wave impacts during severe storms.

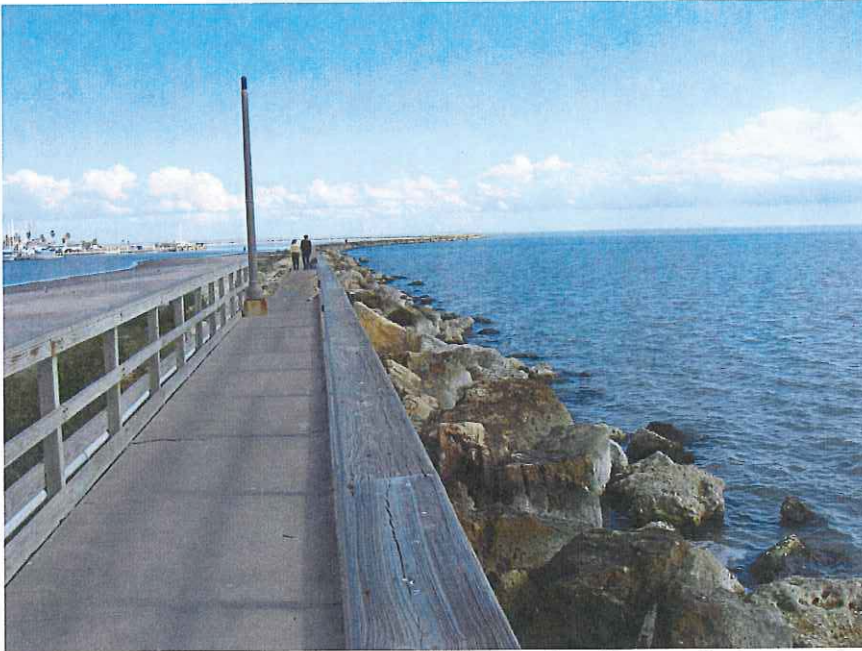
Figure VIII-3. Existing breakwater and walkway, facing north.

The marina rock breakwater extends northward from the old Wienerschnitzel building (across the road from the Coliseum) and around the City marina. The breakwater is approximately 5,800 ft long, with the southern 1,800 ft having a 4-ft wide concrete cap for pedestrian access. The breakwater is connected to the seawall by an elevated concrete walkway with a vendor stand. The walkway has significant damage, including spalled concrete and exposed rebar, large cracks, damaged stairs and handrails (Figure VIII-2). Continued degradation of these elements will eventually lead to more significant structural damage, creating a gap in the breakwater that would leave a portion of the seawall more susceptible to potential wave damage during severe storms. In addition, collapse of the walkway could occur during a severe storm, causing structural debris to damage the seawall and landward infrastructure. See attachment VIII-D for additional site photographs.
