Hooks™

Capital Improvements Review

WHATABURGER

City Capex Summary

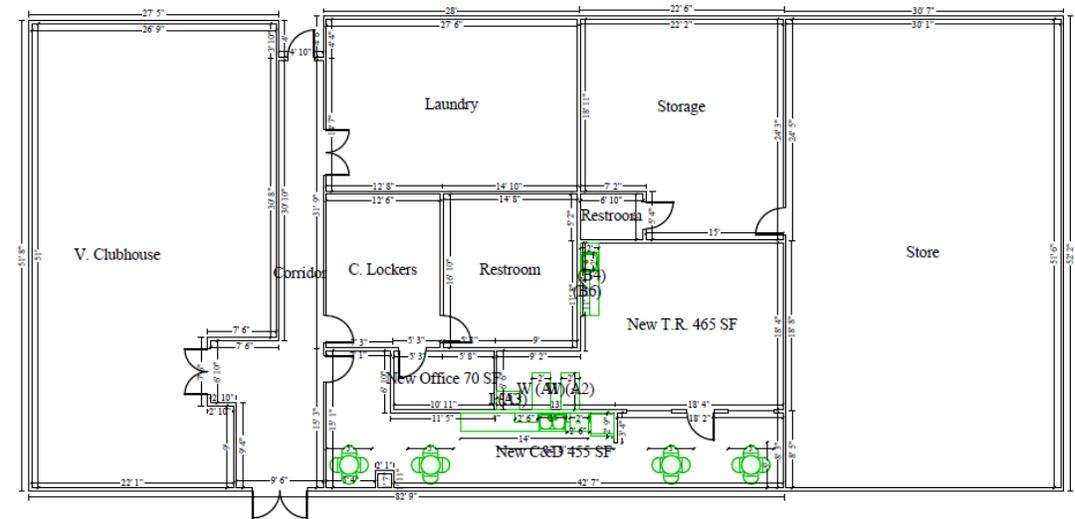
Redesign with dining area

- Cotton Club entrance door replacement (\$16,000)
 - Cotton Club doors are original from 2005
 - Various internal parts have been replaced, but additional issues continue to occur (\$2,500 in repairs over 2019/2020)
 - Current state of doors are difficult to open and are a safety hazard for egress in the event of an emergency
- Home Clubhouse Washer/Dryer replacement (\$35,000)
 - Two washers in the Home Clubhouse are original from 2005 (life expectancy is 8 years)
 - Cost per washer is \$12,000
 - Two dryers in the Home Clubhouse are original from 2005 (life expectancy is 10-15 years)
 - Cost per dryer is \$5,500
 - Visiting Clubhouse washer failed in 2021 and was replaced
- Floor matting tunnel walkways (15,000)
 - Current walkways are bubbling and tearing

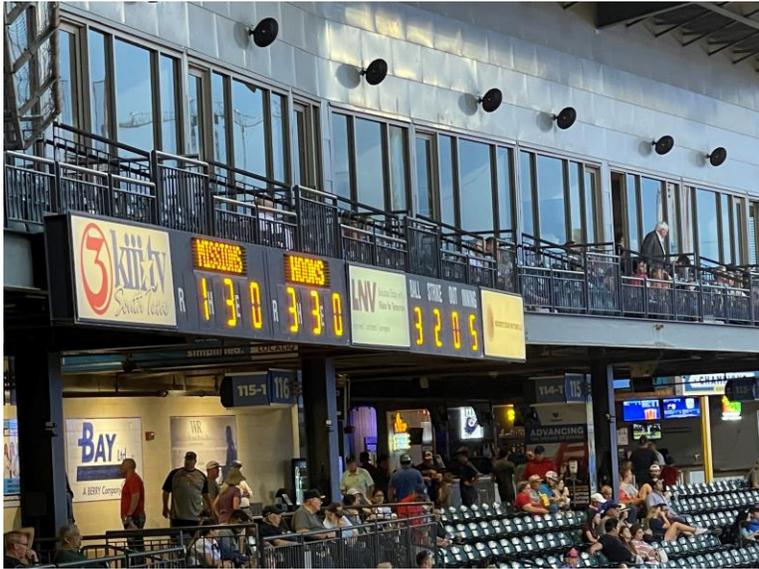
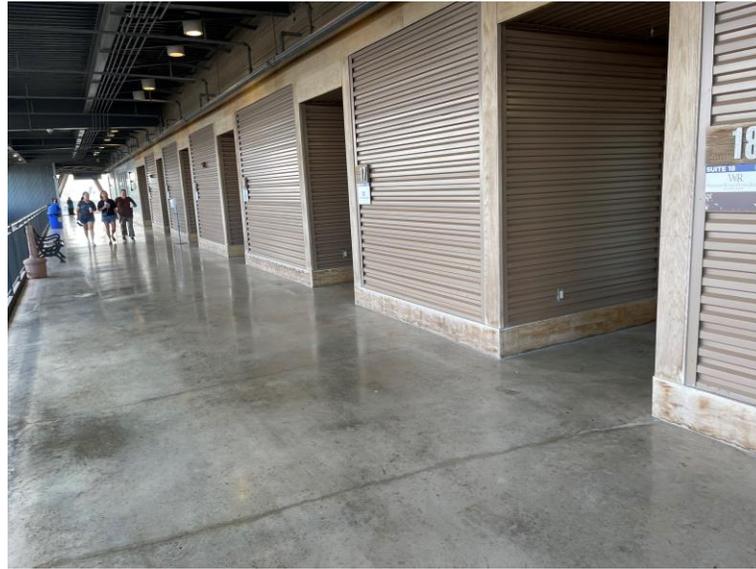
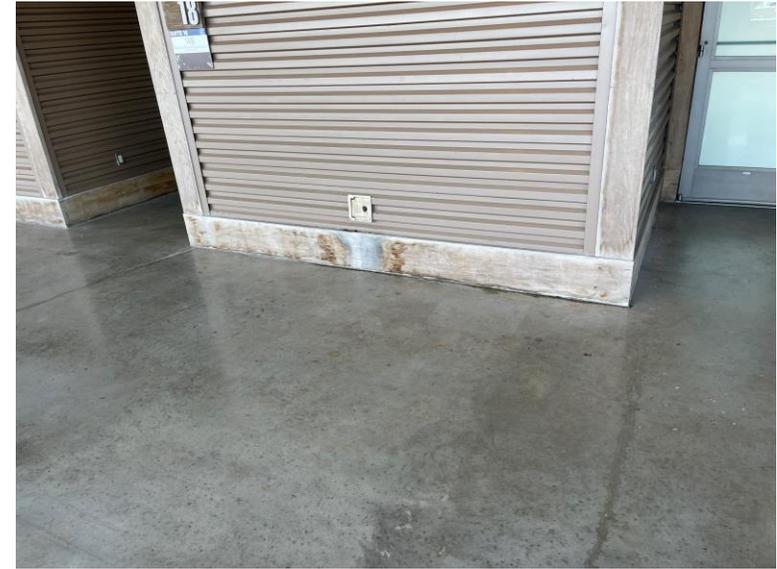
2024

- Refurbish exterior Tickets/Ballpark Office/Whataburger/Cotton Club signs (\$75,000)
- Field replacement including drainage redesign(\$450,000)
- Resurface Roof (\$75,000)

- Replace auxiliary scoreboards with LED ribbon boards (\$300,000)
- Suite level wood trim refurbishment (\$16,000)
- Fire panel replacement. New vendor. Currently stuck with proprietary equipment (\$105,000)

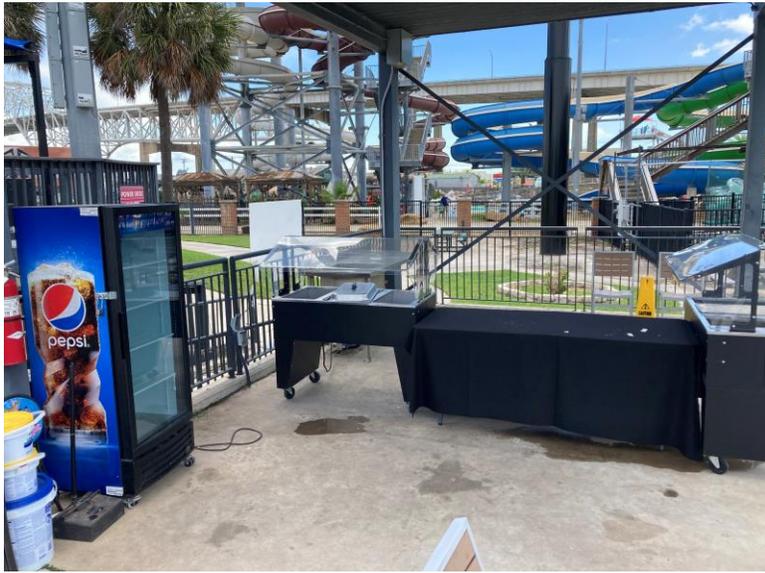
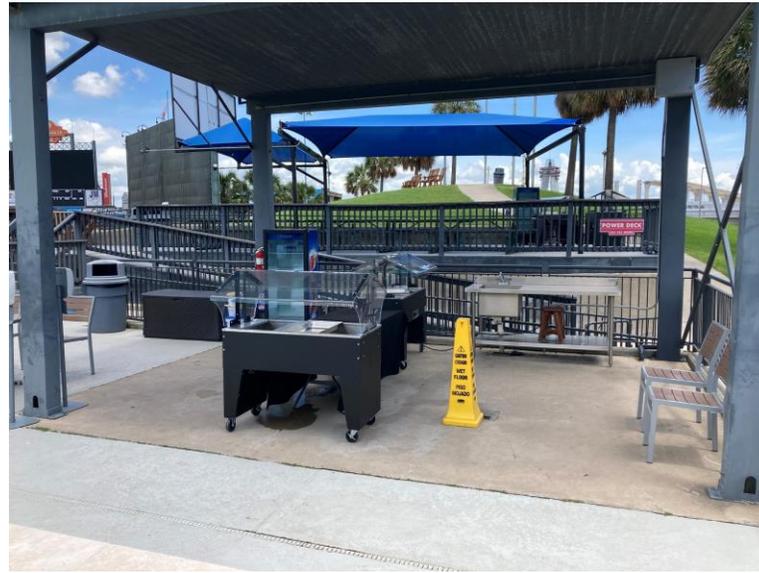
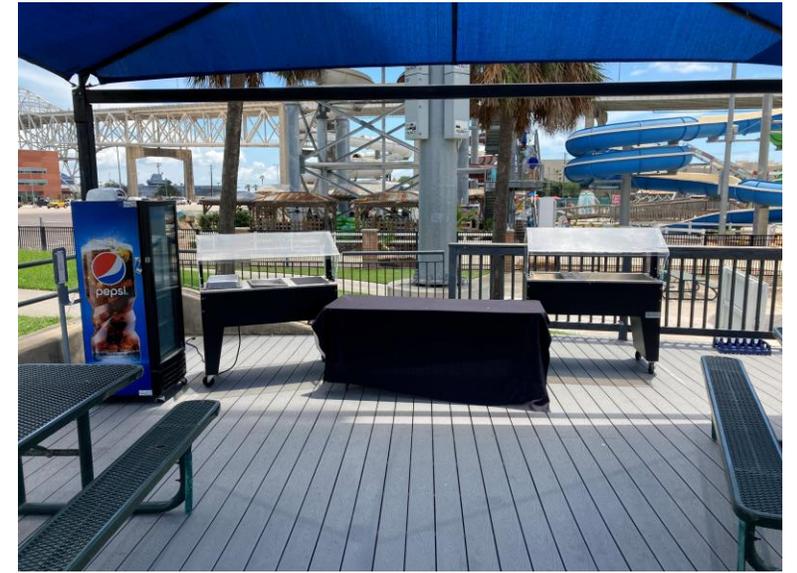
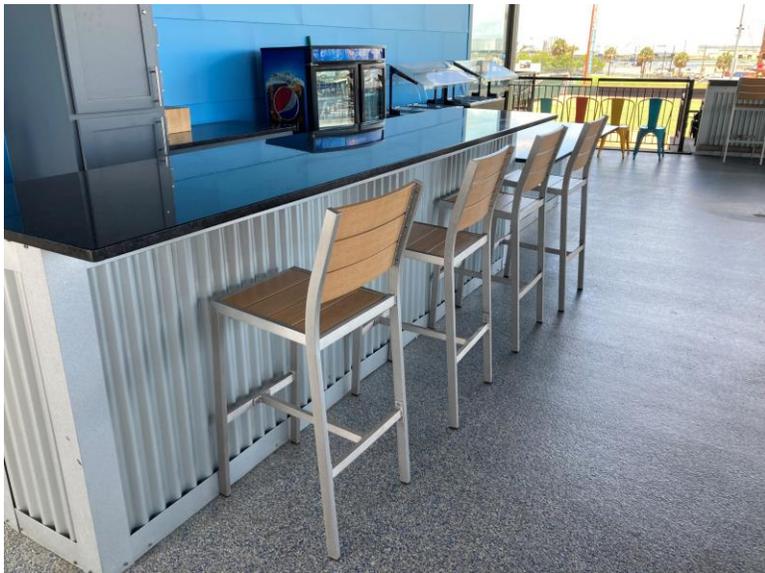
Hospitality Area Service Buildout

Construct permanent service comparable to Mike Shaw Loft
