CORPUS CHRISTI

East General Aviation Hangars

Structural Condition Assessment

January 2011

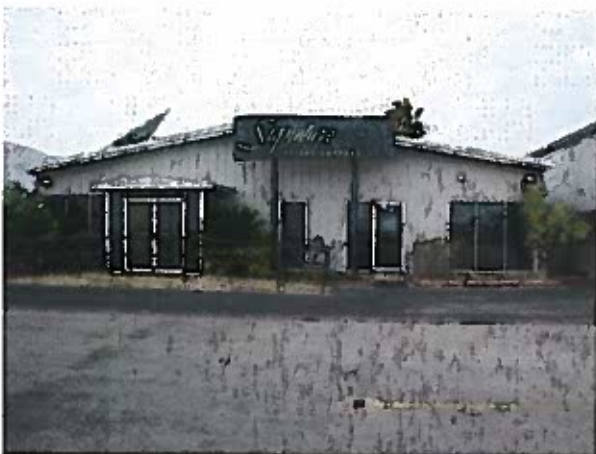
Signature Office Building – Air Side

The exterior of the structure was inspected first. The overall condition of this building is good and no damage was noted on wall cladding panels. The building envelope appears to be intact with no deficiencies noted at the windows and doors. However, several maintenance items need to be addressed for this building. The gutters are filled with debris and should be cleaned to prevent corrosion. In

addition, the gutter downspouts place water directly adjacent to the building foundation. Gutter extensions and splash blocks should be provided. If not corrected, this condition will cause damage to the foundation due to heaving of the underlying soils. General improvements to grading adjacent to the building should be performed to prevent the buildup of water adjacent to the foundation.

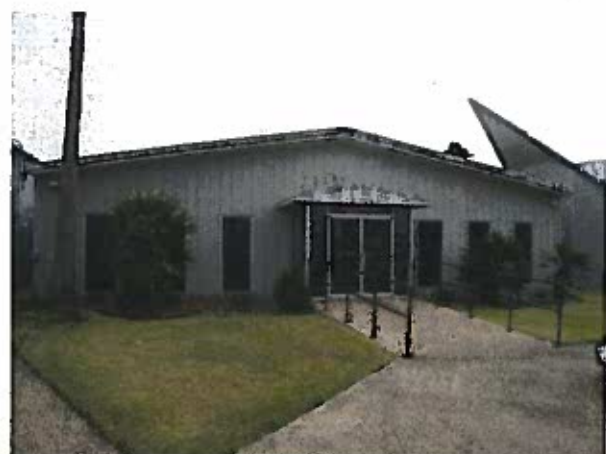
Signature Office Building – Land Side

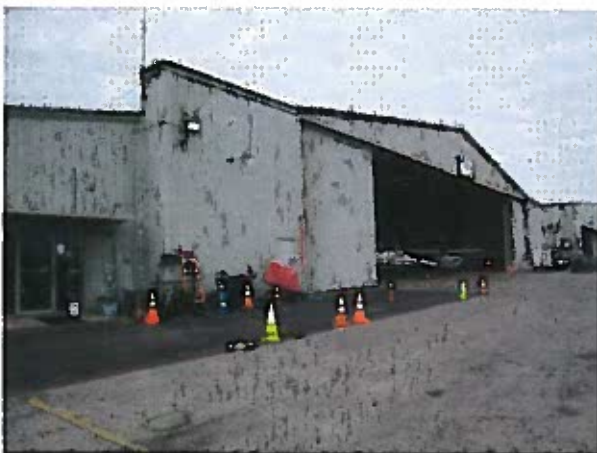
East GA Hangar 2 – Ocean Air Center – Air Side

An inspection of the exterior portions of the building revealed some damage to the corrugated steel wall panels although this damage is not extensive. No other structural distress was noted from the outside of the building in this area at the time of inspection although building envelope issues are apparent. The eave trim and gutters are corroded and should be replaced. Downspouts were missing as well.

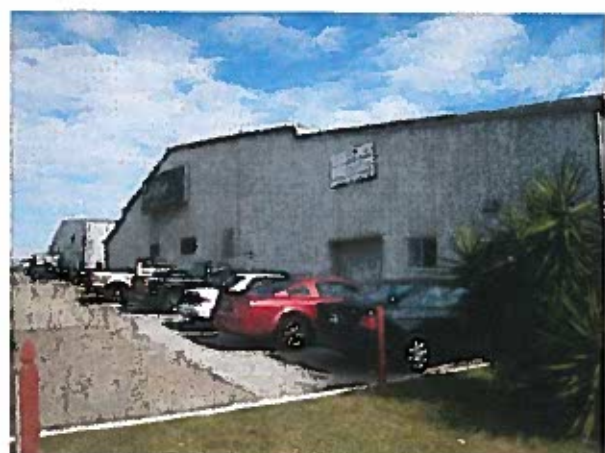
East GA Hangar 2 – Ocean Air Center – Land Side

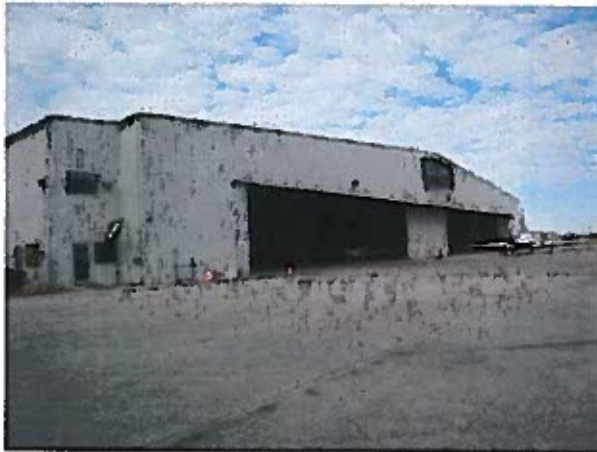
East GA Hangar 3 – Air Side (East)

The exterior inspection of Hangar 3 revealed mechanical damage to wall panels although this damage is not extensive. There is moderate to severe damage to the gutters and downspouts and some downspouts are missing. There is inadequate caulking around the windows. All of the fan louvers are in need of replacement and it appears that the fans are inoperable as well. There is some evidence of water infiltration in the area where Dodd Aviation is located as indicated by staining of the ceiling tiles in the restroom areas. It could not be determined if this staining was caused by rainwater infiltration or other moisture sources.

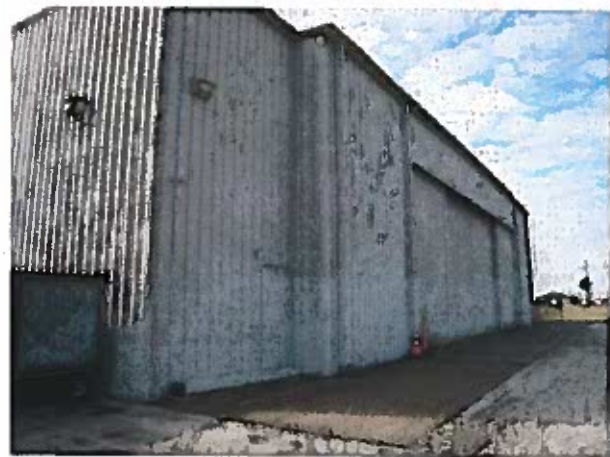
East GA Hangar 3 – Air Side (North)
