# Packery Channel Restoration (H17019) Preliminary Design Report

Corpus Christi, Texas

November 26, 2018

*Prepared for the City of Corpus Christi*

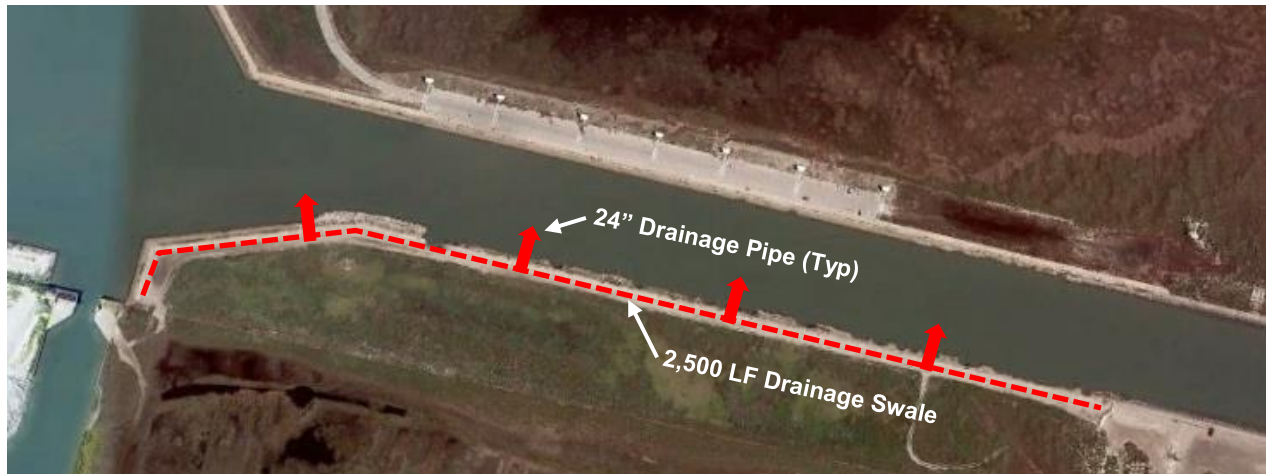
Figure 25 – Drainage System Concept.

As discussed in Section 2, localized washouts and seepage from surface runoff likely contributed to loss of foundation material under the sidewalks and beneath the ABMs. A drainage system is proposed along the south bank to help prevent this failure mechanism during future storms. The drainage system would extend approximately 2,500 LF adjacent to the south side of Reach 3 as shown in Figure 25. The drainage system would consist of a continuous 12-ft wide swale lined with geotextile fabric and riprap to capture and route surface drainage to inlet structures spaced approximately 500 feet along the swale. As a potential cost-saving measure, the swale could be lined with crushed concrete from the demolished walkway or recycled ABM from the revetment. The inlet structures would discharge water from surface drainage through 24” aluminum (or other corrosion-resistant material) pipes penetrating through the bank protection to the channel.

| Table 10 – Example Construction Costs for Range of Repair and Improvement Combinations. | | | | |
|---|---|---|---|---|
| | + | Reach 3 Bank Improvements<br>Drainage System Along South Bank (2,500 LF)<br>(See Figure 25 for Location)<br>\$203,000 | + | = \$7,263,000 |
