Water Supply Update

Including a review of the Mary Rhodes Pipeline and Pumping System

August 19, 2025

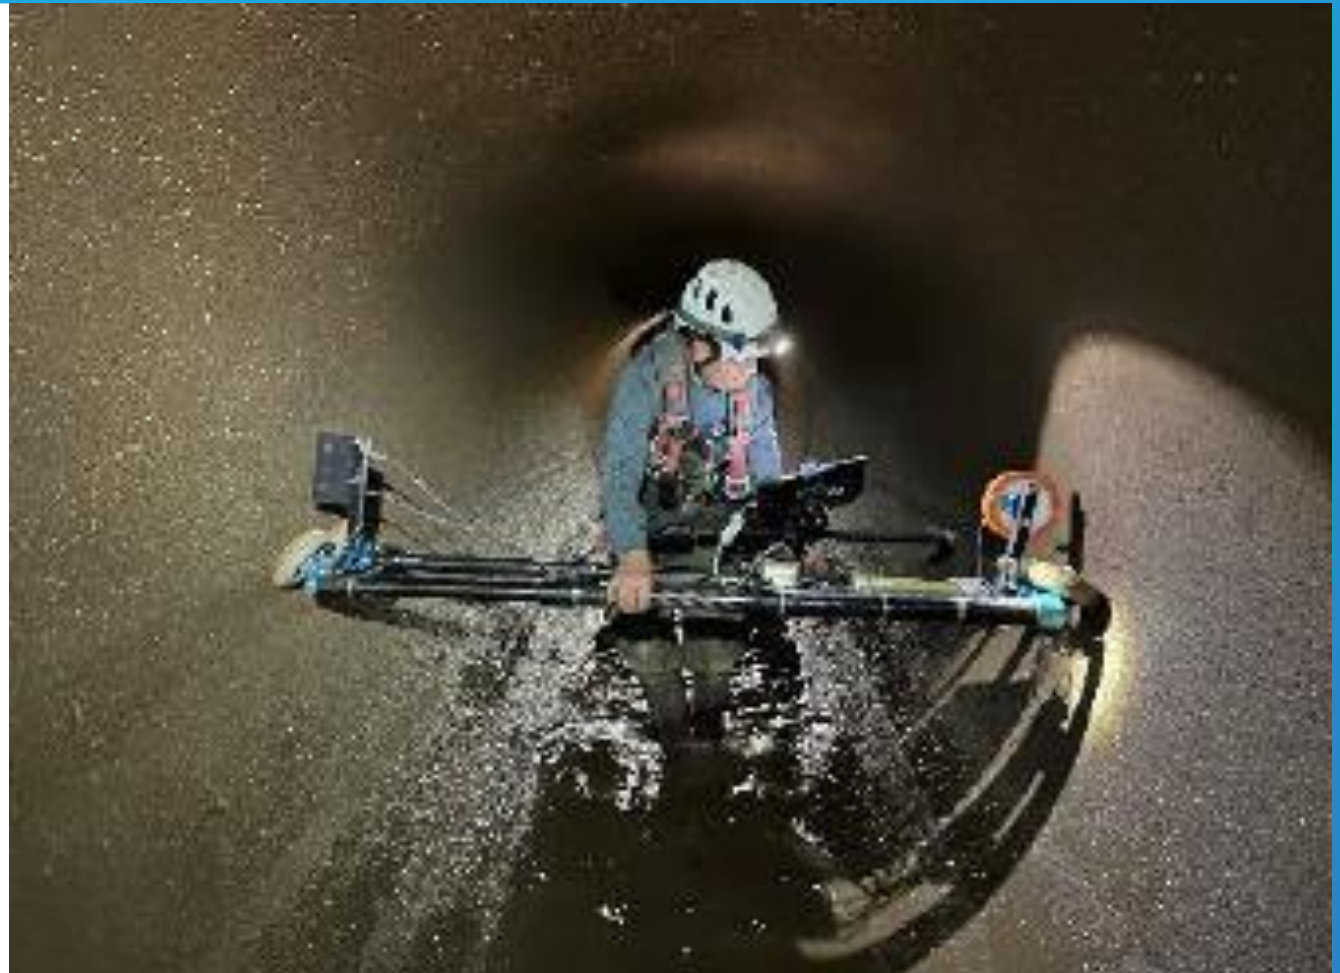
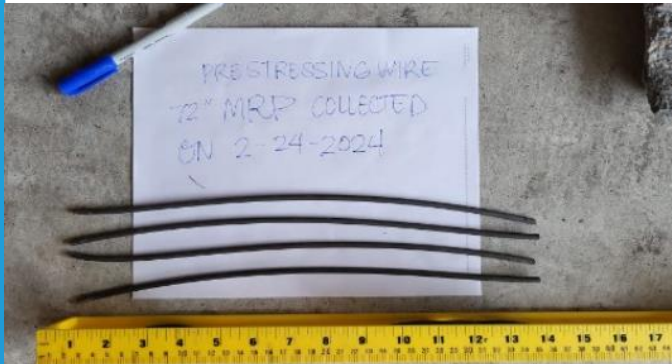
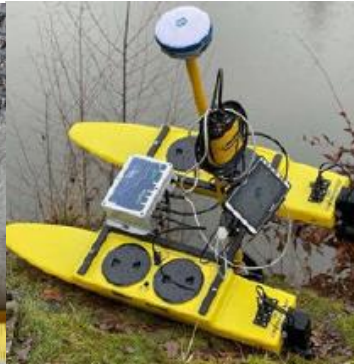
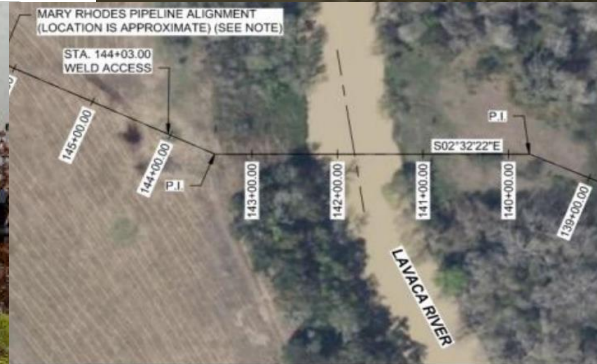
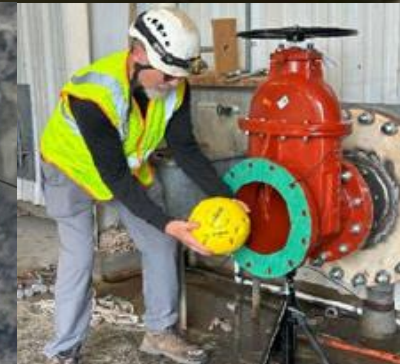
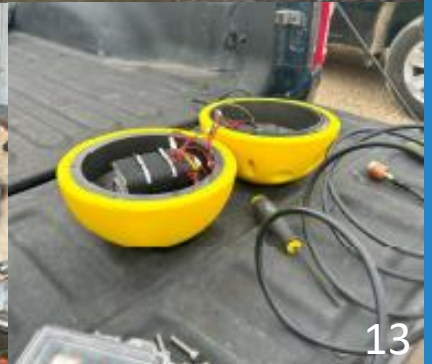
Condition Assessment

- Internal condition assessment
 - Acoustic leak detection
 - Electromagnetic evaluation
 - Mortar and wire analysis
 - Visual
- Drone survey (aerial & water)
- Hydraulic analysis
- Soil corrosivity analysis
- External condition assessment
- Completed in May 2024

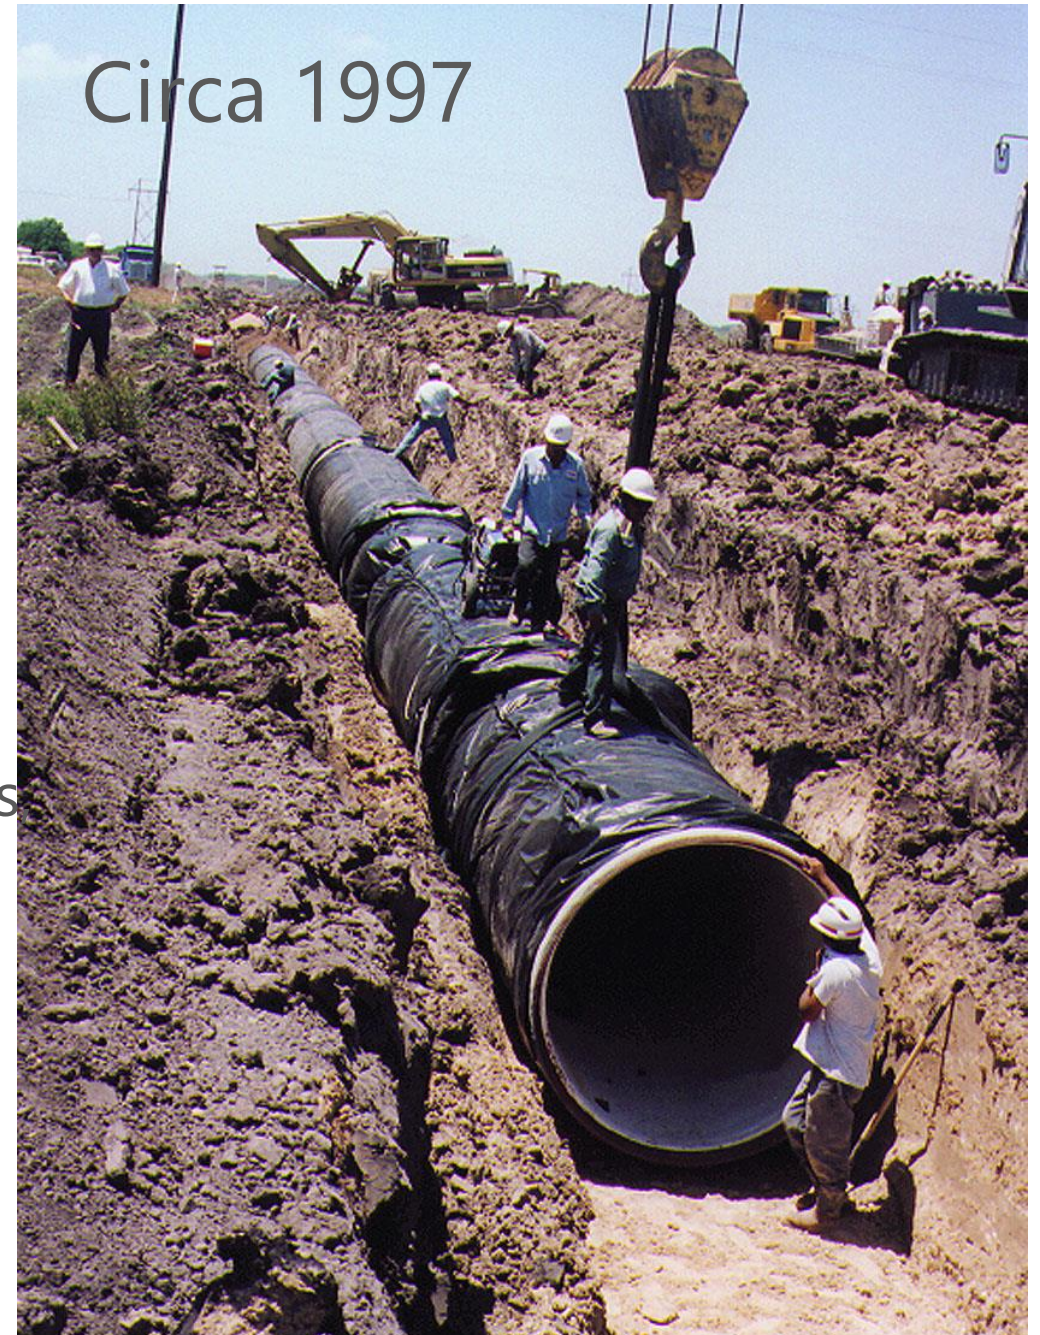
Findings and Observations

- MRP is performing satisfactorily at the current pumping rate (Schedule 4)
 - The overall integrity of the pipe is good
 - Acoustic ball inspections identified three small leaks which have been repaired
- Past failures are typically associated with Schedule 2 and 3 access points, air relief valves and joints
- Erosion areas reducing the cover over the pipeline have been identified at various water crossings

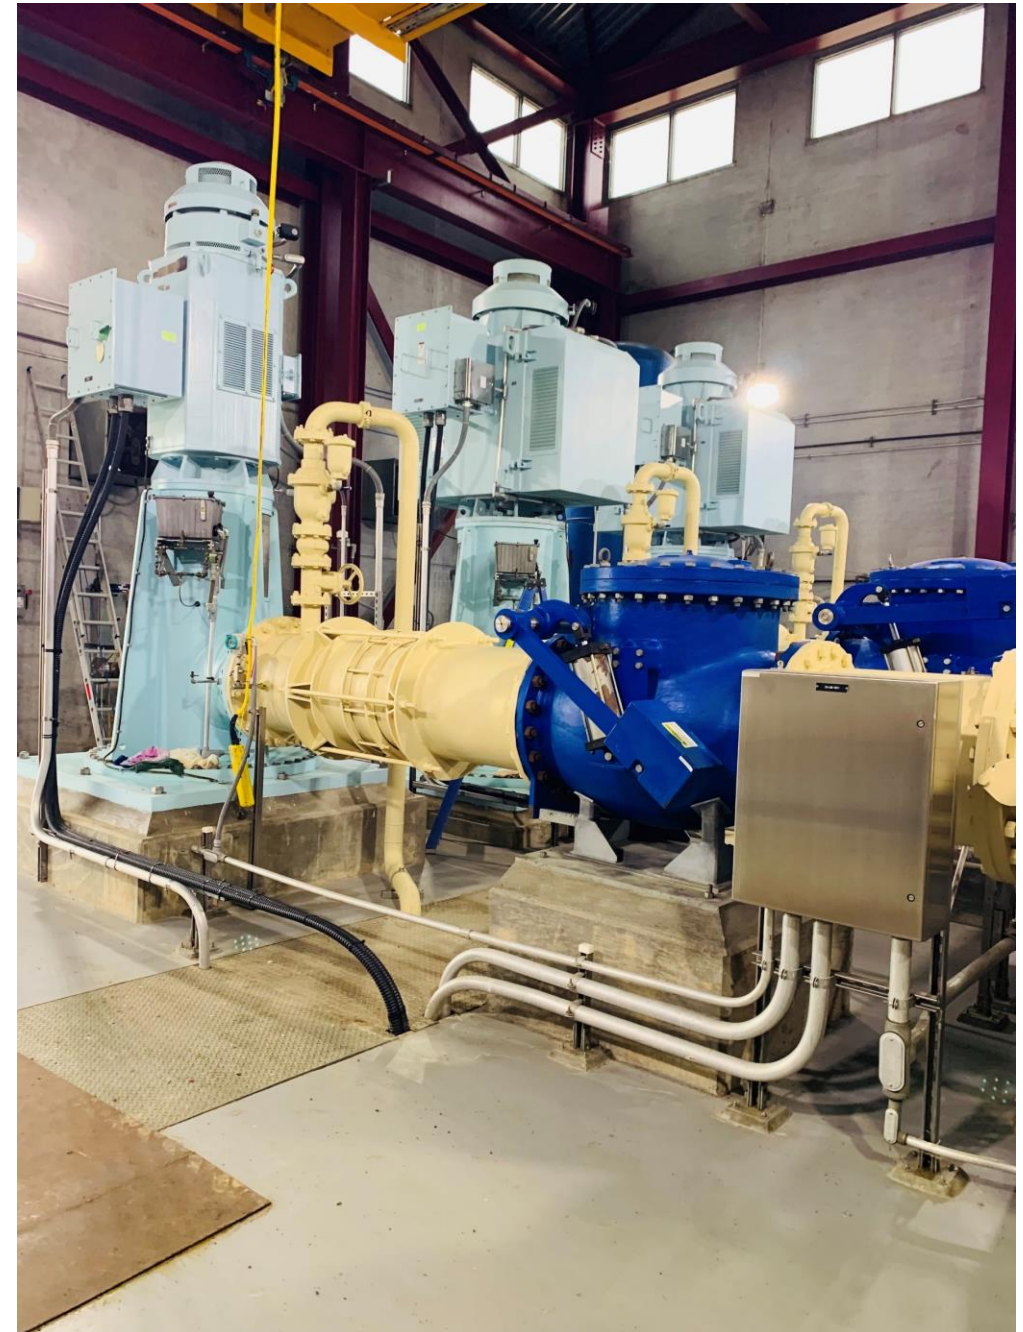
Findings and Observations (Continued)

- Varying soil corrosivity conditions exist throughout the length of the pipeline, and current cathodic upgrades should continue as planned
- Pump station upgrades are needed and should continue as planned
- Pipe pressure exceedance areas have been identified
