Preliminary Technical Memorandum

Improvement Concepts for Salt Flats Levee

Salt Flats Levee System, Phase 2, Task Order 4

City Project Number: E12070
HDR Project Number: 10026049

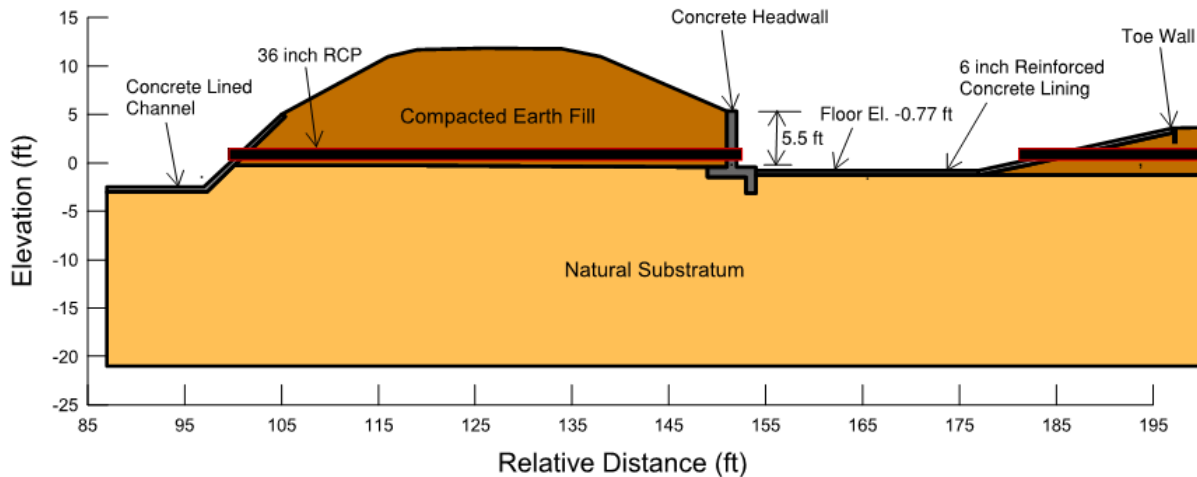
As previously noted, Maverick Engineering designed a concrete inlet/headwall near Station 7+00, for which the location is shown in Figure 3 and a schematic cross-section is shown in Figure 5. The headwall supports two pipe penetrations that extend through the levee, each discharging stormwater into the Salt Flats Channel. One of these two pipe was installed as part of the original levee construction in 1956 and consists of a 36-inch reinforce concrete pipe (RCP). The other pipe was installed as part of the Maverick Engineering design package and consists of 36-inch diameter HDPE. Based on the design drawings, this particular pipe was installed by a bore method.

Figure 5 – Schematic of Headwall Design

The stability of the levee at and near Station 7+00 is highly dependent upon the stability of the concrete headwall (refer to Figure 5). Analysis of the headwall was beyond the scope of the current assessment. During future detailed design of the levee improvements, the headwall should be analyzed in more detail for other external modes of failure (including sliding and overturning), as well as internal structural capacity, using active loadings generated during the 100-year flood event.

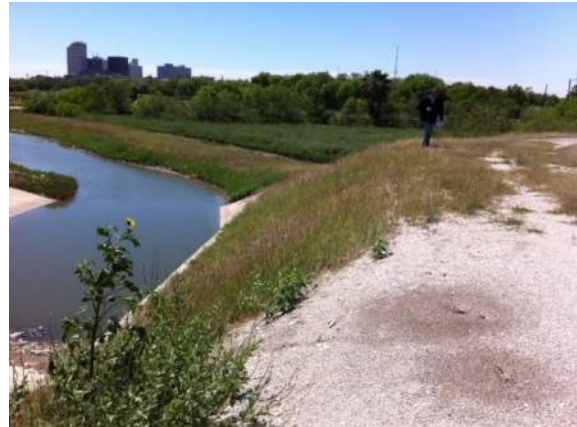
The headwall and associated basin represent a discontinuity because the levee slope in this particular area is essentially vertical below approximate El. +5.33 feet. Figures 10 and 11 provide recent photographs of the headwall and basin area.

Figure 11 – Interior Drainage Ditch and Basin Area

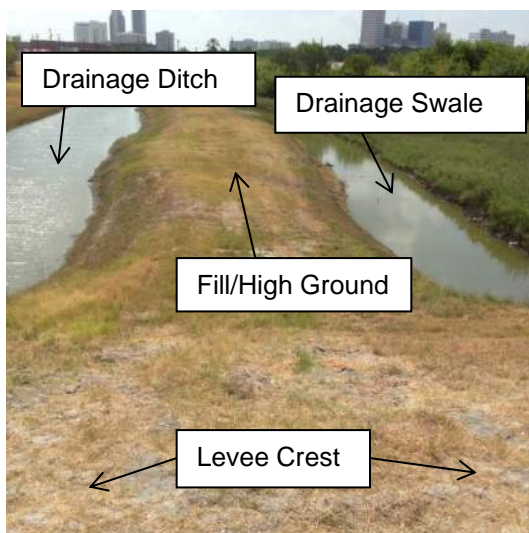
A third pipe penetration exists south of the headwall at approximate Sta. 6+50. This particular penetration discharges stormwater from the drainage swale that was identified in Figure 3. There does not appear to be a concrete headwall associated with this particular penetration. The topographic survey indicated the pipe is installed at the toe of the levee at an invert elevation of -0.81 feet (bottom of drainage swale). The pipe was identified as being a 30-inch diameter reinforced concrete pipe. Figure 12 and 13 illustrate the drainage swale and the approximate location of the pipe.

Figure 12 – Drainage Ditch and Swale

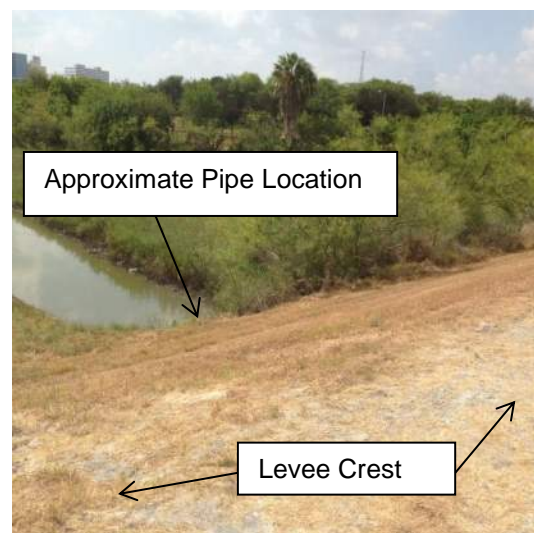
Figure 13 – Approximate Pipe Location

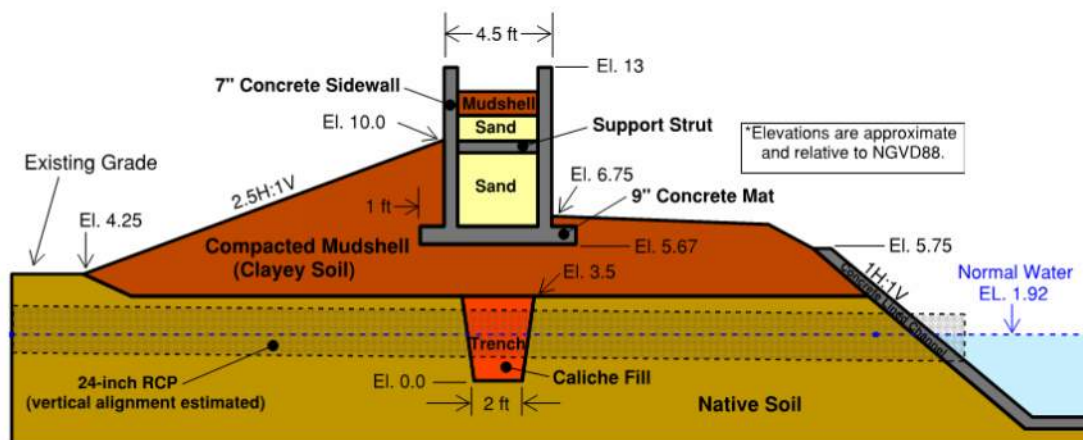
The concrete crib wall was constructed in approximately 1956 as part of the original Salt Flats levee construction. There is one known storm drain that extends underneath the crib wall, a 24-inch diameter reinforced concrete pipe. A schematic of the crib wall, based on the 1956 design drawings and recent site observations, is shown in Figure 20.

Figure 20 – Schematic of Existing Crib Wall

Based on the above considerations, HDR recommends the crib wall be replaced with a inverted T-Wall. A conceptual T-Wall design is provided in Figure 27.

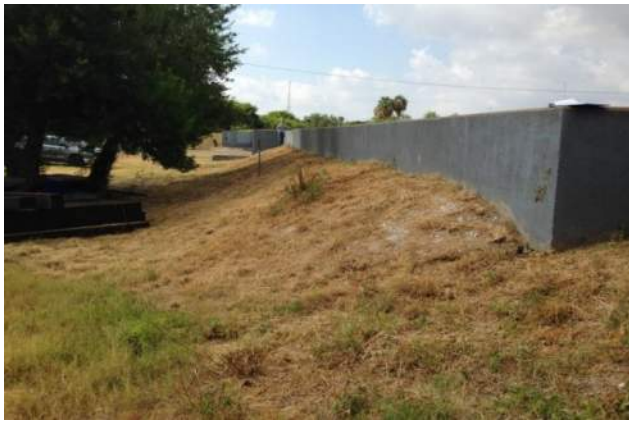
Figure 23 – Backslope of Crib Wall

Based on this assessment, the existing crib wall is recommended to be replaced with an inverted concrete T-Wall. The base slab of the T-Wall would be founded on existing embankment material and the stem portion would structurally tie into the adjacent concrete storage bunker to the south and concrete wingwall to the north. As conceptualized, the wall would extend approximately 6.5 feet above the supporting base slab to coincide with a top elevation of +13 feet (NAVD88). Compacted cohesive material would be placed along the protected side to enhance stability of the T-Wall during a significant flood.

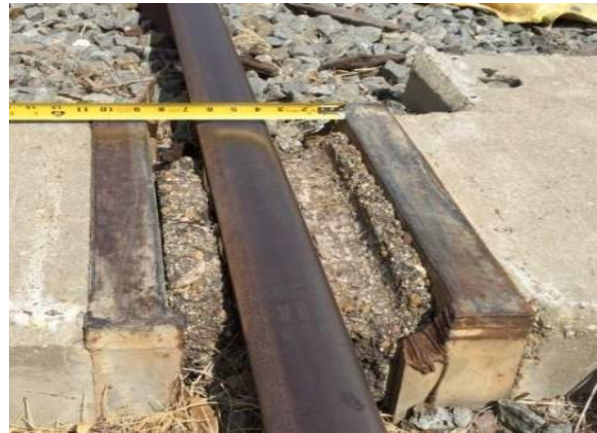
Figure 31- Asphalt Infill Material

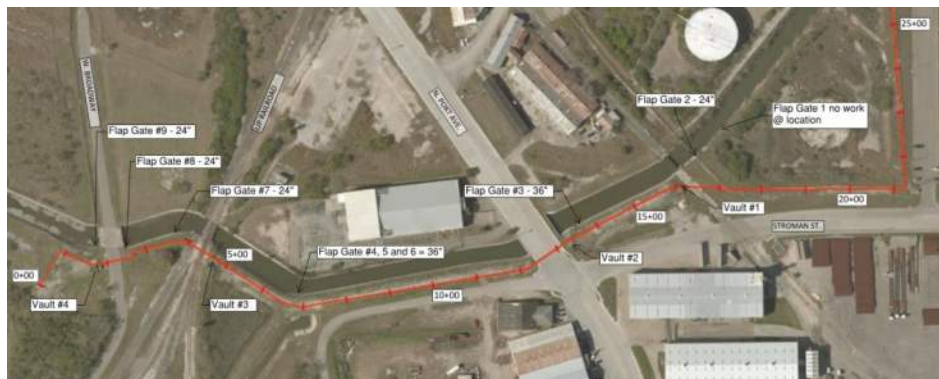
There are 9 known flap gates located along the drainage outfall, as illustrated on Figure 32.

Figure 32 – Known Flap Gate Locations

In general, the metal flap gates are corroded and pitted, and likely no longer open and close as freely as desired. A photograph of a typical flap gate is provided as Figure 33.

A total of nine flap gates are currently attached to the discharge end of storm drains that penetrate the levee and empty into the Salt Flats Channel. The purpose of these gates is to prevent reverse flow from the channel, in particular during a high water condition within the channel. Eight of the gates are in marginal condition and should be replaced as part of routine maintenance. It is recommended these eight flap gates be replaced with duckbill-type check valves, which are generally considered more reliable.
