# Packery Channel Restoration (H17019) Preliminary Design Report

Corpus Christi, Texas

HDR Project 10130118

November 26, 2018

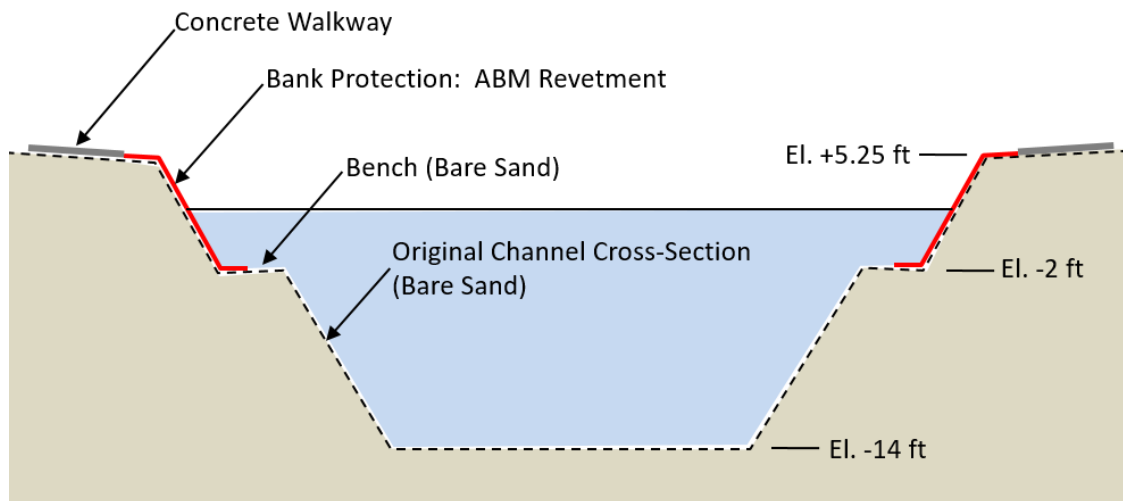
Figure 3 – Original Channel Cross-Section (Reach 3).

This section provides a description of the primary failure and/or damage mechanisms for the ABM revetment in Reach 3, riprap bank protection in Reach 2, and the adjacent concrete walkways. These features were the most heavily damaged components of the project. Figure 3 provides a schematic cross section of the ABM revetment, concrete walkway, and channel as originally constructed. Note that the toe of the ABM revetment terminated at elevation -2.0 ft and did not extend to the bottom of the channel. Although not shown in Figure 3, the toe stone for the bank protection (landside jetty) in Reach 2 rested on a sand bench at elevation -6.0 ft.

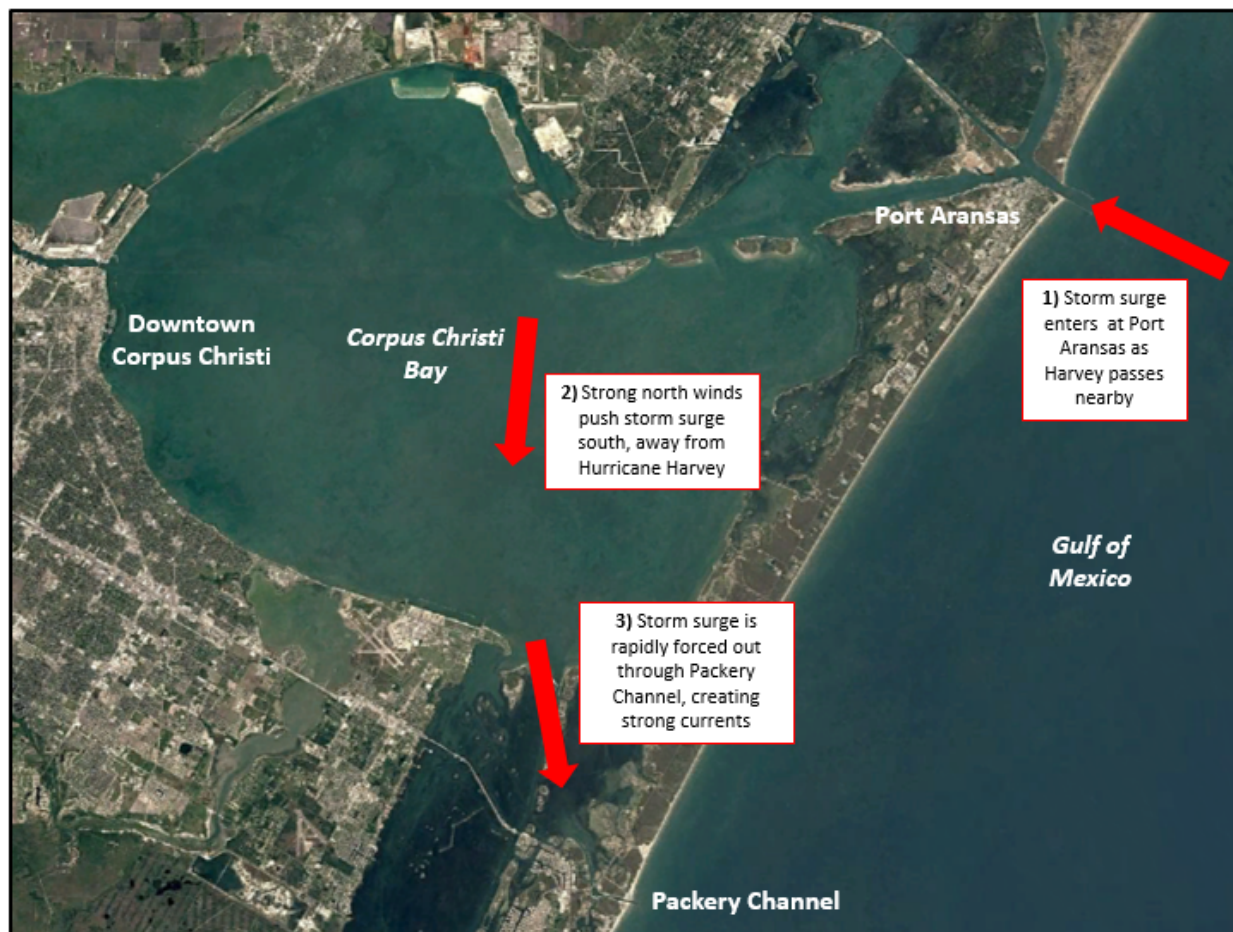
Figure 4 – Storm Surge Flow Pathway During Hurricane Harvey.

As depicted in Figure 4, Hurricane Harvey forced water into Corpus Christi Bay through Aransas Pass, creating elevated water levels (storm surge) in the bay. Strong north winds then pushed the storm surge towards Packery Channel, where the surge was rapidly forced out of the bay as the hurricane shifted inland. The discharging surge caused strong currents of approximately 5 fps in Packery Channel as water flowed from the bay to the Gulf (Williams and Tissot 2018). Based on review of post-Harvey bathymetric surveys performed by the City, these strong currents caused erosion and scour to depths exceeding -18 ft NAVD along the lower, unprotected portions of the channel (Figure 5), resulting in loss of the original bench that supported the toe of the ABM revetment, particularly along the south bank in Reach 3 where the strongest currents were focused. Erosion also occurred beneath the toe of the landside jetty in Reach 2, where currents caused erosion and scour of the bench to depths of approximately -8 ft NAVD.

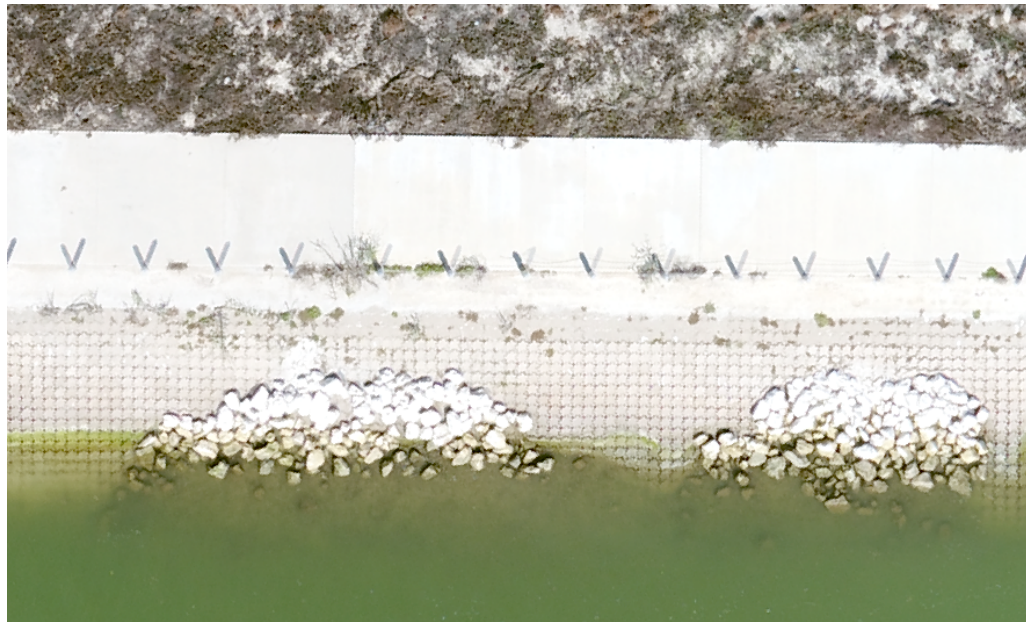
Figure 10 – Example of previous repairs constructed by capping damaged ABM in-place with riprap.

1. Smaller, more isolated damage areas, and damage along areas that are less exposed to daily wave and current action, are recommended to be repaired by capping the damaged ABM in place with riprap. This repair approach has been successful for previous repairs to short sections of the ABM revetment by the USACE and the City (for example, see Figure 10). This approach should include placement of geotextile fabric and riprap along the exposed slope below the ABM to help prevent future toe scour and undermining.

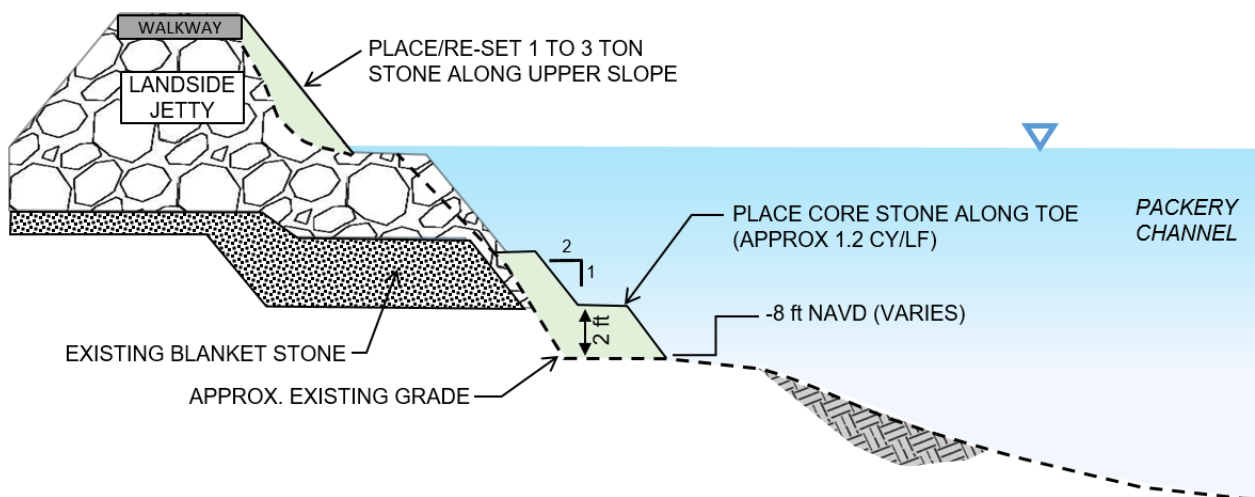
Figure 12 – Harvey Repair Option for Reach 2 (Landside Jetty).

<b>Table 4 – Harvey Repair Recommendations (Return Project to Approximate Pre-Harvey Condition).</b>		
<b>Location</b>	<b>Repair Description</b>	<b>Approximate Quantity</b>
Reach 1	– Re-Set Jetty Armor Stone.	5 Stones
Reach 2 (Figure 11)	<ul style="list-style-type: none"> <li>– Re-set/replace 1-3 ton stone along upper slope of landside jetty.</li> <li>– Place 1,000 lb core stone to repair toe protection to approximate elevation -8 ft NAVD (see Figure 12).</li> </ul>	1,070 LF
Reach 3 (Figure 9)	– Cap damaged ABM in-place with riprap. Also place riprap on geotextile fabric along exposed slope below bottom edge of damaged ABM to approximate elevation -8 ft NAVD.	530 LF
	<ul style="list-style-type: none"> <li>– Replace ABM Revetment</li> <li>– Extend new ABM downslope to approximate elevation -8 ft NAVD (see Figure 13).</li> </ul>	2,400 LF
Miscellaneous	– Fill Voids under Concrete Walkway (North Bank, Reach 3)	360 LF

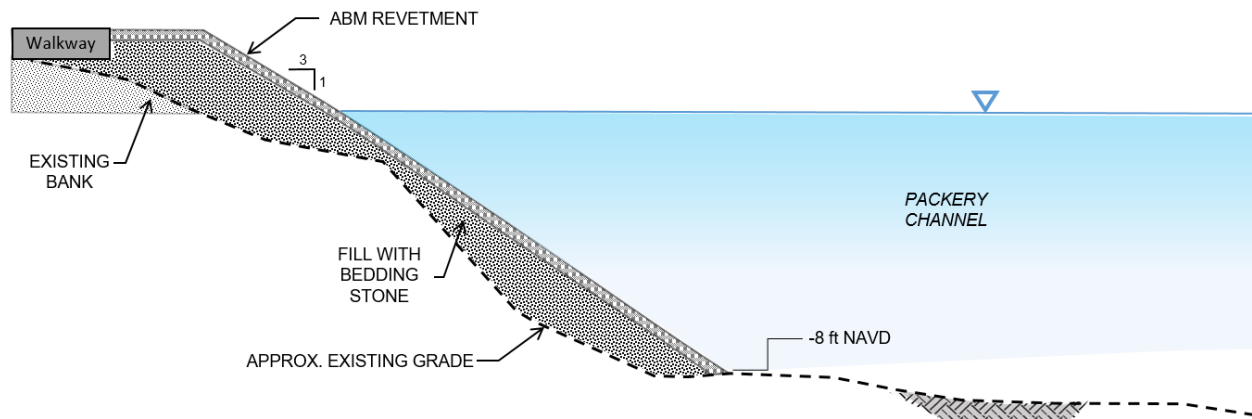
Figure 13 – Harvey Repair Option for Reach 3 (ABM Revetment).

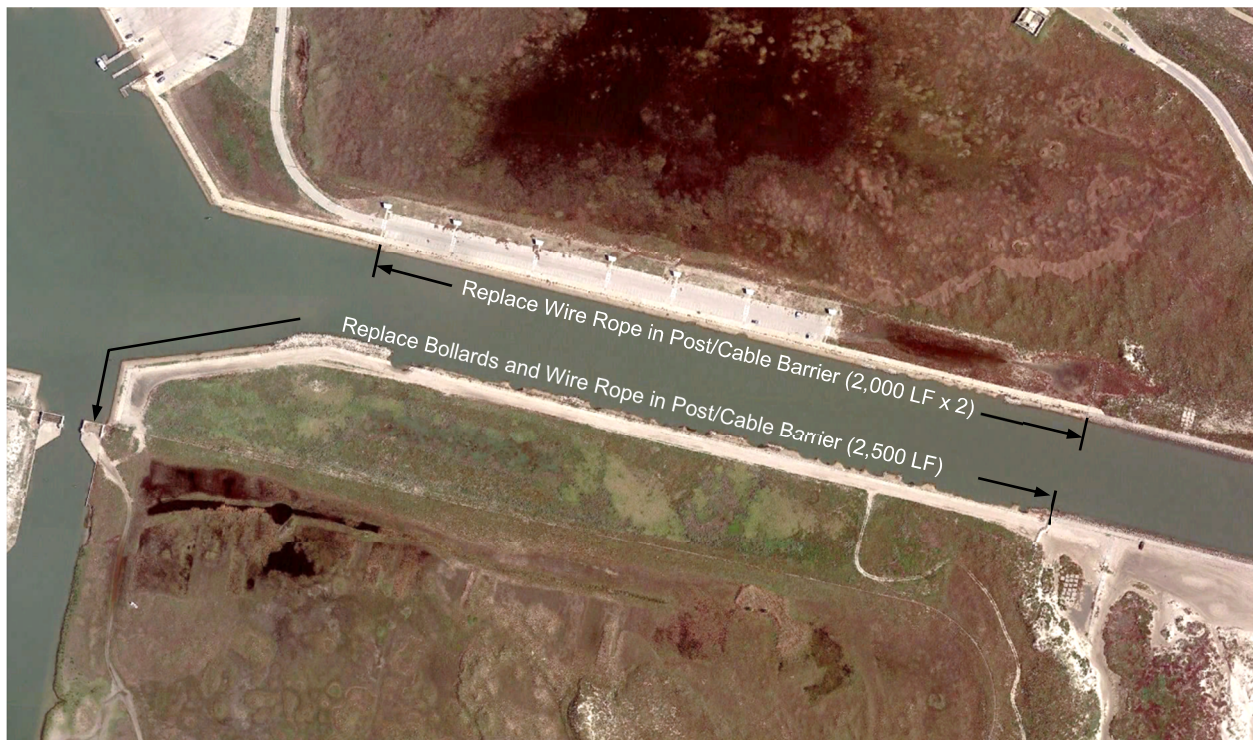
Figure 14 – Harvey Repair: Post/Cable Barriers.

– Replace Concrete Walkway (South Bank, Reach 3)	1,780 LF
	– Remove Debris from Channel	15 Items
	– Replace Post/Cable Barriers (South Bank) (see Figure 14)	2,600 LF
	– Replace Cables in Post/Cable Barriers (North Bank) (see Figure 14)	4,000 LF
	– Repair Voids at Storm Drain Outfalls (North Bank)	2 Locations

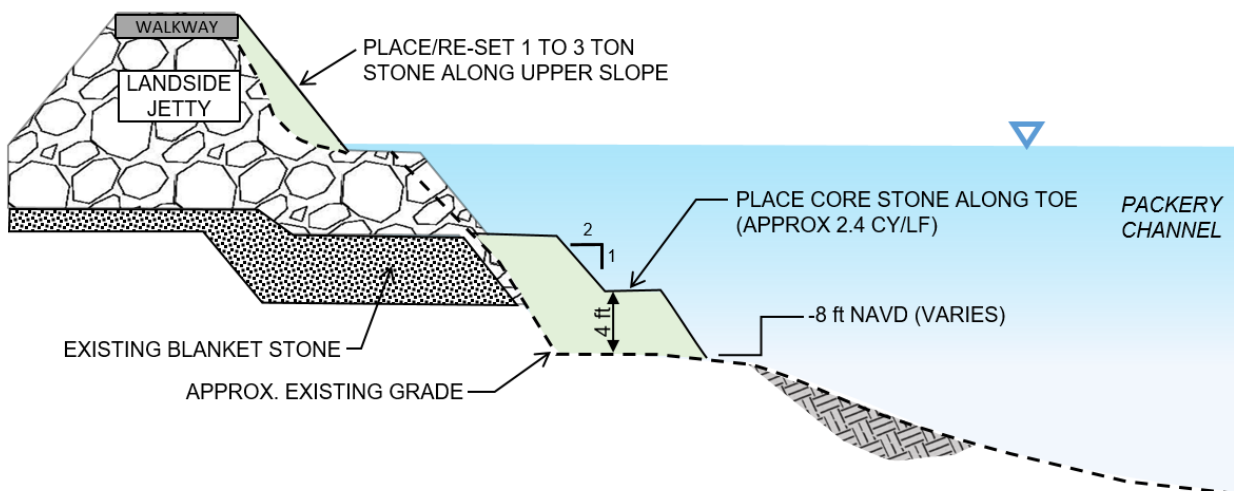
Figure 16 – Hazard Mitigation, Reach 2 (Landside Jetty).

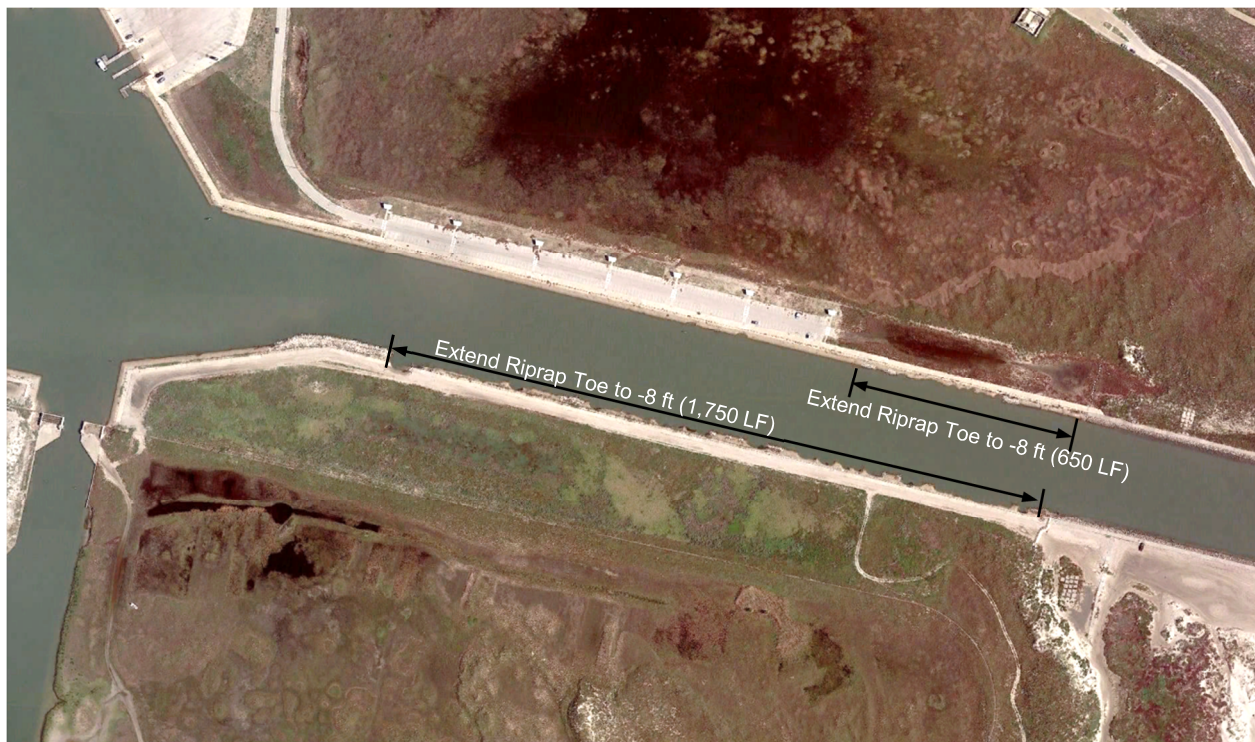
Figure 17 – Hazard Mitigation, Reach 3, Option 1 (Replace ABM with Riprap Revetment).

A potential disadvantage of the bulkhead Hazard Mitigation option in Reach 3 is that it would reflect more wave energy than the revetment alternative(s), creating rougher conditions for boats in the channel. The bulkhead alternative is therefore not recommended for construction along both the north and south bank, only along the south bank as shown in Figure 21. The less-reflective riprap revetment (Option 1 or 2) is recommended along the north bank as shown in Figure 17.

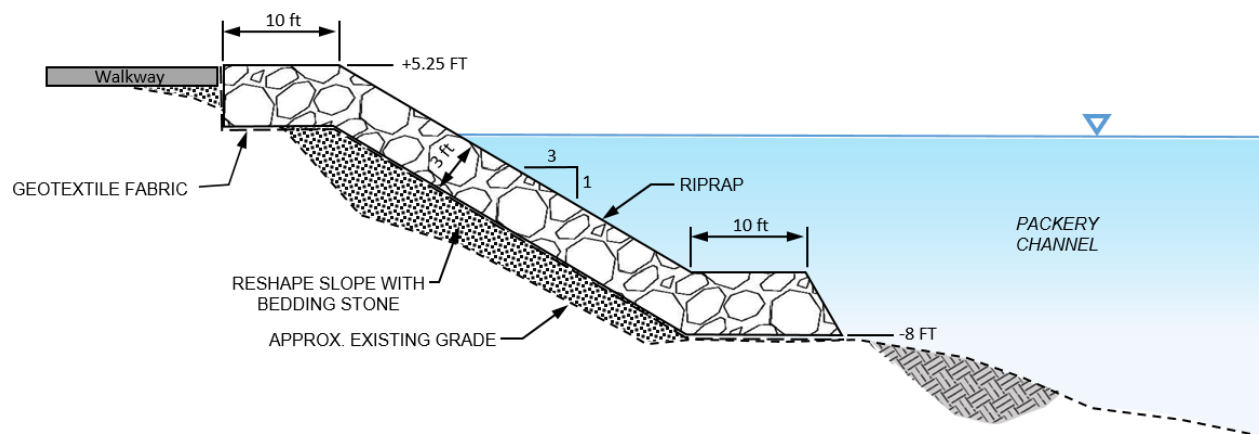
Figure 18 – Hazard Mitigation, Reach 3, Option 1 (Replace ABM with Riprap Revetment to -8 ft).

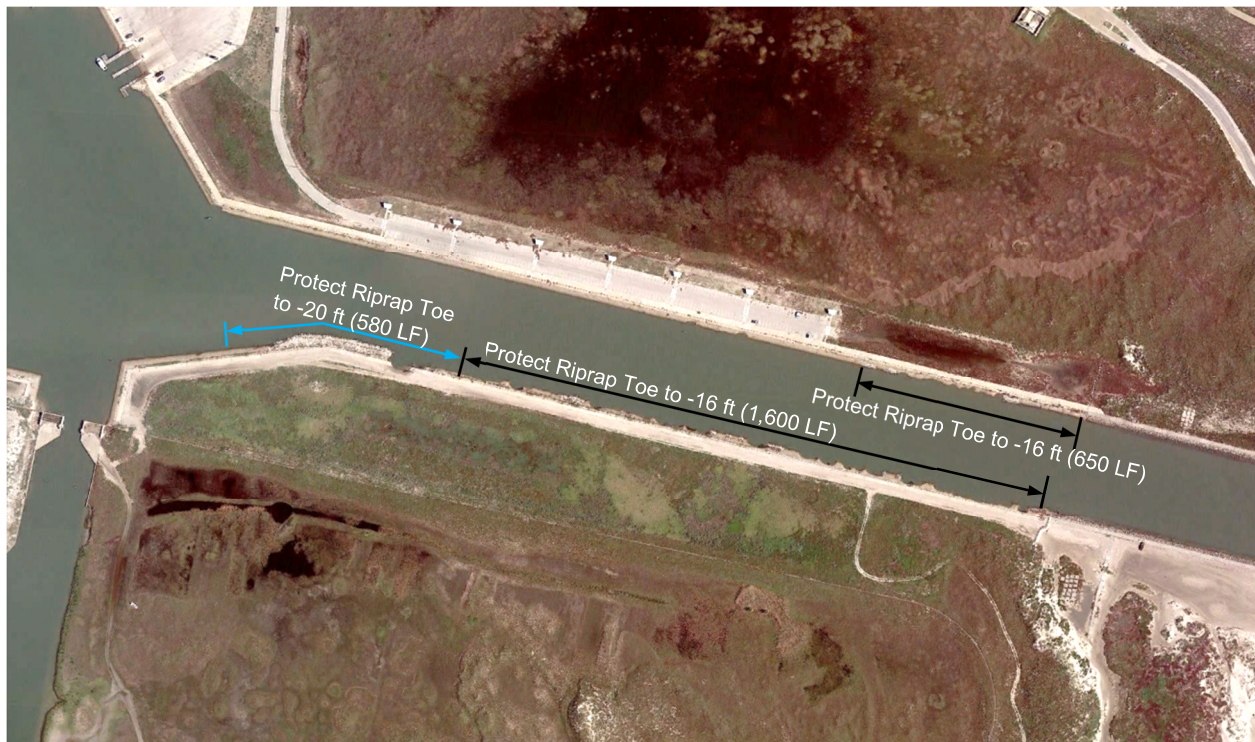
Figure 19 – Hazard Mitigation, Reach 3, Option 2 (Replace ABM with Riprap Revetment).

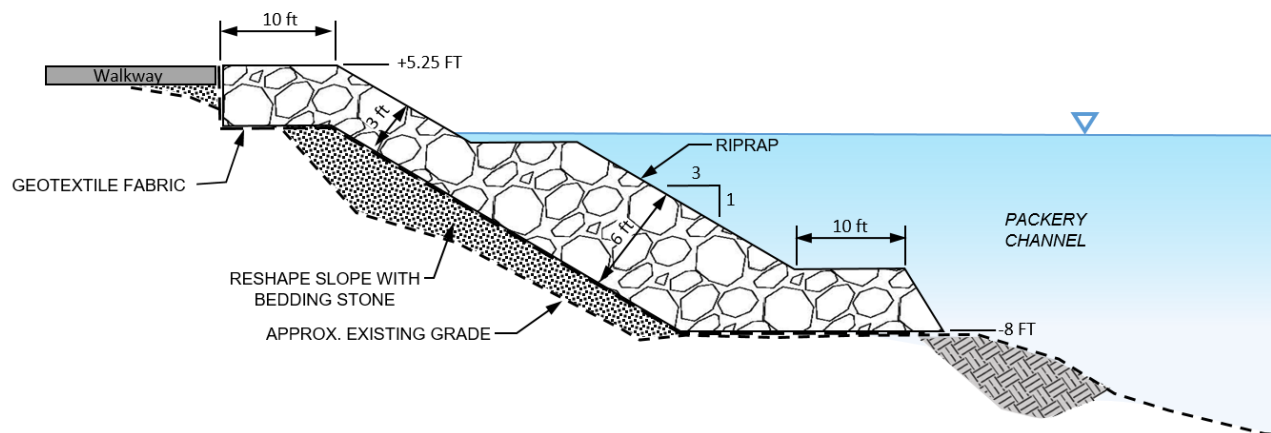
Figure 20 – Hazard Mitigation, Reach 3, Option 2  
(Replace ABM with Riprap Revetment, provide launching  
toe to accommodate scour to -16 ft and -20 ft).

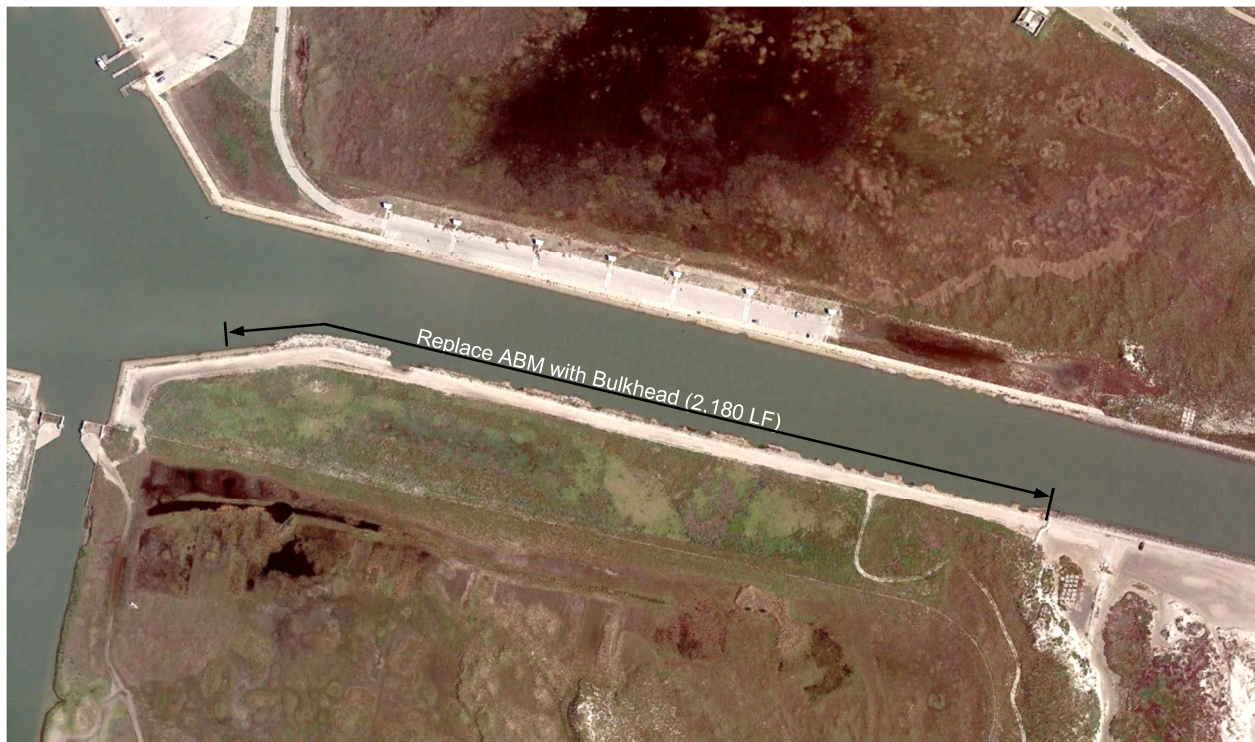
Figure 21 – Hazard Mitigation, Reach 3, Option 3 (Replace ABM with Bulkhead).

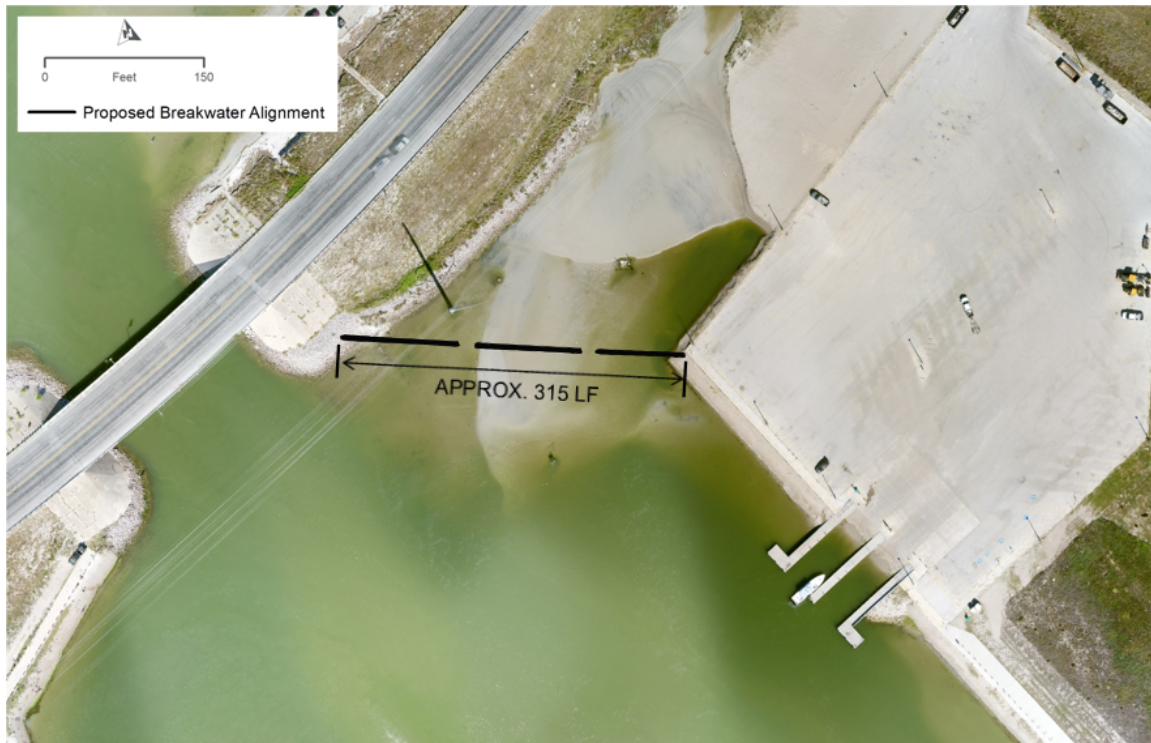
Figure 23 – Approximate alignment of riprap breakwater concept in Reach 4 (breakwater gap locations and dimensions to be determined).

As discussed in Section 5, the breakwater proposed for Hazard Mitigation in Reach 4 (Figure 23 and Figure 24) is recommended to be permitted through USACE as a separate action than the other repairs. It is also recommended to be included as an additive bid option in the construction procurement package that will be prepared during detailed design.

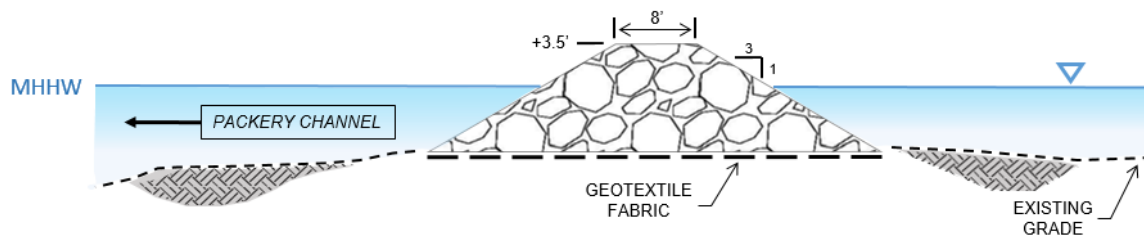
Figure 24 – Hazard Mitigation, Reach 4, Breakwater Concept.

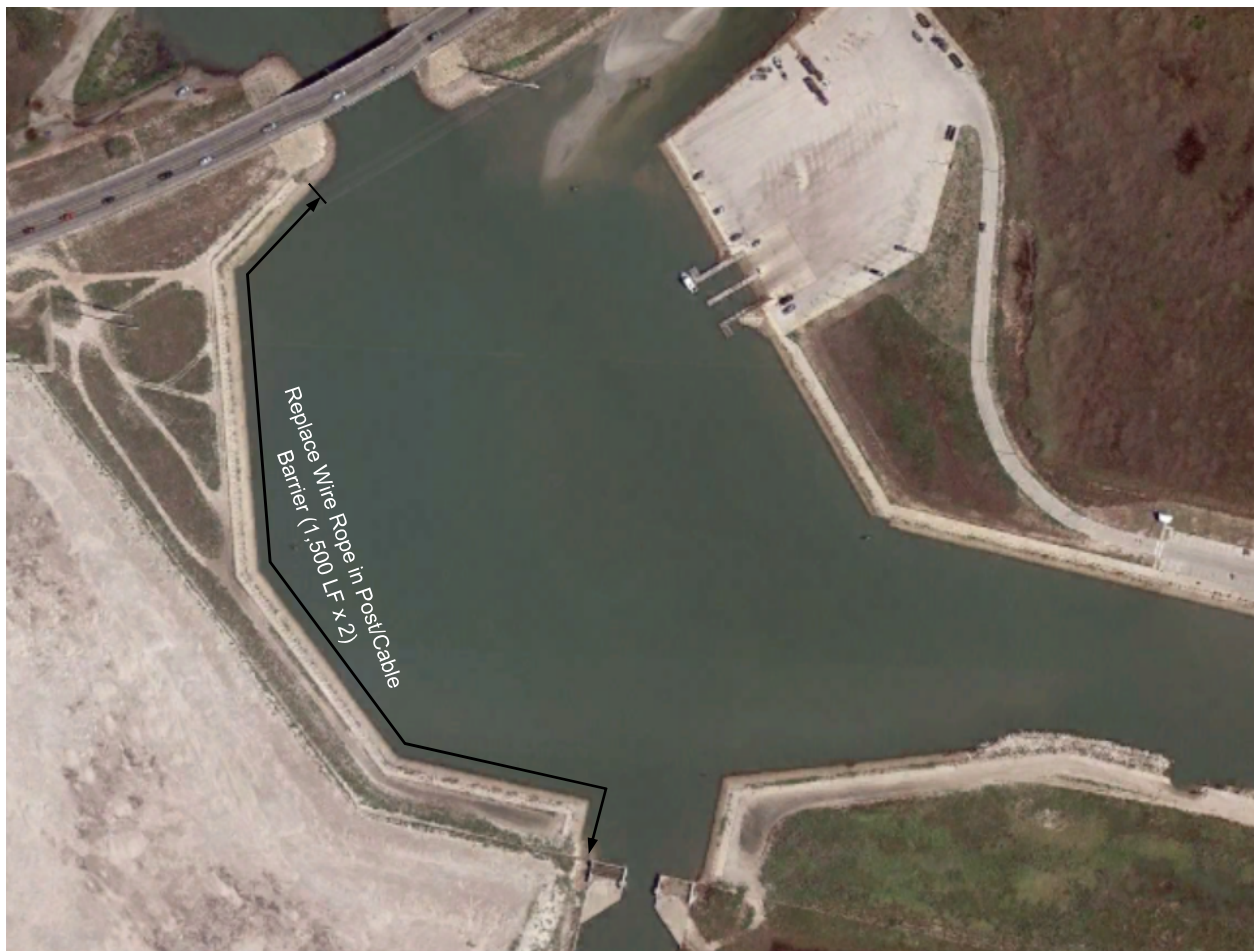
Figure 27 – Maintenance Repair: Replace Wire Rope in Post/Cable Barriers.

Table 6 – Maintenance Recommendations.		
Location	Repair Description	Approximate Quantity
Reach 1 (Figure 26)	– Re-Set Jetty Armor Stone	82 stones
Reach 2 (Figure 11)	<ul style="list-style-type: none"> <li>– Re-set/replace 1-3 ton stone along upper slope of landside jetty (only include stone displaced by previous storms).</li> <li>– Place 1,000 lb core stone to repair toe protection to approximate elevation -8 ft NAVD (see Figure 12).</li> </ul>	1,070 LF
Miscellaneous	– Replace Wire Rope in Post/Cable Barriers along South Bank (see Figure 27).	3,000 LF
	– Replace Missing Section of Handrail at North Jetty (see Figure 28).	30 LF

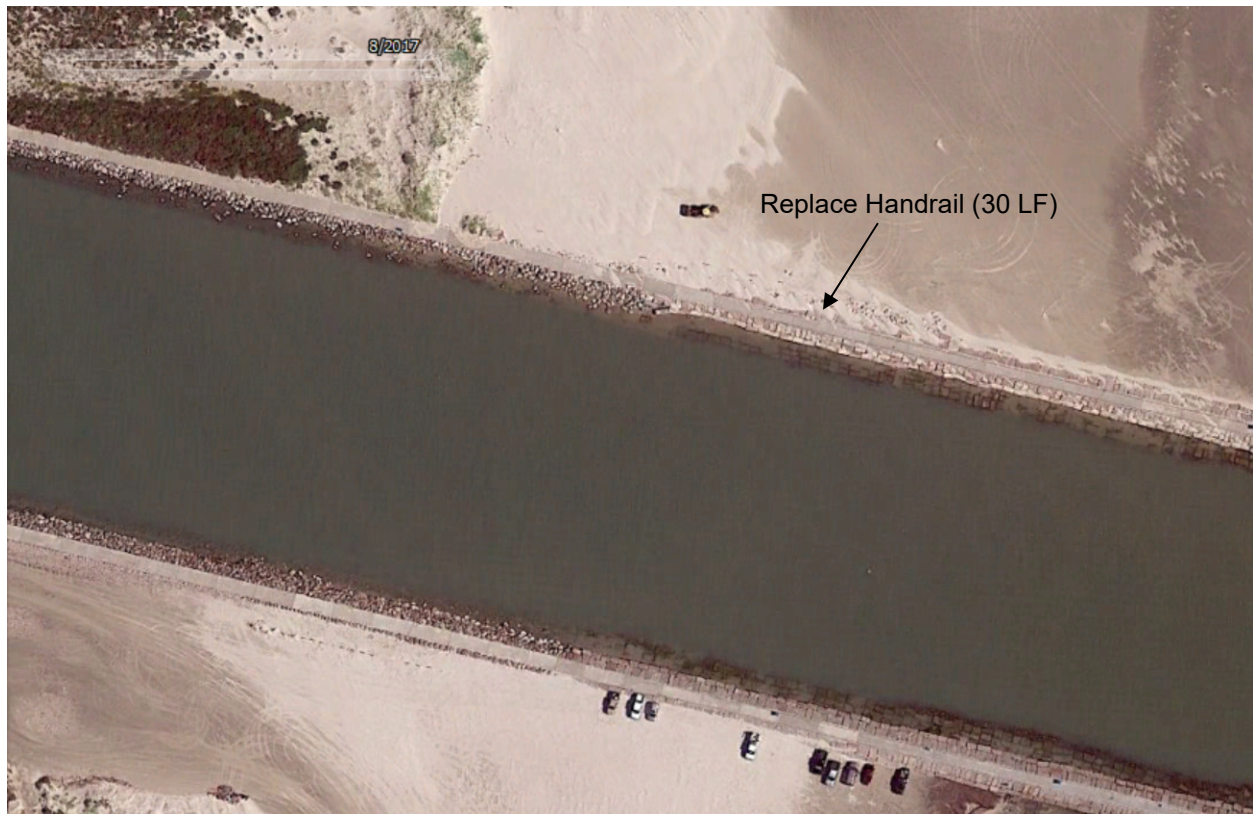
Figure 28 – Maintenance Repair: Replace Handrail.

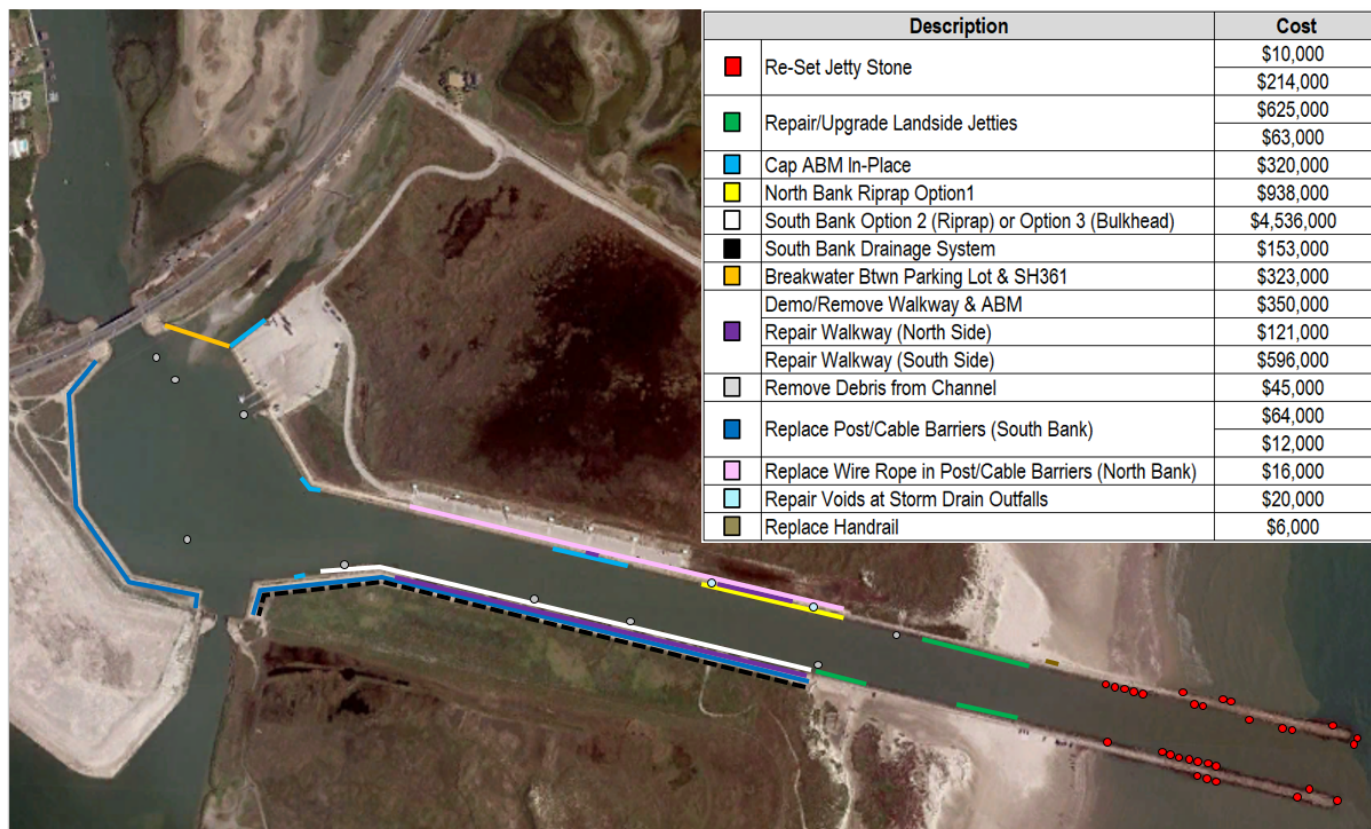
Figure 29 – Overall Summary of Recommended Repair Plan  
 (Note: Costs shown exclude contingencies. Refer to Table 11 for total costs.)

A summary of HDR's recommendations for the repairs, and associated costs, is shown in Table 11 and Figure 29. The overall timeframe for USACE permitting is estimated to be approximately 6 to 12 months. Detailed design and preparation of construction procurement documents (including plans and specifications) will likely require approximately 8 months. Based on the City's project partnering agreement with USACE and review of the Packery Channel Operations and Maintenance Manual (USACE 2007), any design for project repairs, maintenance, or improvements will require review and approval by USACE prior to construction. This coordination should occur as part of the Section 408 approval process. Based on anticipated timelines for permitting and design the project could likely be ready for bidding in December 2019 if the City proceeds with permitting immediately. Construction would likely require approximately 6 to 9 months after bidding and contract award.
