CONCRETE REPAIRS

VIDEOBOARD STEEL REPAIRS

STADIUM SEAT REPLACEMENT

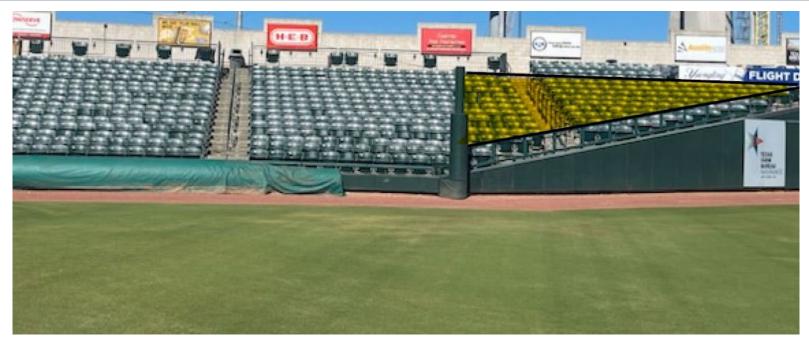
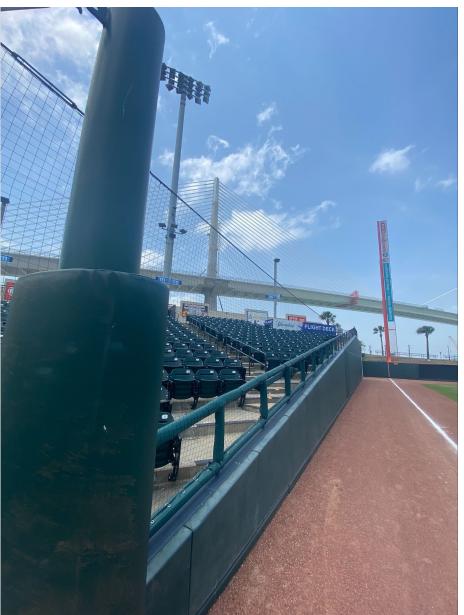
- Extend foul line netting to end point of seating bowl at left and right field.
- Using existing infrastructure, protective netting will be harnessed to on-field pole extending to end of seating bowl utilizing field railing along upward incline.
- Same netting grade as existing netting will be installed for continuity and fan viewing.
- Extension is facilitated by amended guidance from Major League Baseball regarding fan protection.

COMPLETED

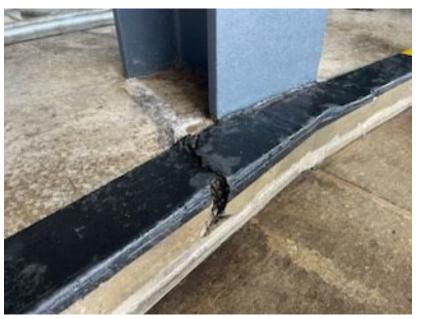
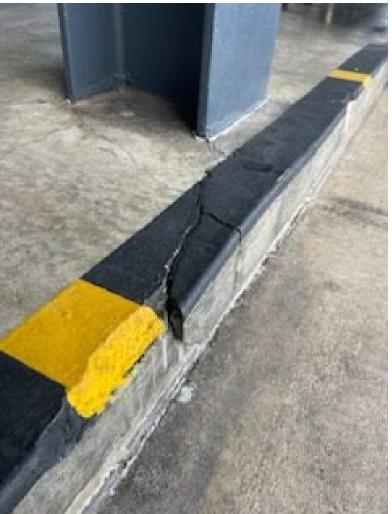
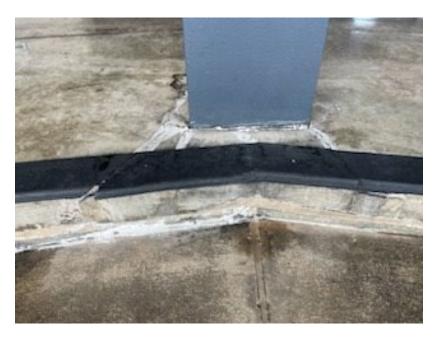
- Repair cracked concrete located where the concourse meets the top steps where aisles contain I-beam placement.
- Total of eleven (11) locations
- Area around all sides of I-beam will be replaced, refortified and new concrete installed

COMPLETED

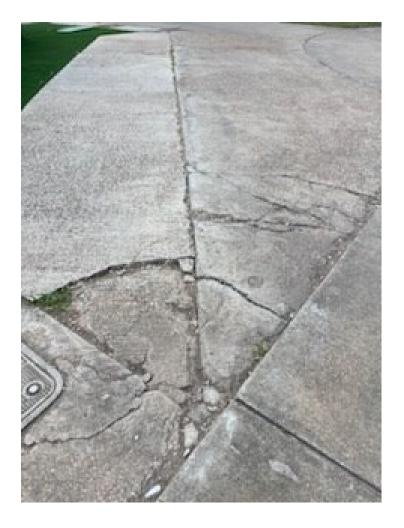
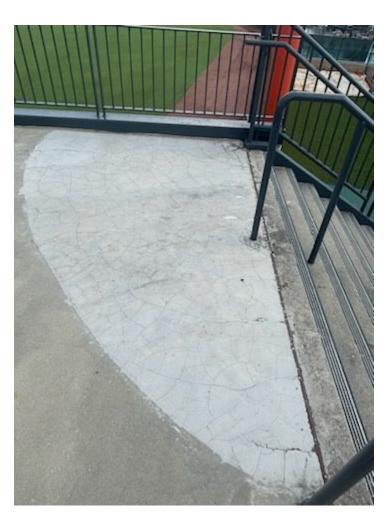
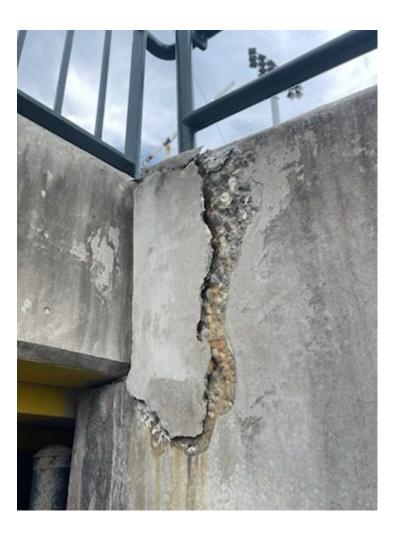
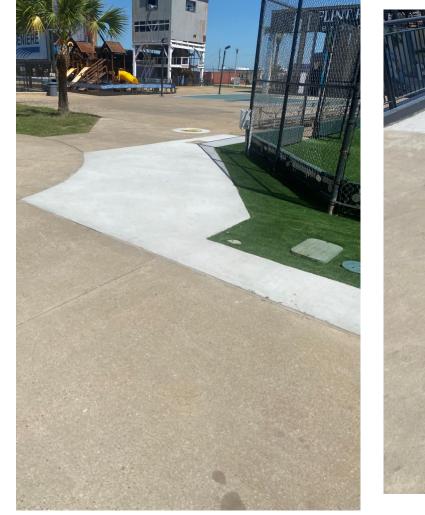
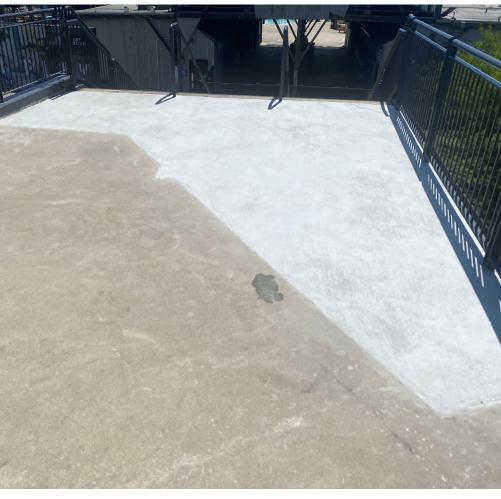
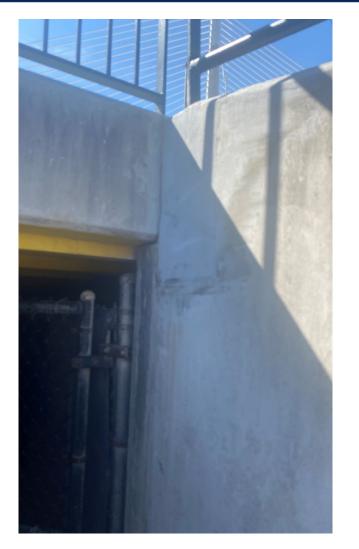
Miscellaneous concrete repairs throughout stadium to eliminate failures and trip hazards

COMPLETED

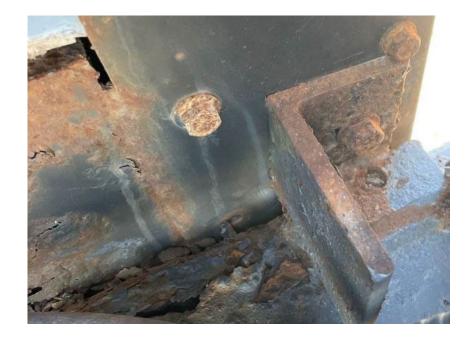
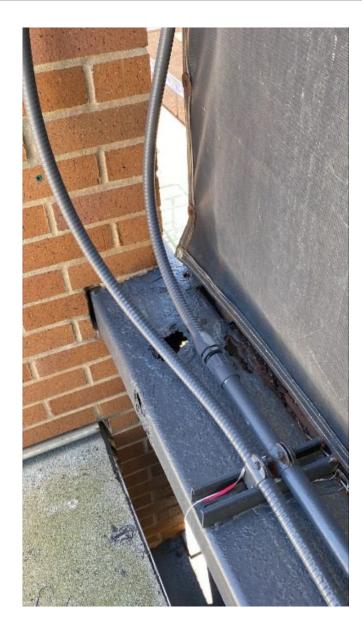
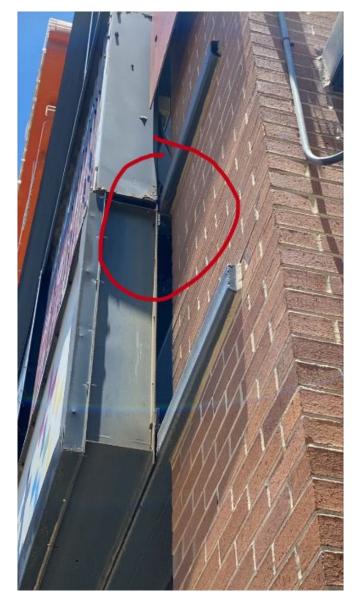
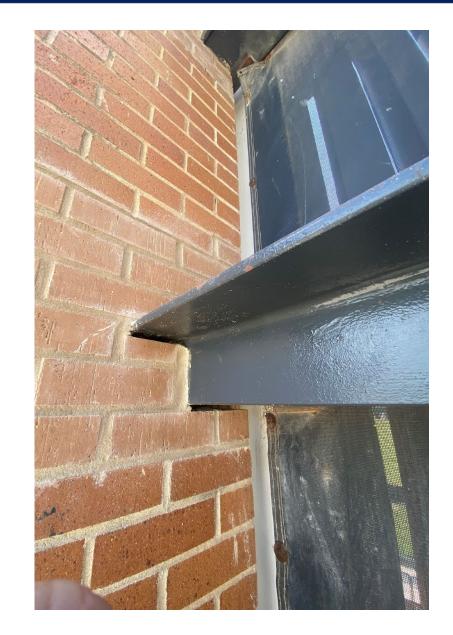
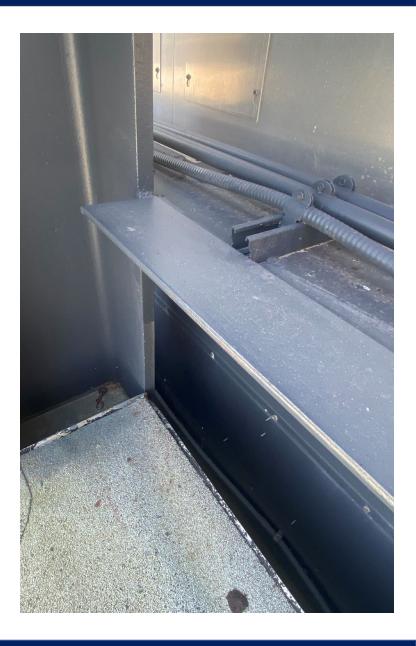
- Repair damaged and deteriorated purlins at the videoboard location.
- Temporarily remove videoboard, scoreboard and rotating panels to allow for replacement and repair of four (4) purlins.
- Assess all bolts and brackets as removal allows for full visibility.

ACCESSIBLE AREAS COMPLETED

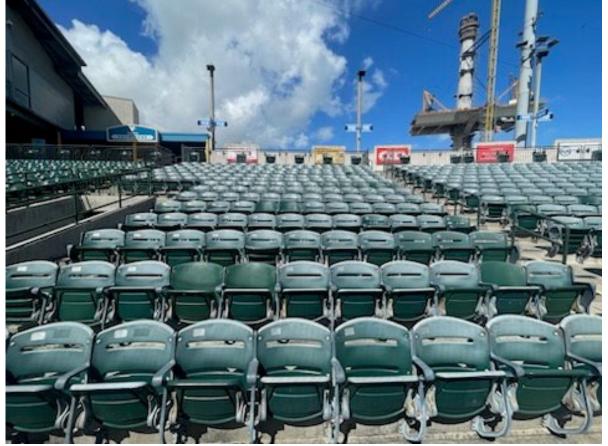
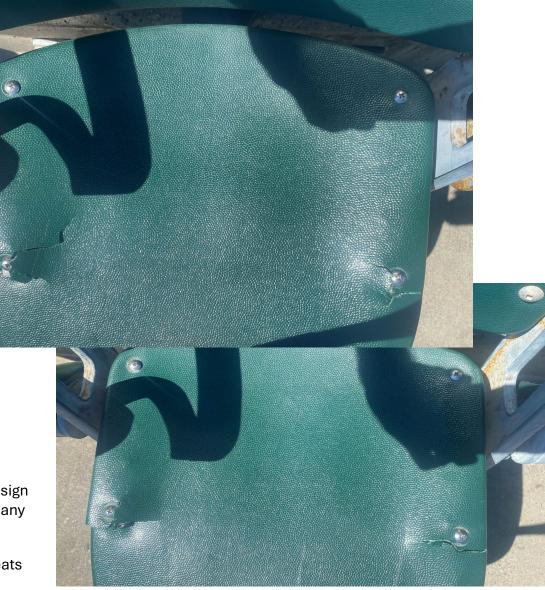
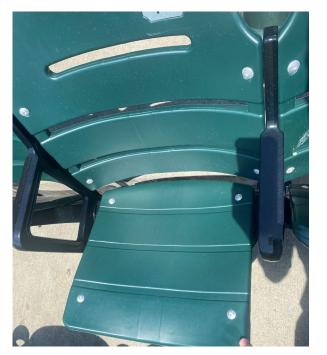
The Hooks will be removing and replacing 1,781 original seats, the last of which remain. The seat design is flawed with a short seat pivot arm supporting the seat bottom and is prone to breaking. The company is long out-of-business and no attic stock remain for ongoing replacements.

New seat stanchions, backs and bottoms to be installed. Seat model will match those of existing seats for interchangeable compatibility.

New seat stanchions, backs and bottoms to be installed. Seat model will match those of existing seats for interchangeable compatibility. COMPLETED
