Hoots

NETTING EXTENSION

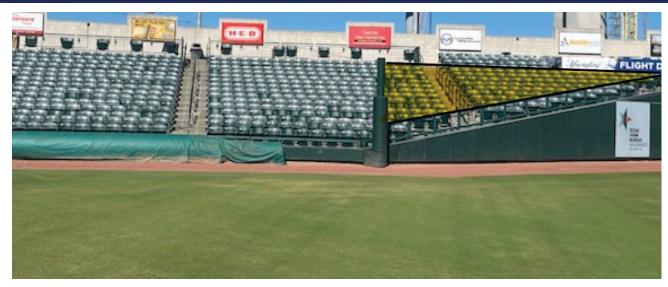
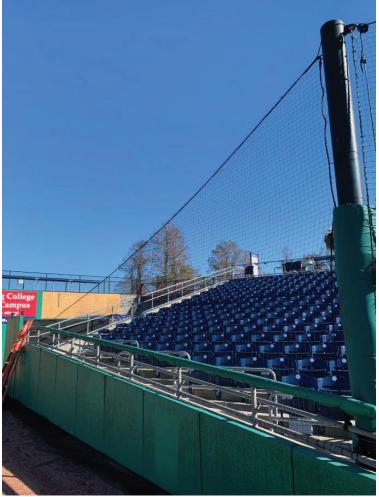
- Extend foul line netting to end point of seating bowl at left and right field.
- Using existing infrastructure, protective netting will be harnessed to on-field pole extending to end of seating bowl utilizing field railing along upward incline.
- Same netting grade as existing netting will be installed for continuity and fan viewing.
- Extension is facilitated by amended guidance from Major League Baseball regarding fan protection.

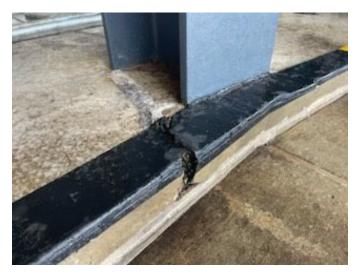
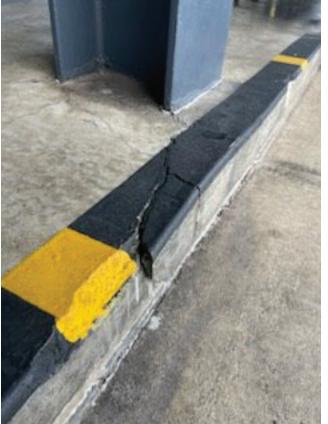
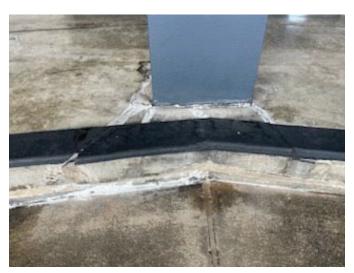
CONCRETE REPAIRS

- Repair cracked concrete located where the concourse meets the top steps where aisles contain I-beam placement.
- Total of eleven (11) locations
- Area around all sides of I-beam will be replaced, refortified and new concrete installed

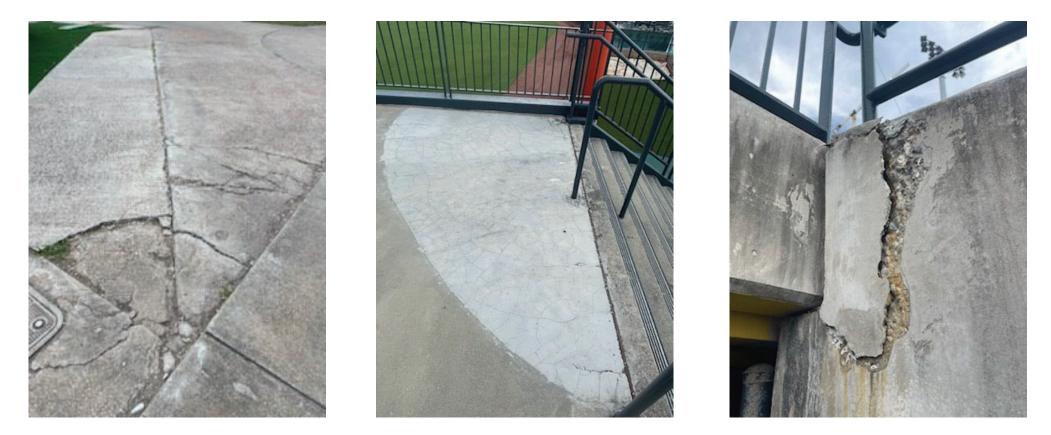
CONCRETE REPAIRS

Miscellaneous concrete repairs throughout stadium to eliminate failures and trip hazards

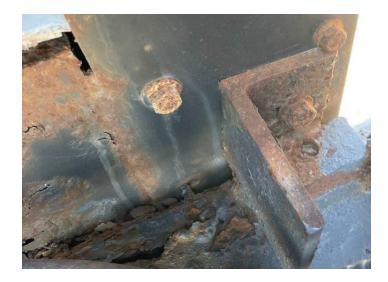
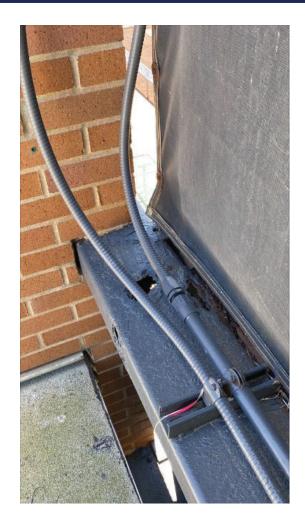
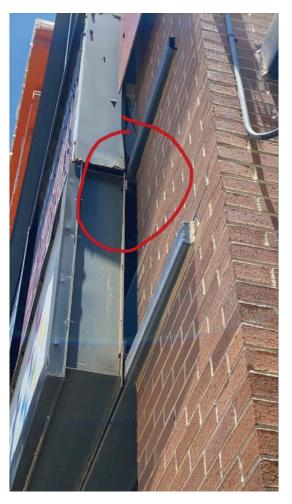
VIDEOBOARD STEEL REPAIRS

- Repair damaged and deteriorated purlins at the videoboard location.
- Temporarily remove videoboard, scoreboard and rotating panels to allow for replacement and repair of four (4) purlins.
- Assess all bolts and brackets as removal allows for full visibility.

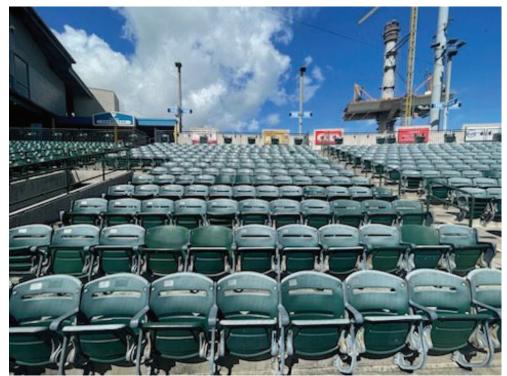
STADIUM SEAT REPLACEMENT

The Hooks will be removing and replacing 1,781 original seats, the last of which remain. The seat design is flawed with a short seat pivot arm supporting the seat bottom and is prone to breaking. The company is long out-of-business and no attic stock remain for ongoing replacements.

New seat stanchions, backs and bottoms to be installed. Seat model will match those of existing seats for interchangeable compatibility.
