1747 15TH ST BUILDING #2-RESIDENTIAL STRUCTURE

Case# V230292-042224

City of Corpus Christi – BUILDING SURVEY

Property Address: 1747 FIFTEENTH ST LW

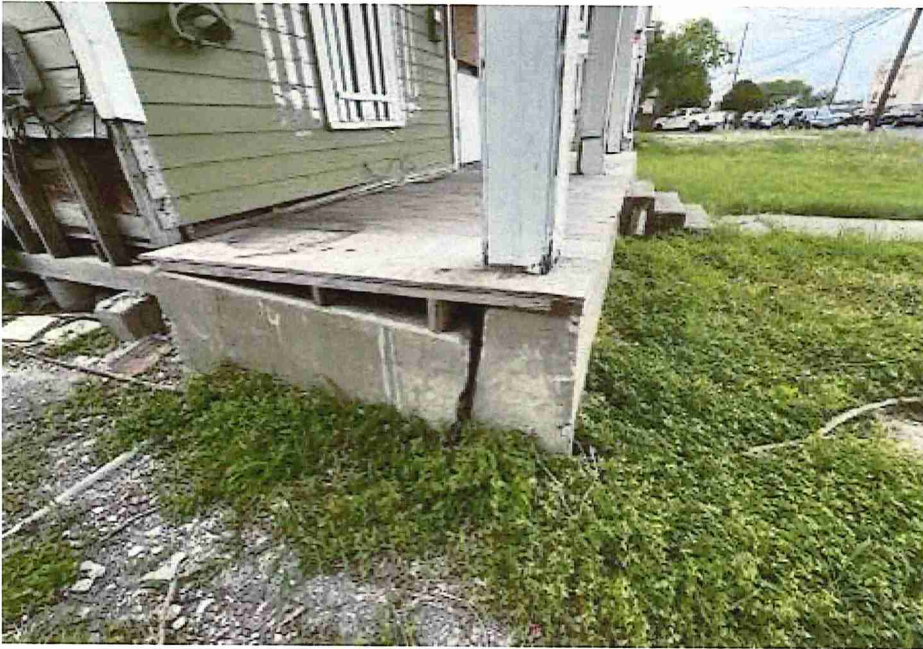
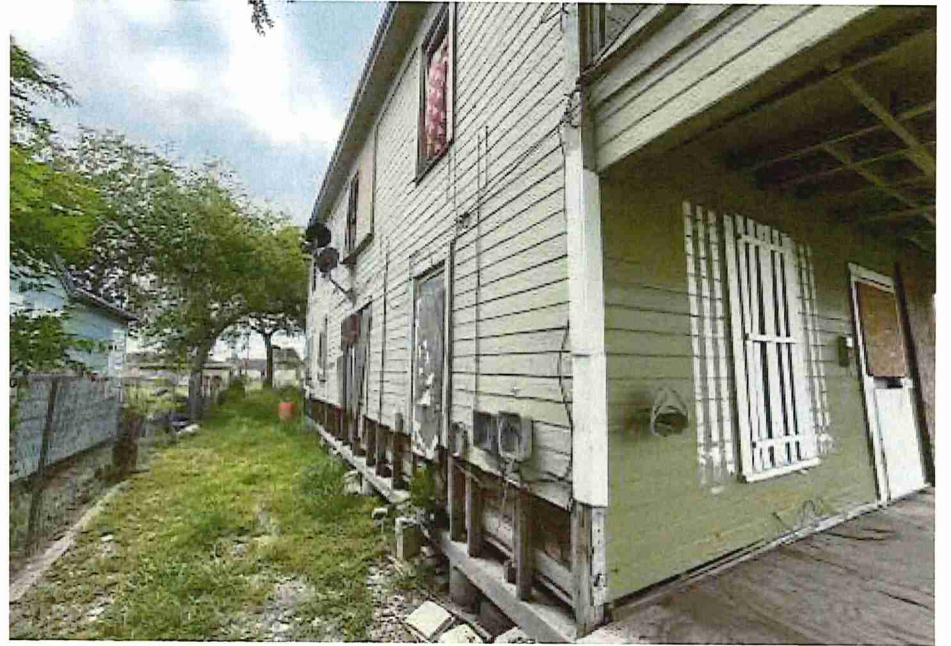
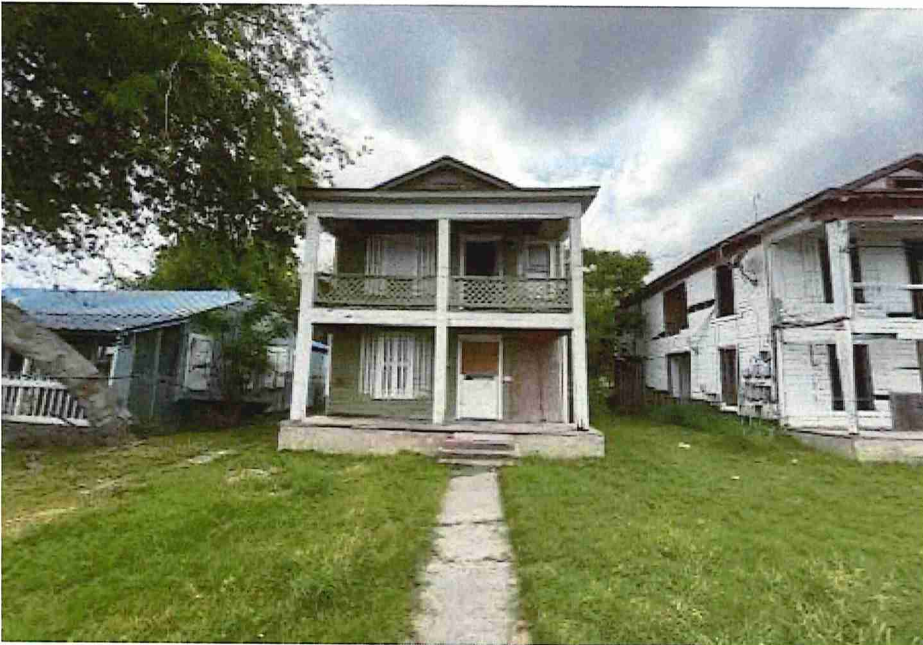
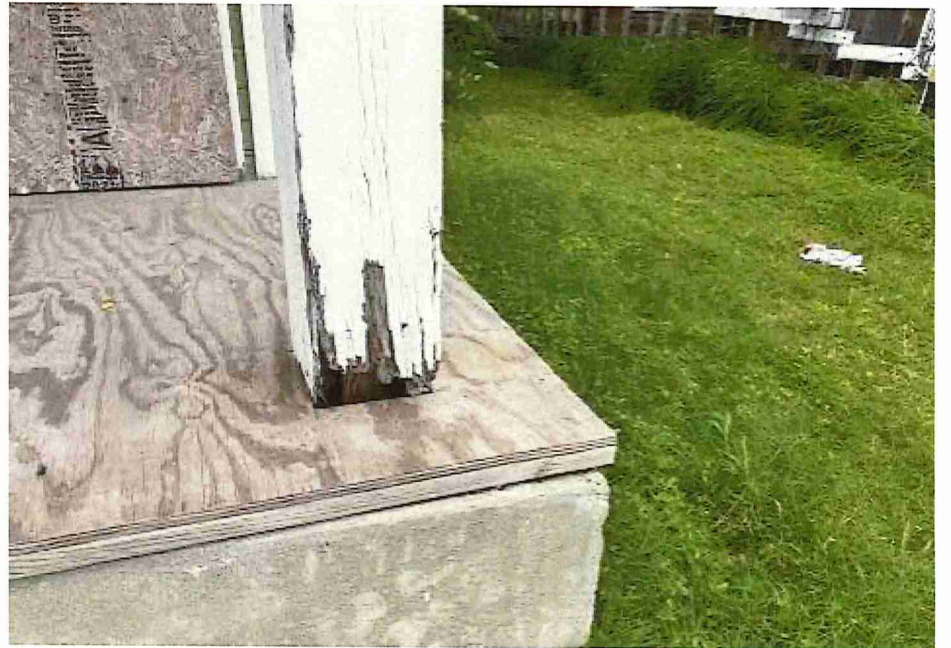
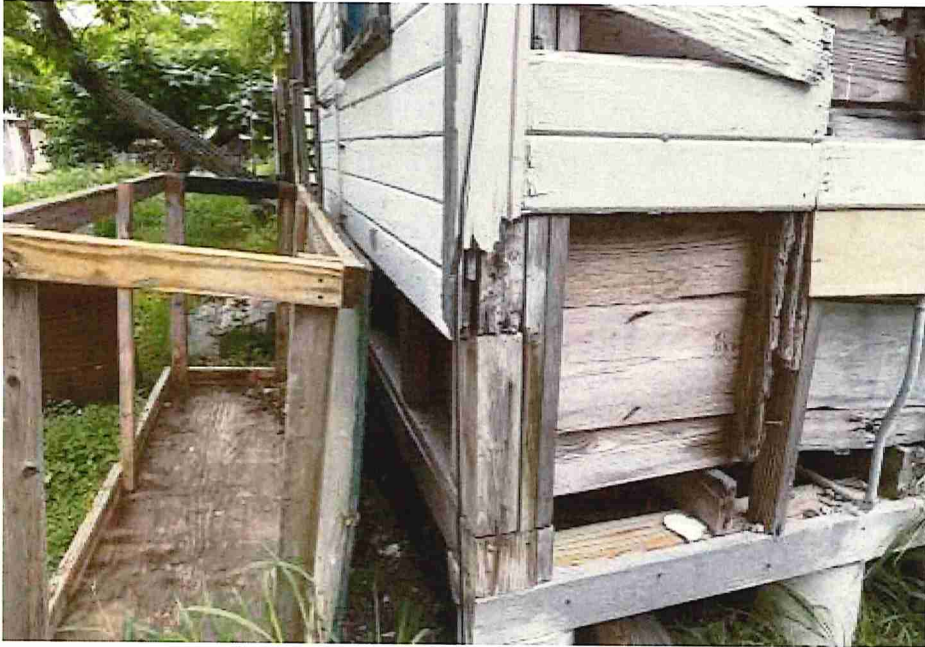
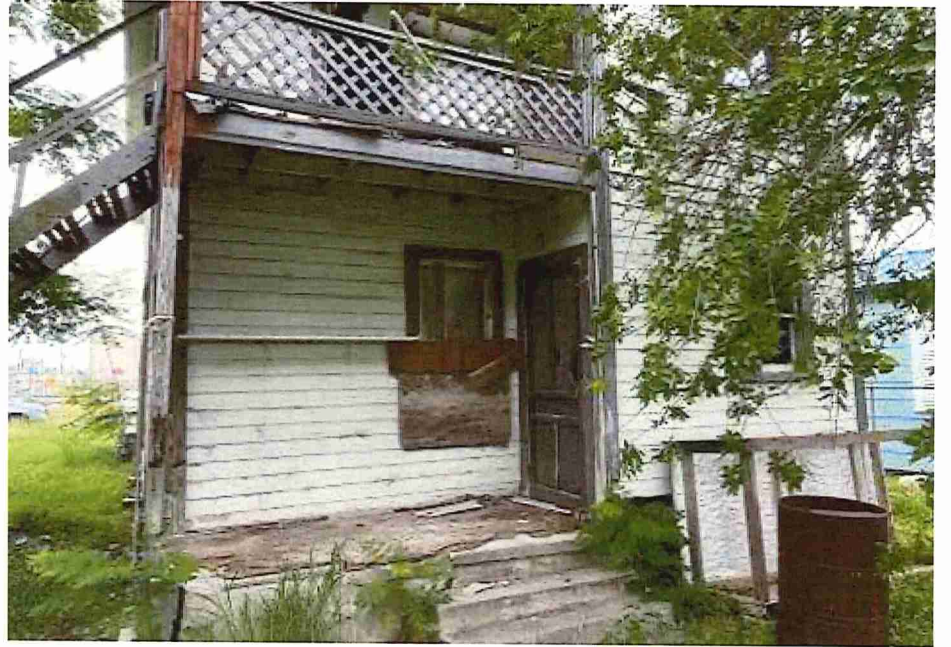
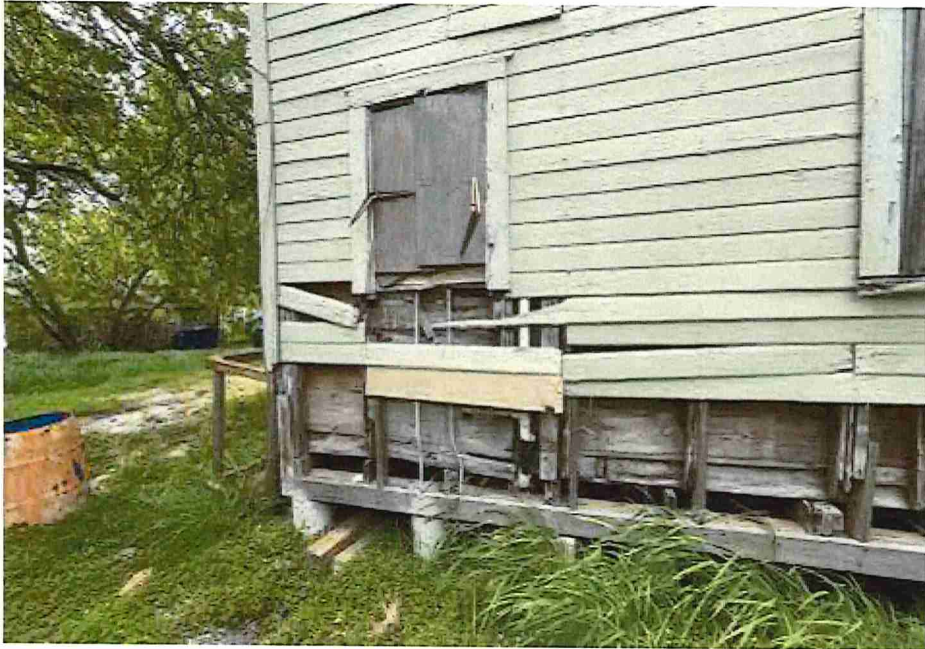
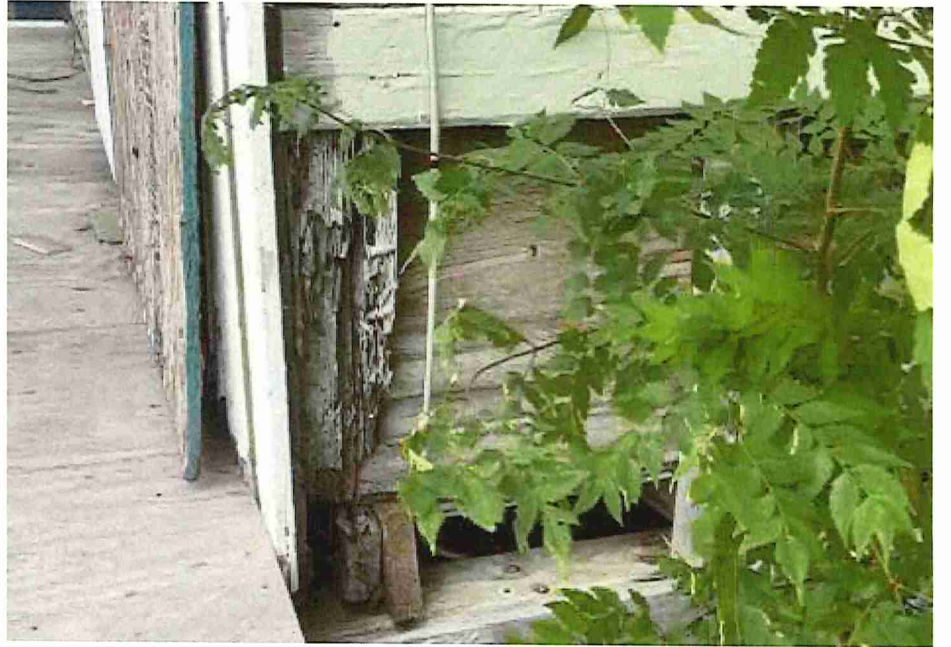
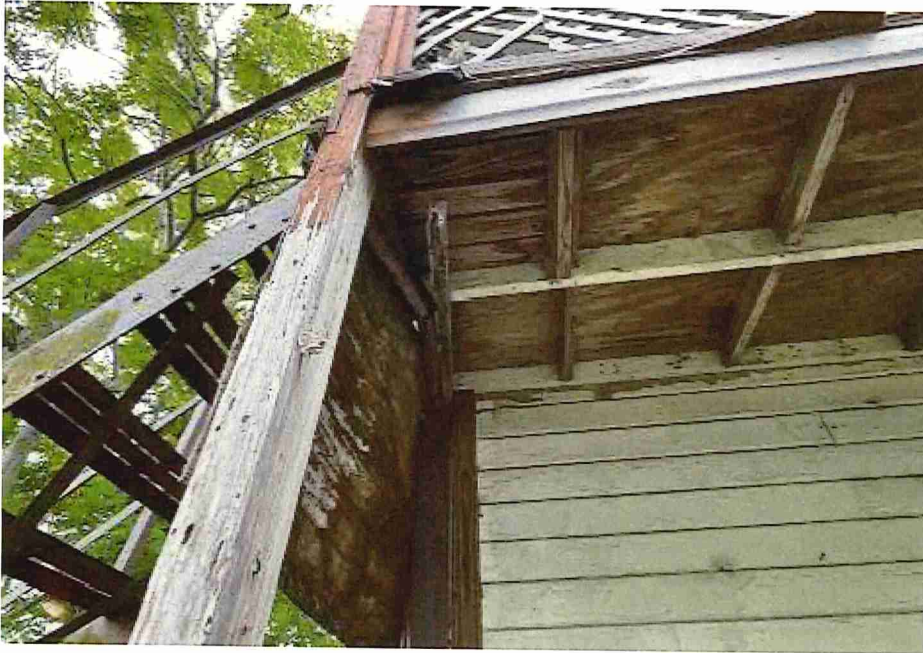
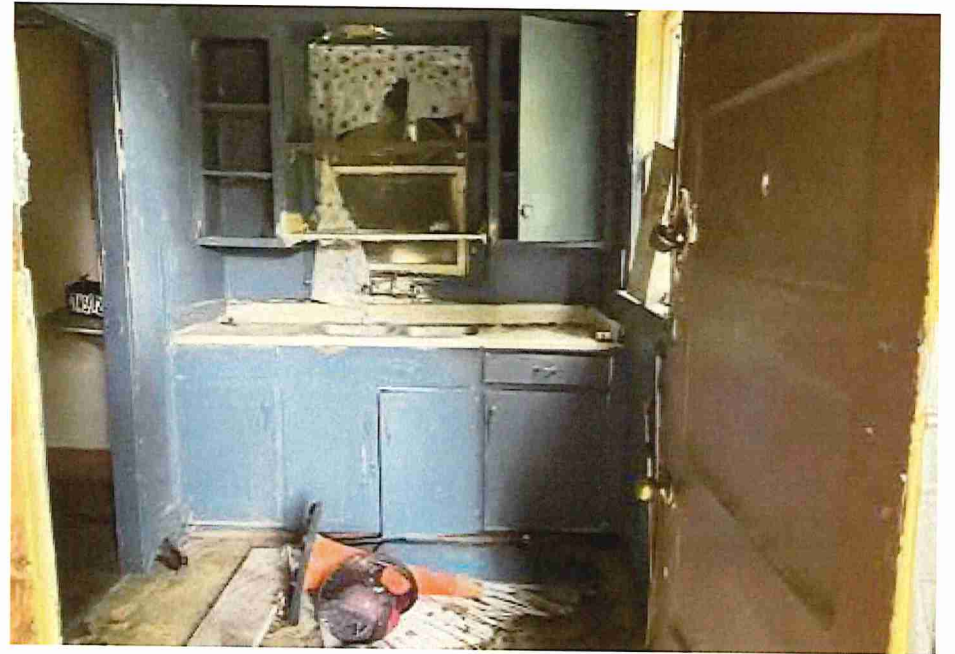
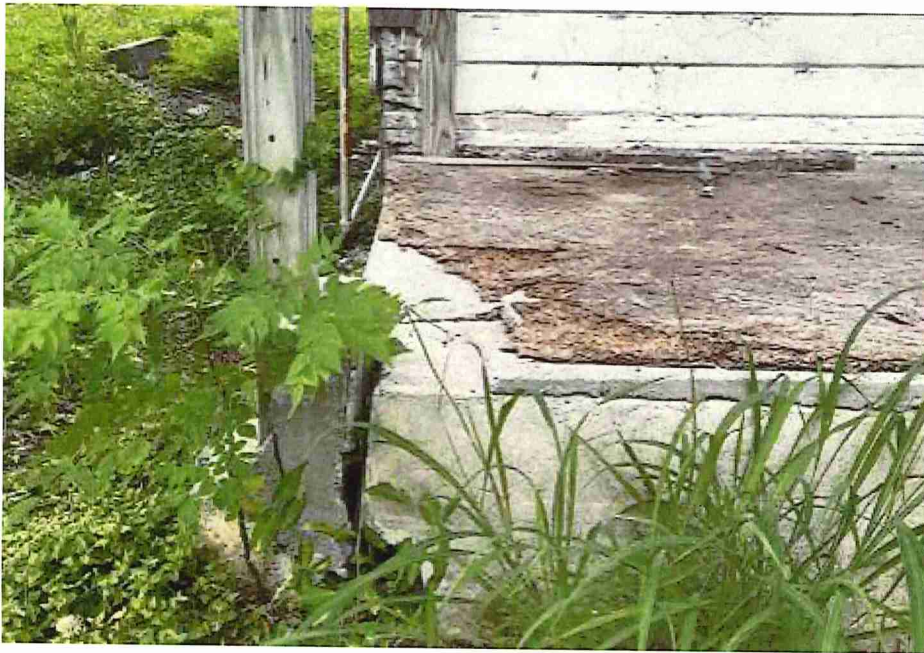
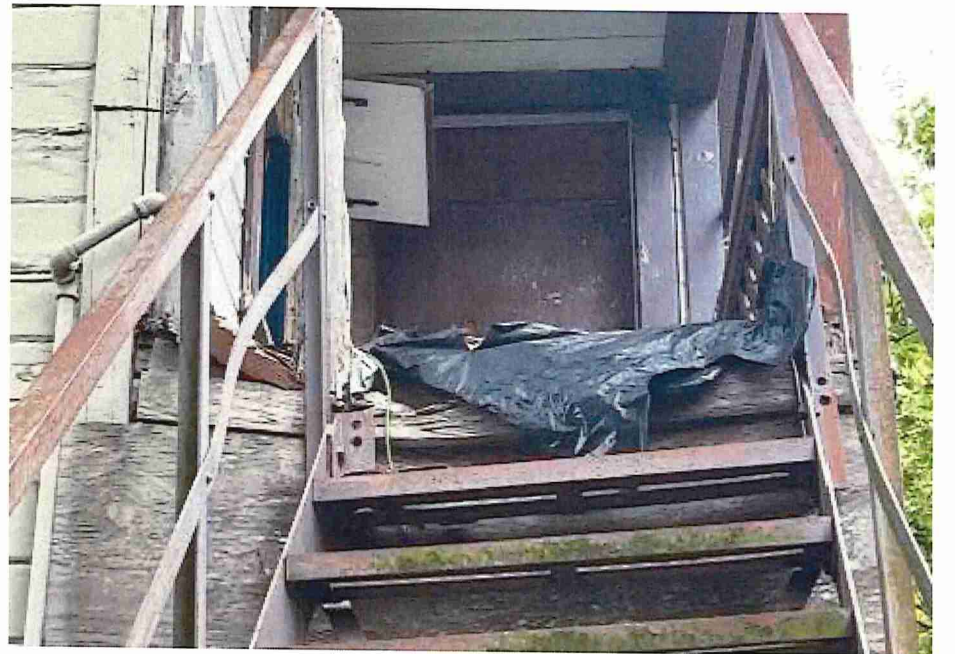
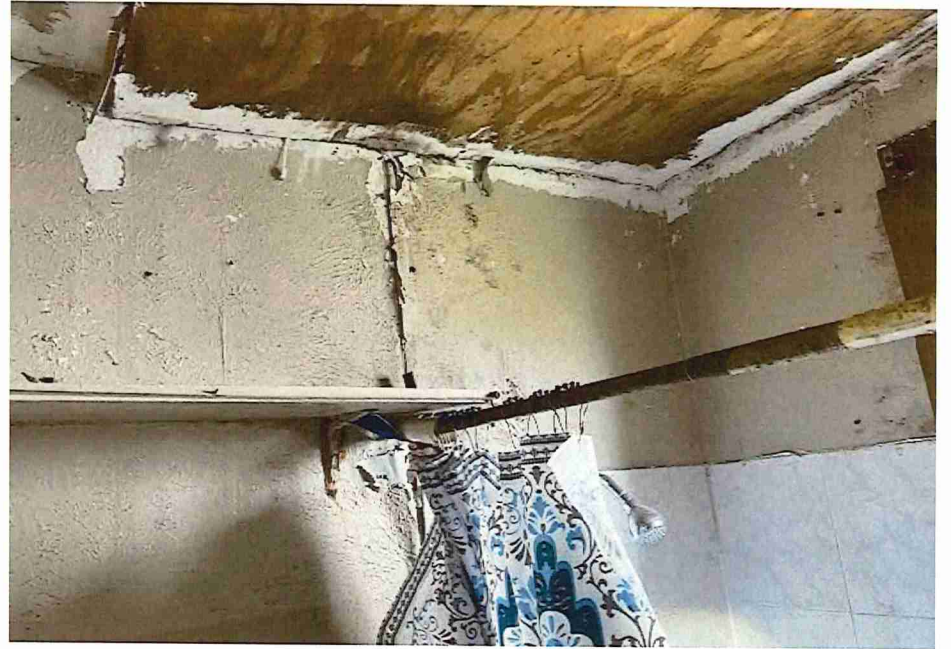
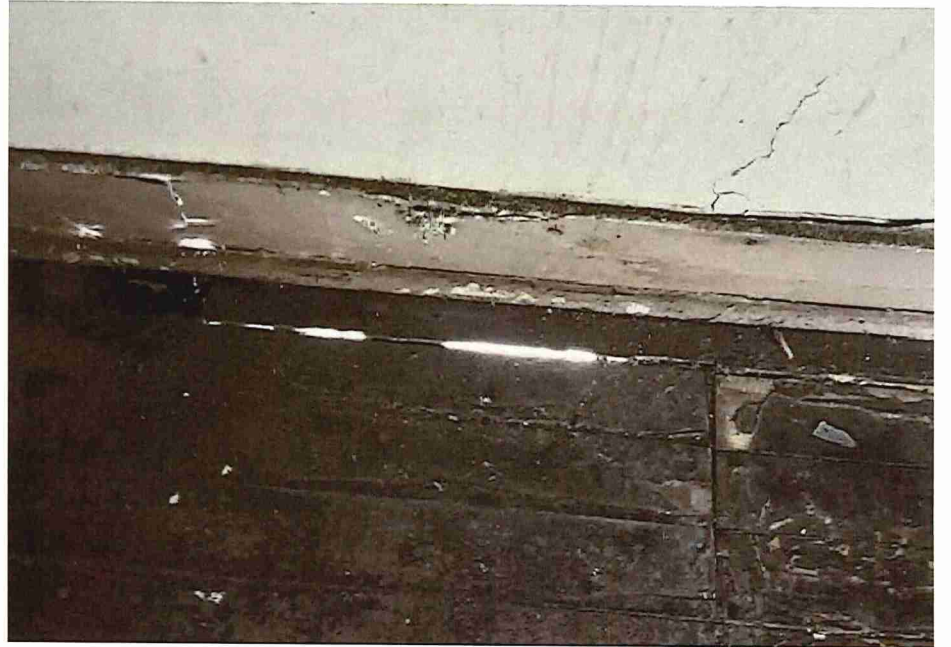
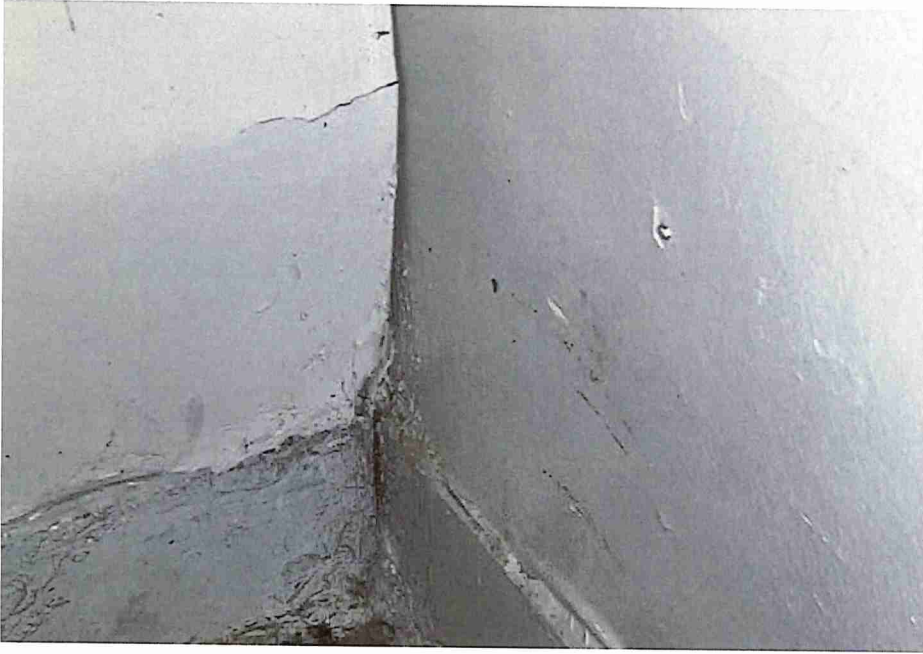
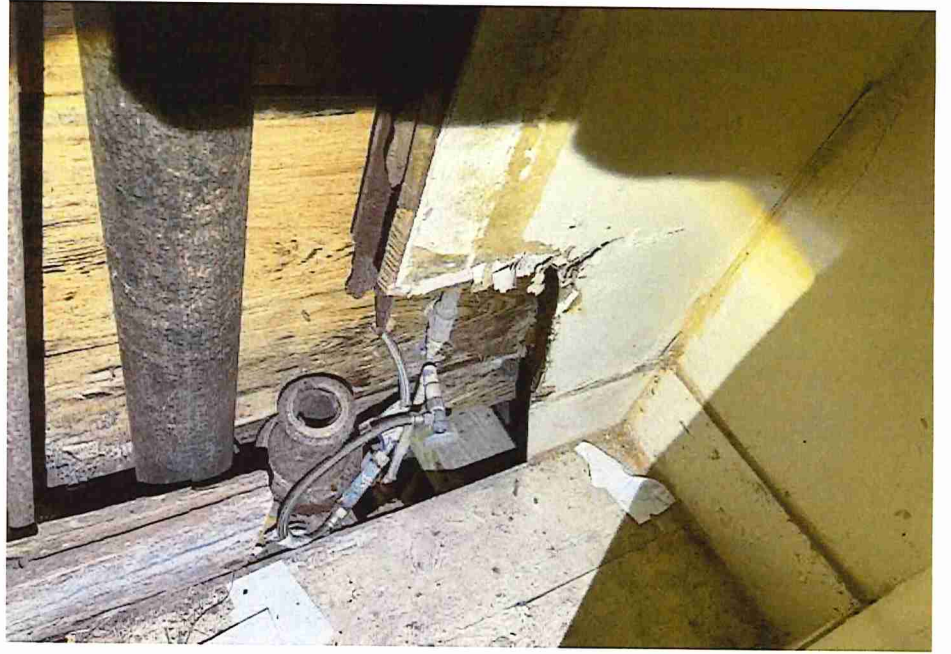
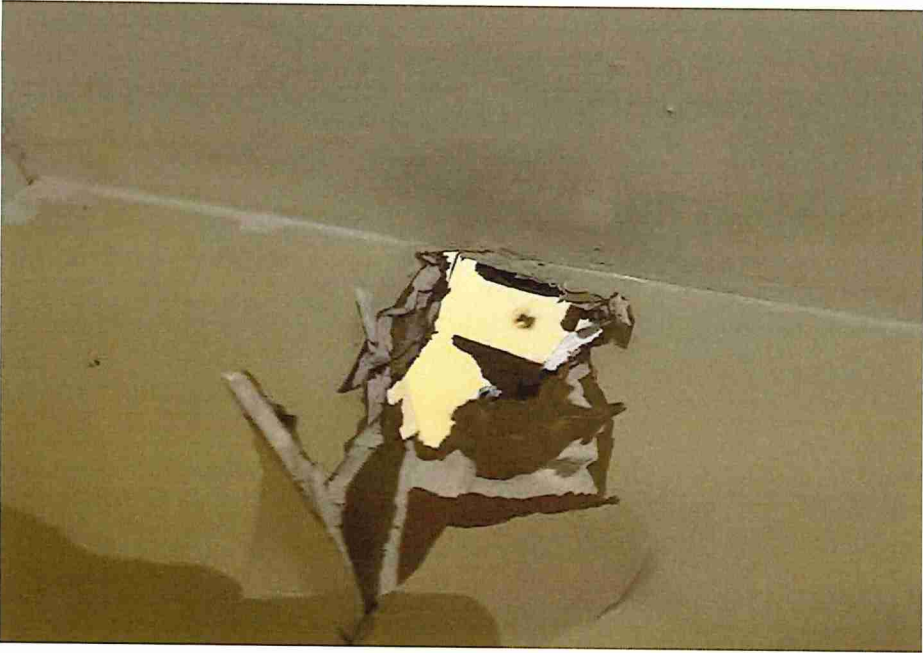
Structure deemed substandard based on the following findings:

- Structure does not meet the minimum requirements and standards as set forth in the Corpus Christi Property Maintenance Code.
- Exterior of the structure is not in good repair, is not structurally sound, and does not prevent the elements or rodents from entering the structure.
- Interior of the structure is not in good repair, is not structurally sound, and is not in a sanitary condition.
- Structure is unfit for human occupancy and found to be dangerous to the life, health, and safety of the public.

VIOLATION(S): 1747 15TH ST. AKA BUILDING #2

108.1.3 Structure unfit for human occupancy. A structure is unfit for human occupancy whenever the code official finds that such structure is unsafe, unlawful or, because of the degree to which the structure is in disrepair or lacks maintenance, is insanitary, vermin or rat infested, contains filth and contamination, or lacks ventilation, illumination, sanitary or heating facilities or other essential equipment required by this code, or because the location of the structure constitutes a hazard to the occupants of the structure or to the public.

304.1 General. The exterior of a structure shall be maintained in good repair, structurally sound and sanitary so as not to pose a threat to the public health, safety or welfare.

304.13 Window, skylight and door frames. Every window, skylight, door and frame shall be kept in sound condition, good repair and weather tight.

304.15 Doors. Exterior doors, door assemblies, operator systems if provided, and hardware shall be maintained in good condition. Locks at all entrances to dwelling units and sleeping units shall tightly secure the door. Locks on means of egress doors shall be in accordance with Section 702.3.

304.6 Exterior walls. Exterior walls shall be free from holes, breaks, and loose or rotting materials; and maintained weatherproof and properly surface coated where required to prevent deterioration.

304.7 Roofs and drainage. The roof and flashing shall be sound, tight and not have defects that admit rain. Roof drainage shall be adequate to prevent dampness or deterioration in the walls or interior portion of the structure. Roof drains, gutters and downspouts shall be maintained in good repair and free from obstructions. Roof water shall not be discharged in a manner that creates a public nuisance.

305.1 General. The interior of a structure and equipment therein shall be maintained in good repair, structurally sound and in a sanitary condition. Occupants shall keep that part of the structure which they occupy or control in a clean and sanitary condition. Every owner of a structure containing a rooming house, housekeeping units, a hotel, a dormitory, two or more dwelling units or two or more nonresidential occupancies, shall maintain, in a clean and sanitary condition, the shared or public areas of the structure and exterior property.

305.3 Interior surfaces. Interior surfaces, including windows and doors, shall be maintained in good, clean and sanitary condition. Peeling, chipping, flaking or abraded paint shall be repaired, removed or covered. Cracked or loose plaster, decayed wood and other defective surface conditions shall be corrected.

City Recommendation: Demolition of the residential structure (Building Survey attached)

Therefore, the owner be required to **demolish** the structure(s) within thirty (30) days. If demolition is not started and completed as required, then the City be authorized to demolish.
